## 5.0 Falls City, Texas, Disposal Site

### 5.1 Compliance Summary

The Falls City, Texas, Uranium Mill Tailings Radiation Control Act (UMTRCA) Title I Disposal Site was inspected on January 20, 2015. The site was in excellent condition. Some perimeter signs are discolored and becoming illegible; these will be replaced. Inspectors identified no other maintenance needs or cause for a follow-up inspection.

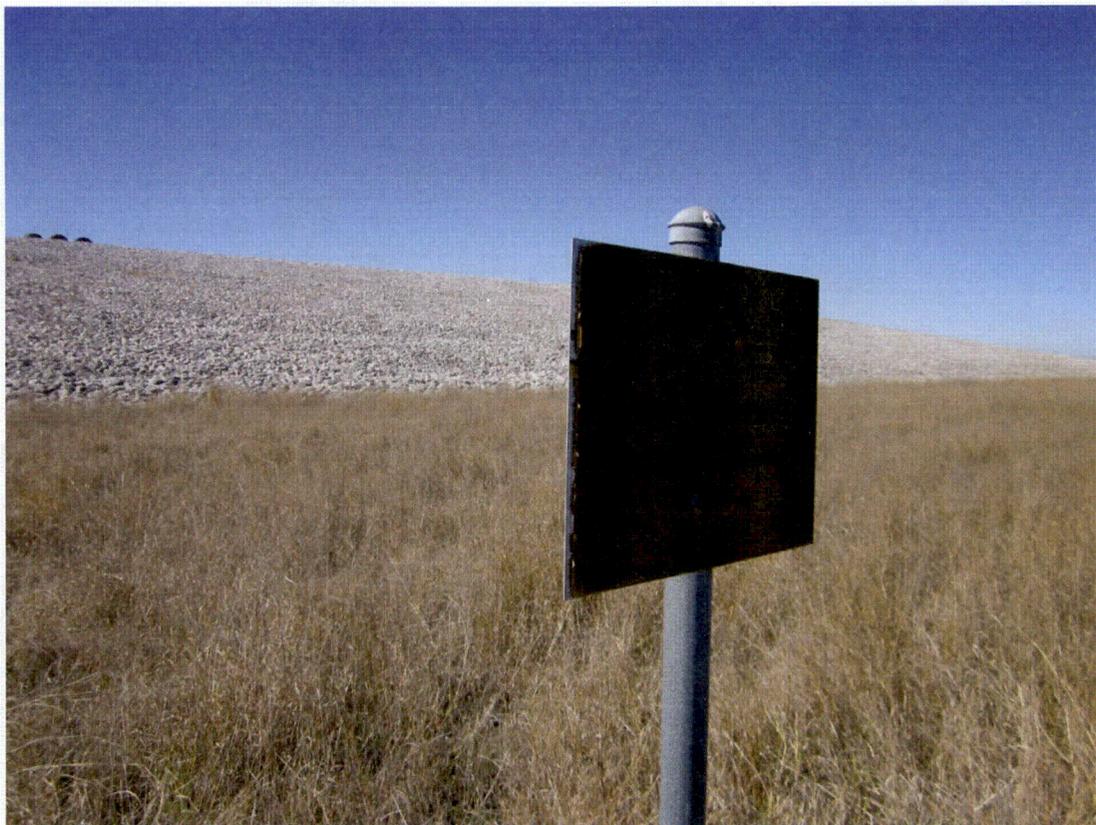
The entrance sign located next to the main entrance gate was in good condition. There are 64 perimeter signs installed along the perimeter fence. One sign has a bullet hole but remains legible. Other signs, particularly those facing Farm-To-Market Road 1344, are discolored and several polypropylene signs are bent; these will be replaced (PL-1).

FCT 1/2015. PL-1. Perimeter sign P63.

A Huisache tree located near perimeter sign P27 was treated with herbicide and will be removed. Routine site vegetation management continued in 2015 and DOE will recommend a program for controlling grass on the side slopes. DOE will determine if controlled grazing will be beneficial for vegetation management and turf vitality. DOE will replace weathered and discolored perimeter signs.

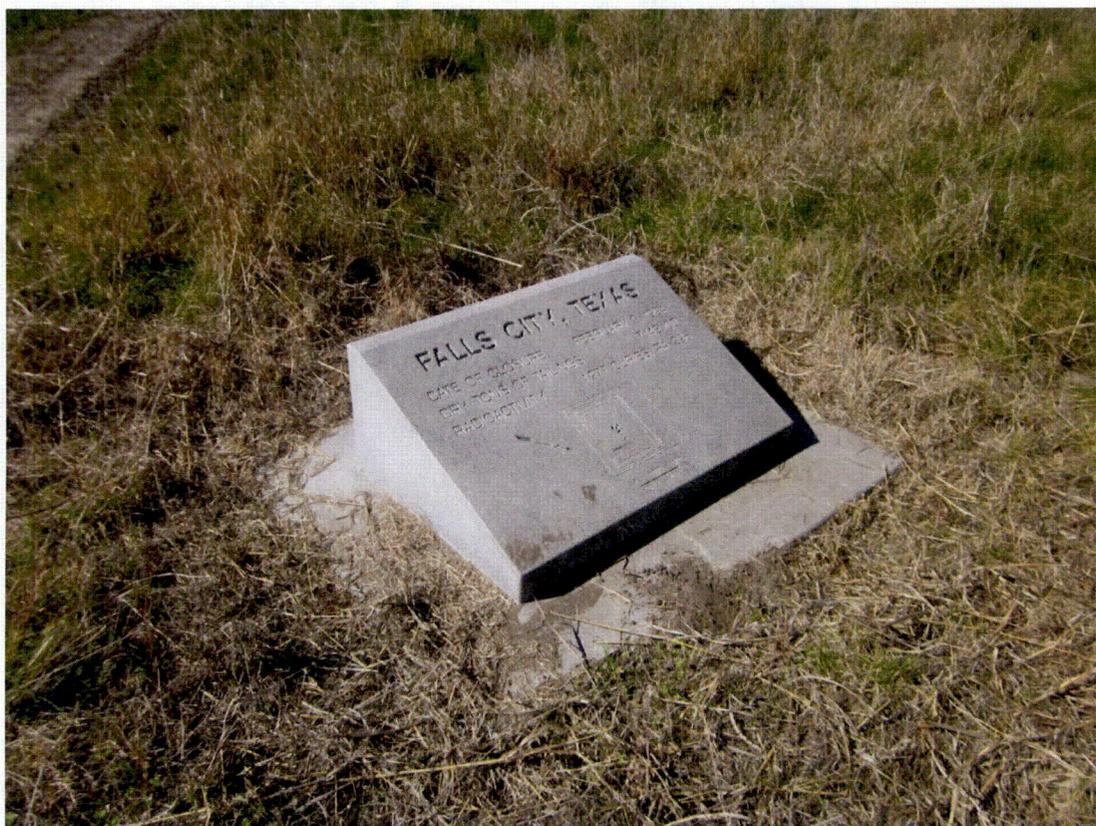
There are two site markers. The marker on top of the disposal cell (SMK-2) was in excellent condition. The marker at the entrance gate (SMK-1) was also in excellent condition (PL-2), but the corners of the concrete base around the marker are cracked. The cracks appear to be unchanged from last year, and repairs are not needed at this time.

FCT 1/2015. PL-2. Site marker SMK-1.

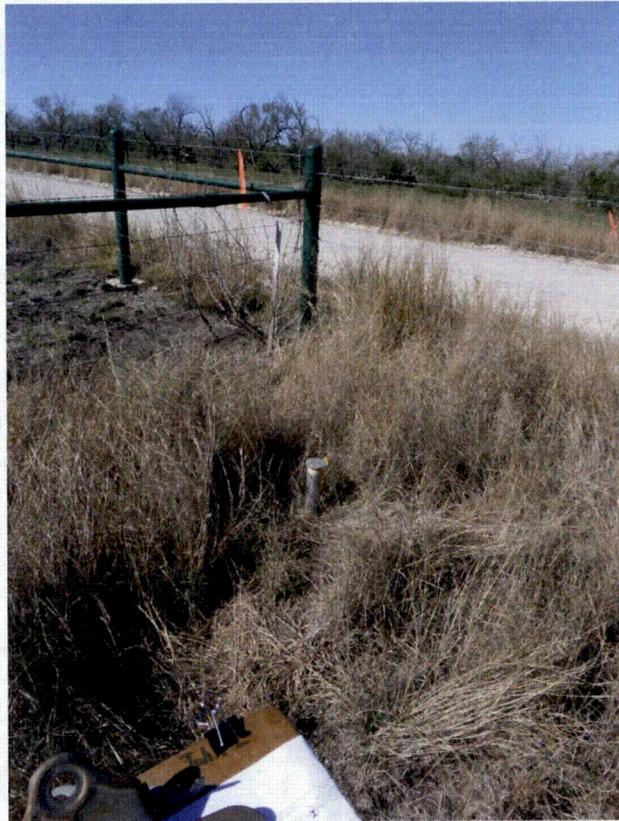
Three survey monuments and two boundary monuments situated at the corners of the site were undisturbed and in excellent condition (PL-3).

*FCT 1/2015. PL-3. Boundary monument BM-1.*

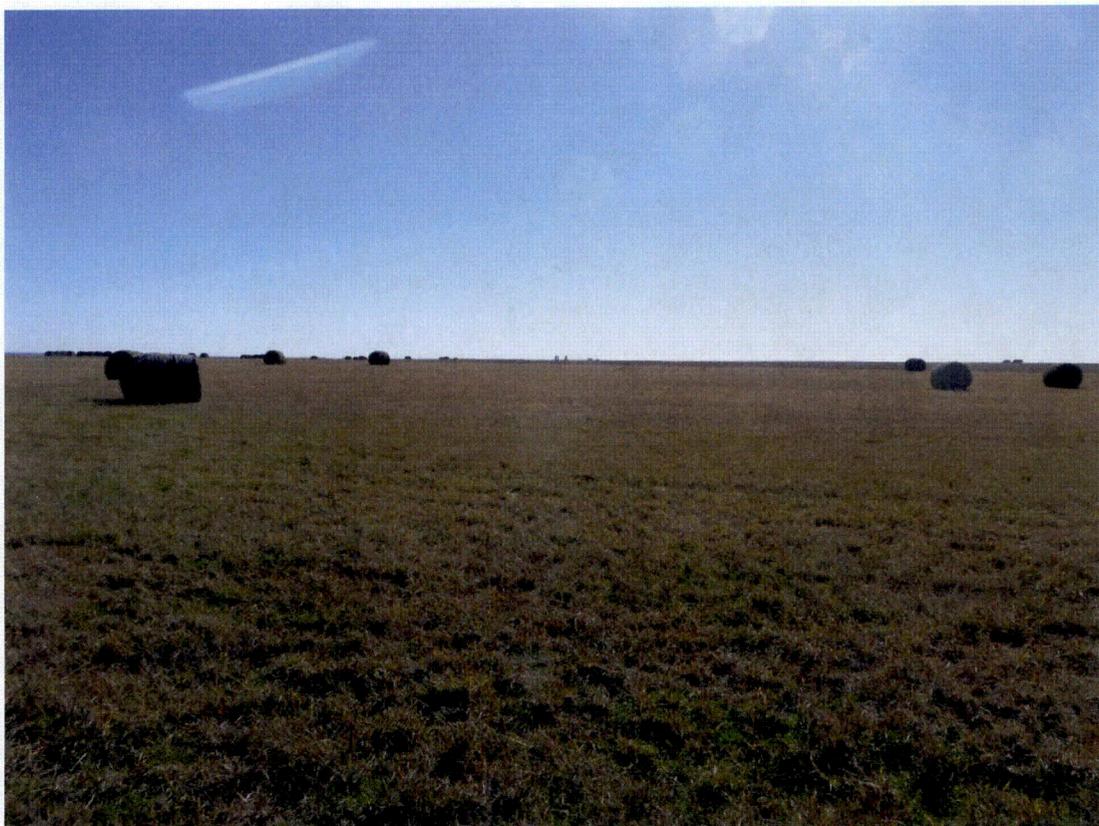
The top of the disposal cell was in excellent condition (PL-4). The cell is covered with well-established coastal Bermuda grass, kleingrass and other species are interspersed. Inspectors found very few woody plants in the turf areas. The maintenance subcontractor spot-sprays woody vegetation on the top slope and between the cell and the site perimeter.

*FCT 1/2015. PL-4. Cell top slope.*

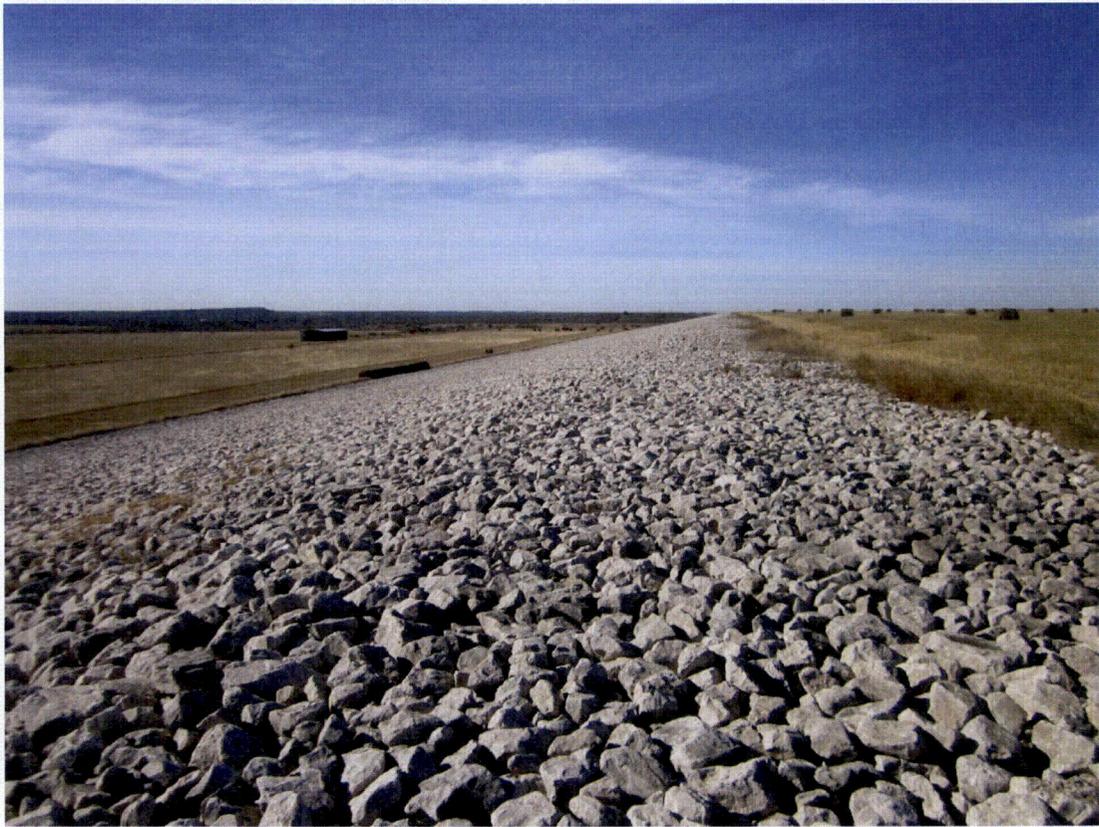
The side slopes are covered with riprap and were in excellent condition (PL-5). DOE has monitored several small depressions on the northwest side slope of the disposal cell since 2010. These depressions do not compromise the protectiveness of the riprap side slope and no changes have been observed since 2010.

*FCT 1/2015. PL-5. Southeast side slope.*

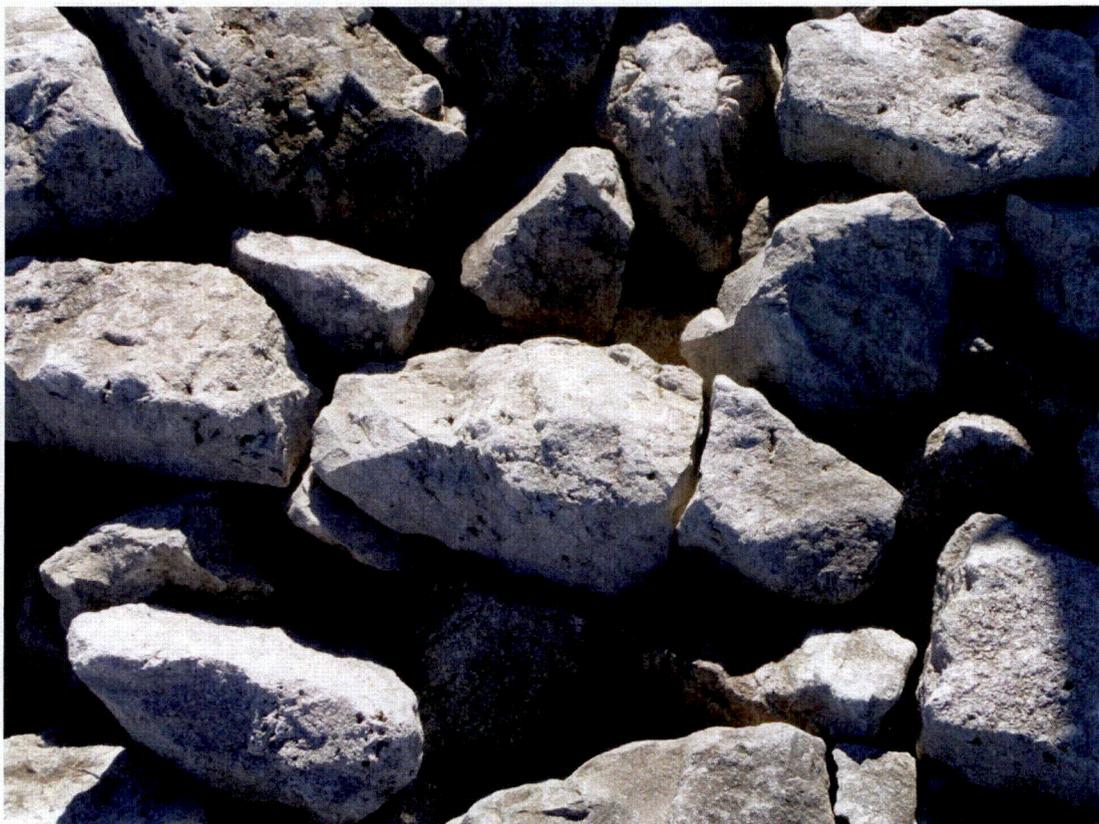
Fractured riprap has been observed on the side slopes of the disposal cell since the cell was completed. Pieces of riprap are fractured in place, indicating that the fracturing occurred after placement (PL-6). Inspectors suggest this is a consequence of thermal expansion and contraction. Riprap condition does not appear to be continuing to deteriorate. During this year’s inspection, photos were taken of riprap at the base of Post 4, near the access ramp on the west corner of the disposal cell (PL-7). Compared to photos taken in previous years at this location, there is no indication that the riprap is degrading. DOE will continue to monitor this process during future inspections and, if the number of fractured rocks appears to be increasing, will establish a more quantitative monitoring program, which may consist of establishing plots and conducting rock size or mass surveys.

*FCT 1/2015. PL-6. Fractured riprap.*

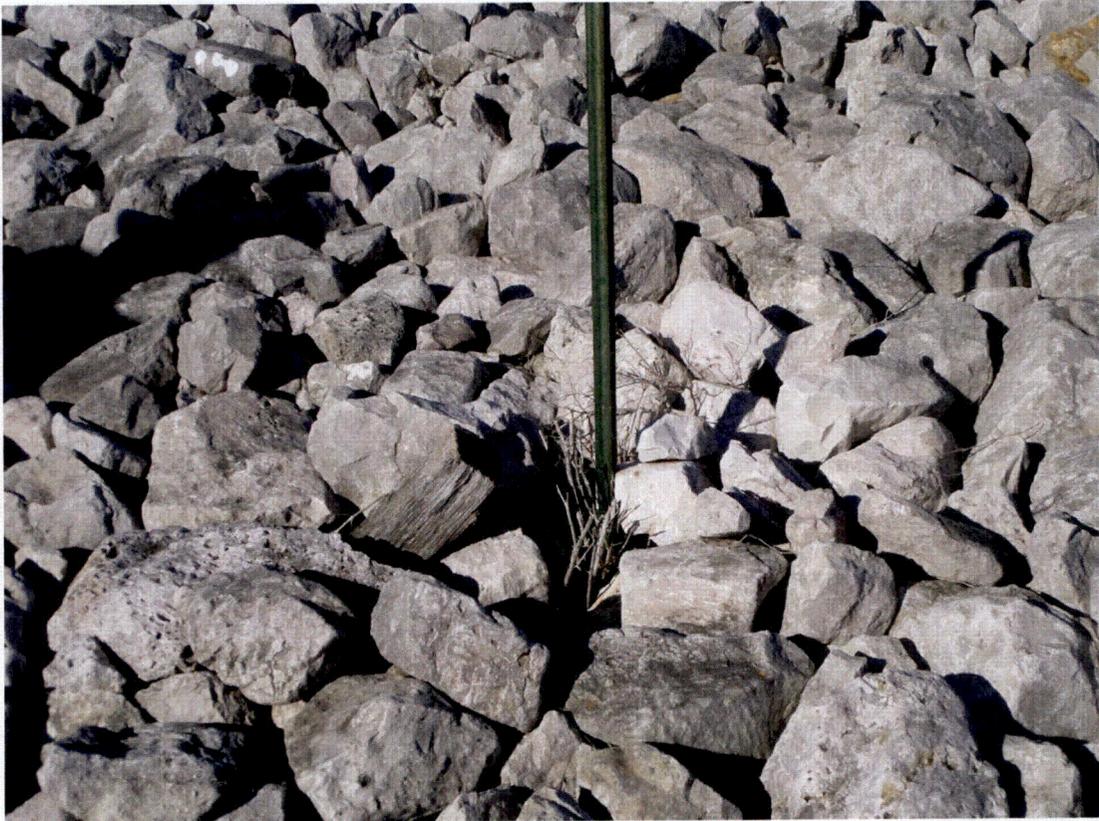
*FCT 1/2015. PL-7. Riprap at post 4 near ramp.*

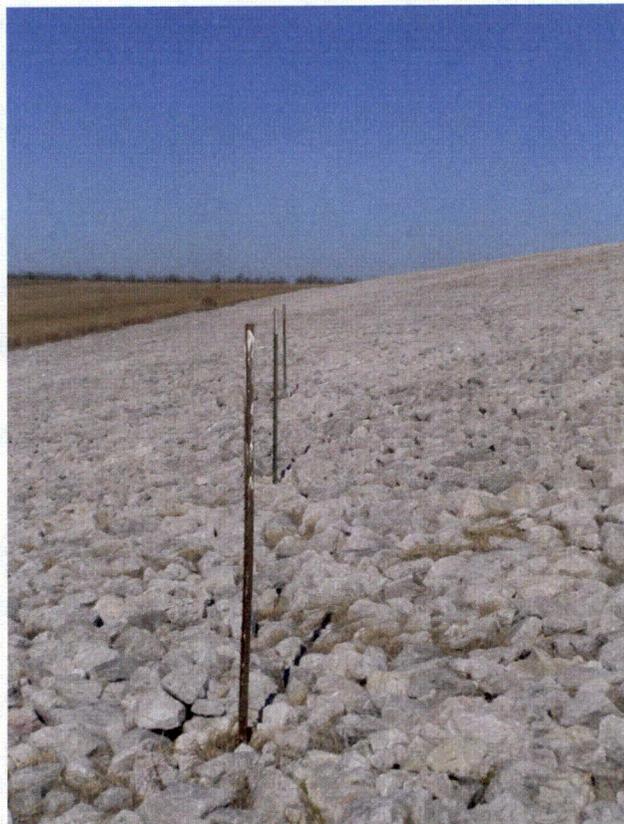
In 2007, inspectors noted a possible slight slumping of riprap at the toe of the south corner of the side slope. Three t-posts were installed in a straight line running at an orientation of 317 degrees in 2008. Each post was installed at a vertical pitch of 90 degrees. These three posts provide reference points that are used to assess if the area is undergoing movement. Movement of a post out of line with the other two posts or the change in pitch of an individual post will indicate possible movement in the area. The three posts remain in the same straight line at which they were installed and are at the same vertical pitch, indicating that no movement has occurred (PL-8).

*FCT 1/2015. PL-8. Posts at south corner of cell for monitoring slope creep.*

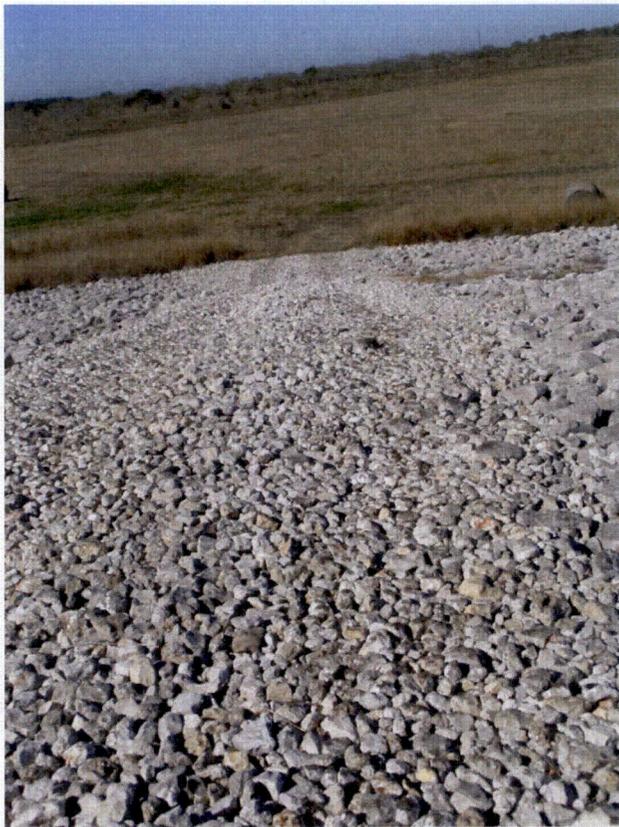
*FCT 1/2015. PL-9. Ramp on east corner of cell.*

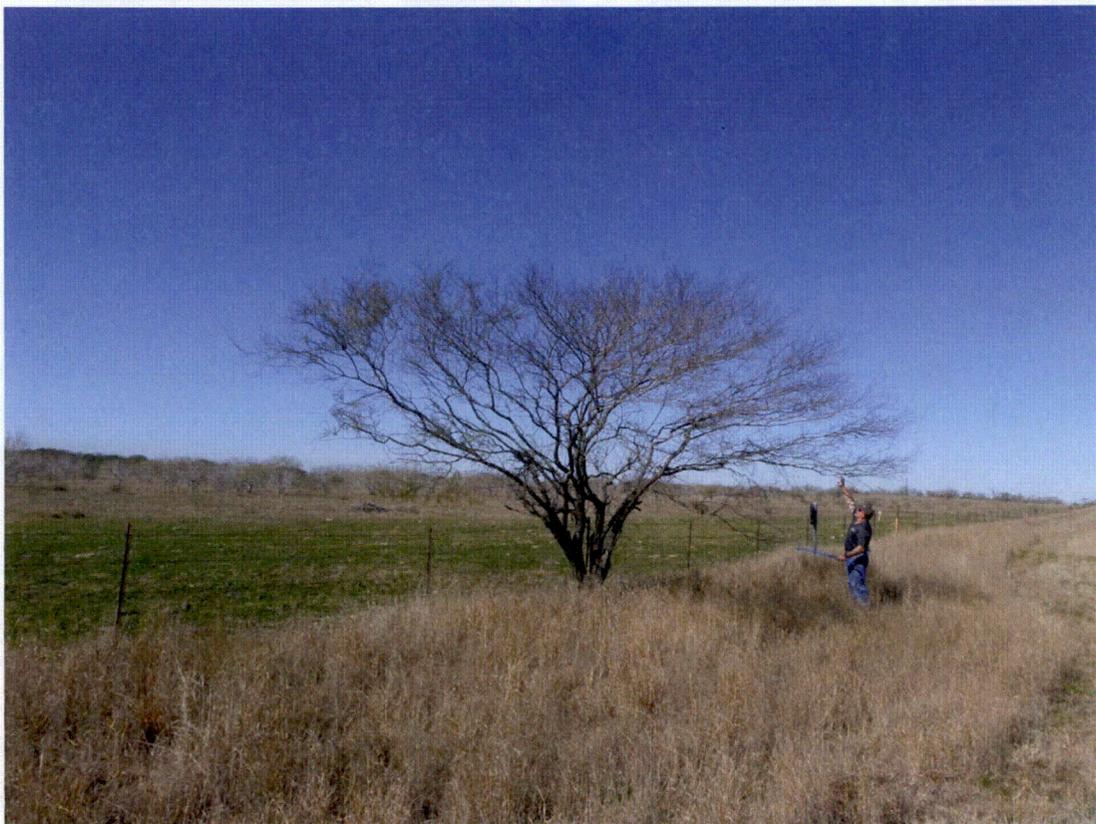
*FCT 1/2015. PL-10. Huisache tree on southwest property boundary.*

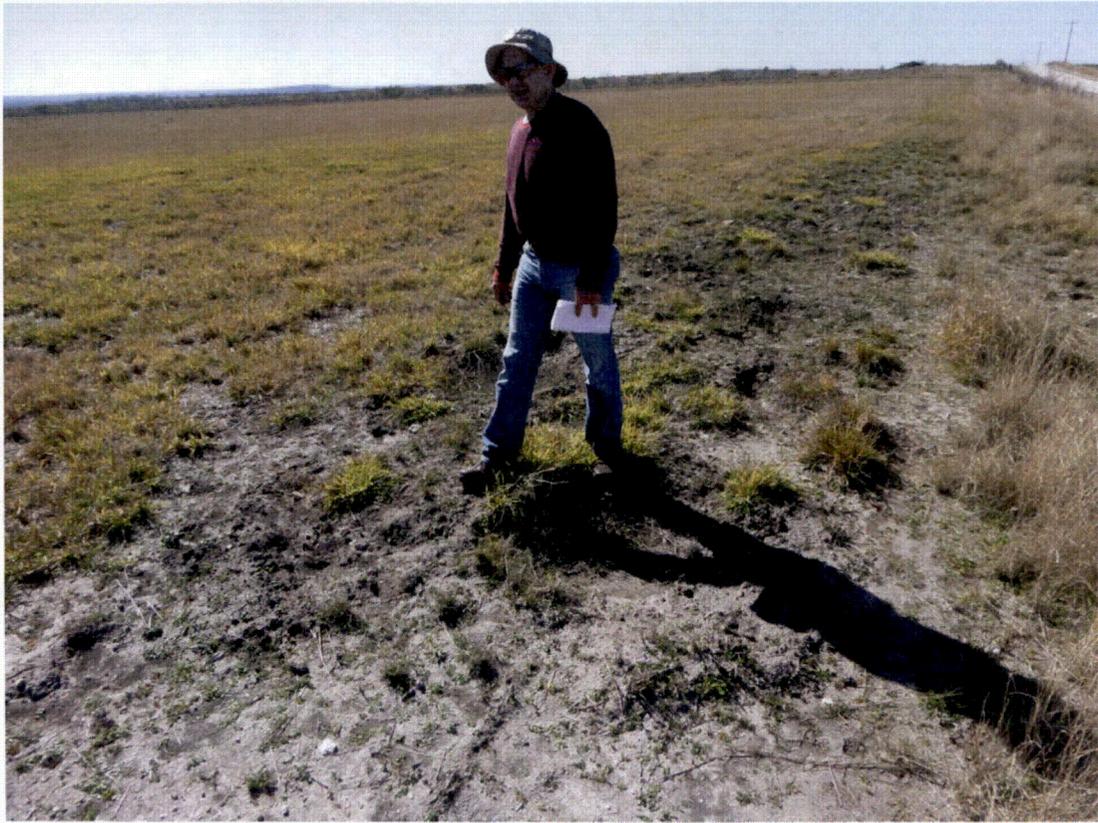
Wild hogs burrow along the fence line in some areas. Their burrows are filled in by the maintenance contractor as they are located because they might compromise the integrity of the fence or create depressions that could result in damage to haying equipment. Several areas along the northwest fence line were disturbed by hogs, resulting in minor bare spots (PL-11).

*FCT 1/2015. PL-11. Area denuded by wild hogs.*

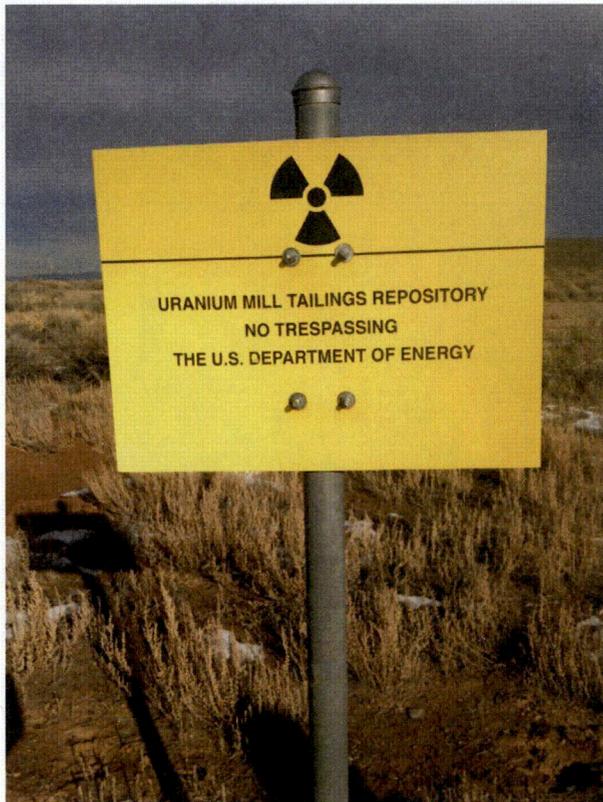
The perimeter fence was functional, secure, and in good condition. Sign P16 was damaged by a bullet hole but legible, and sign P24 has been displaced over time but is also legible and stable. All of the other perimeter signs were present and in good condition (PL-1).

GRJ 12/2015. PL-1. Perimeter sign P7.

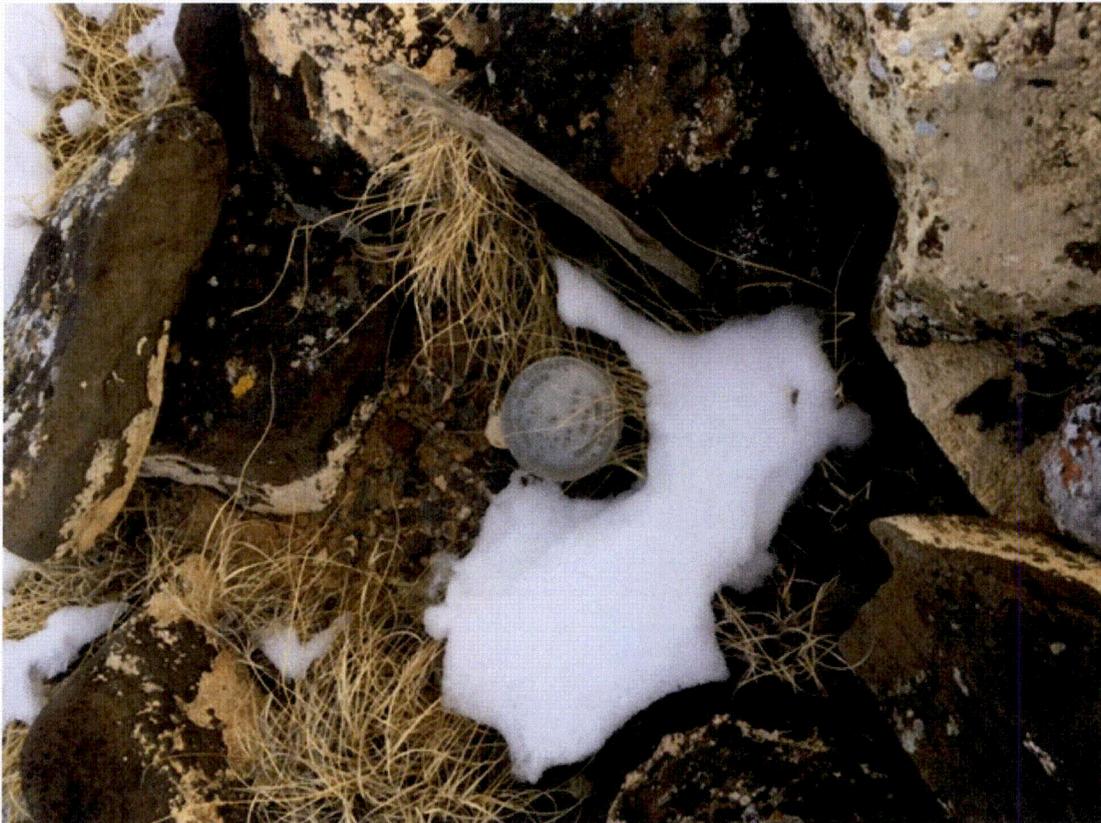
The site has four permanent boundary monuments, one at each of the four corners. All of the boundary monuments were located by inspectors and are in good condition (PL-2).

GRJ 12/2015. PL-2. Boundary monument 1.

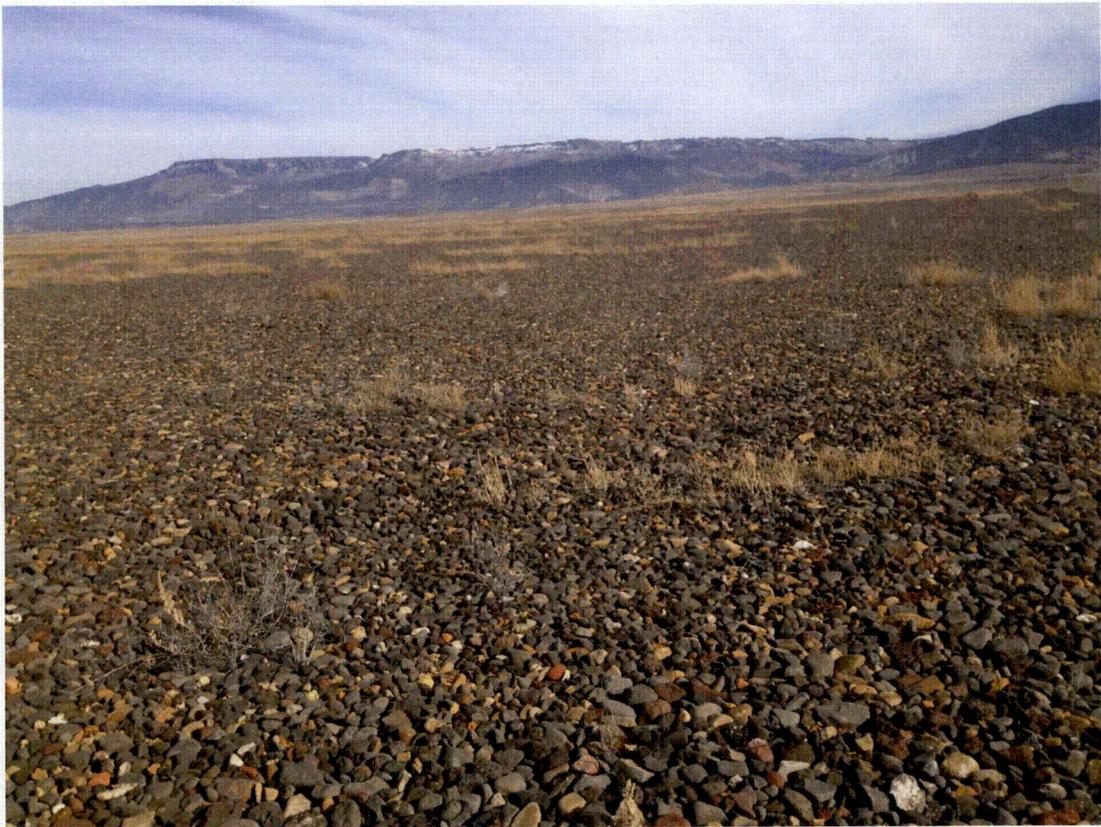
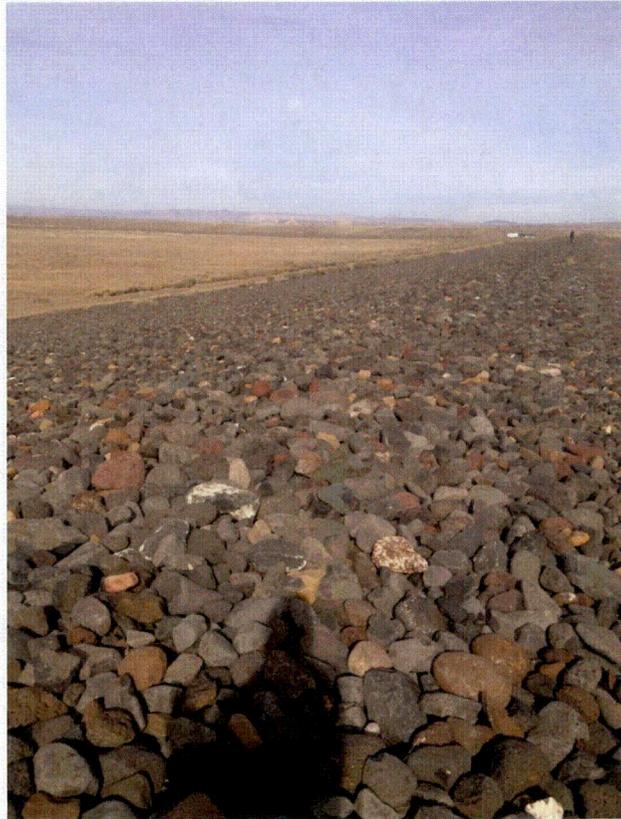
Basalt riprap covers the top and side slopes of the disposal cell. The rock was in good condition with no significant weathering. The disposal cell top and side slopes showed no evidence of settling, slumping, cracking, erosion, or slope instability (PL-3, PL-4).

*GRJ 12/2015. PL-3. Disposal cell cover.*

*GRJ 12/2015. PL-4. West side slope of the disposal cell.*

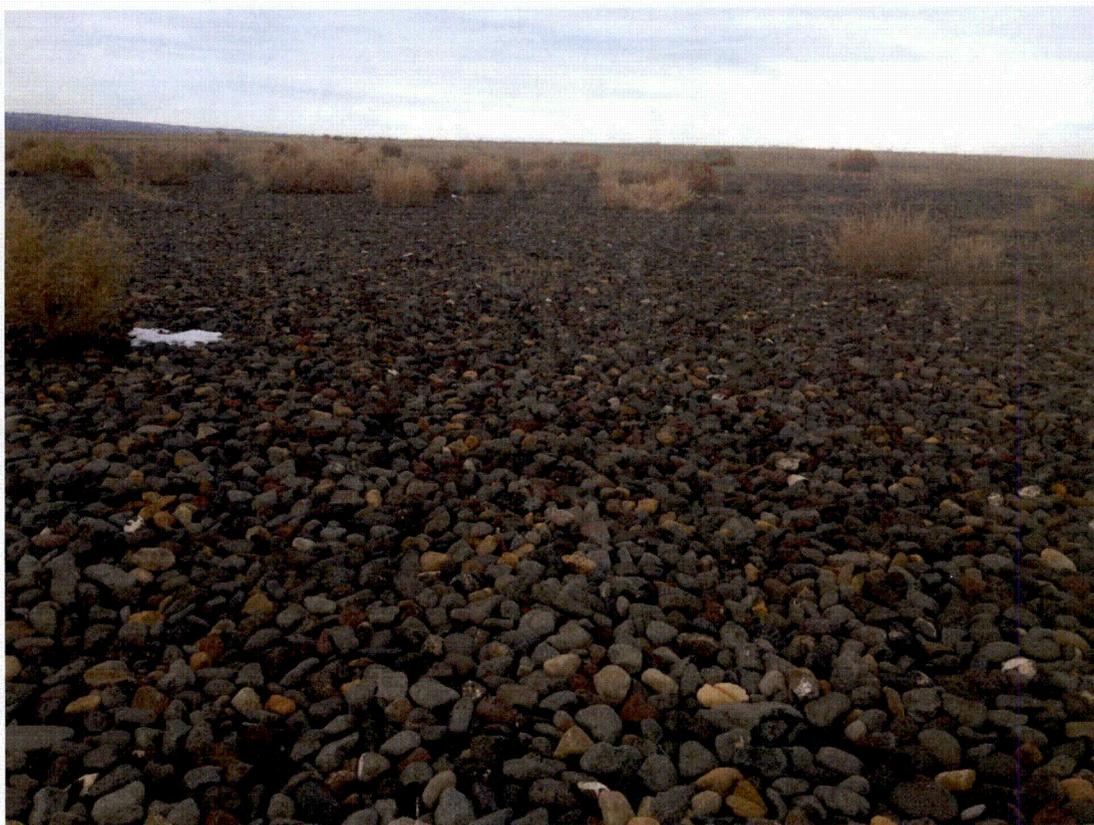
*GRJ 12/2015. PL-5. Southeast portion of the disposal cell cover showing shrub growth.*

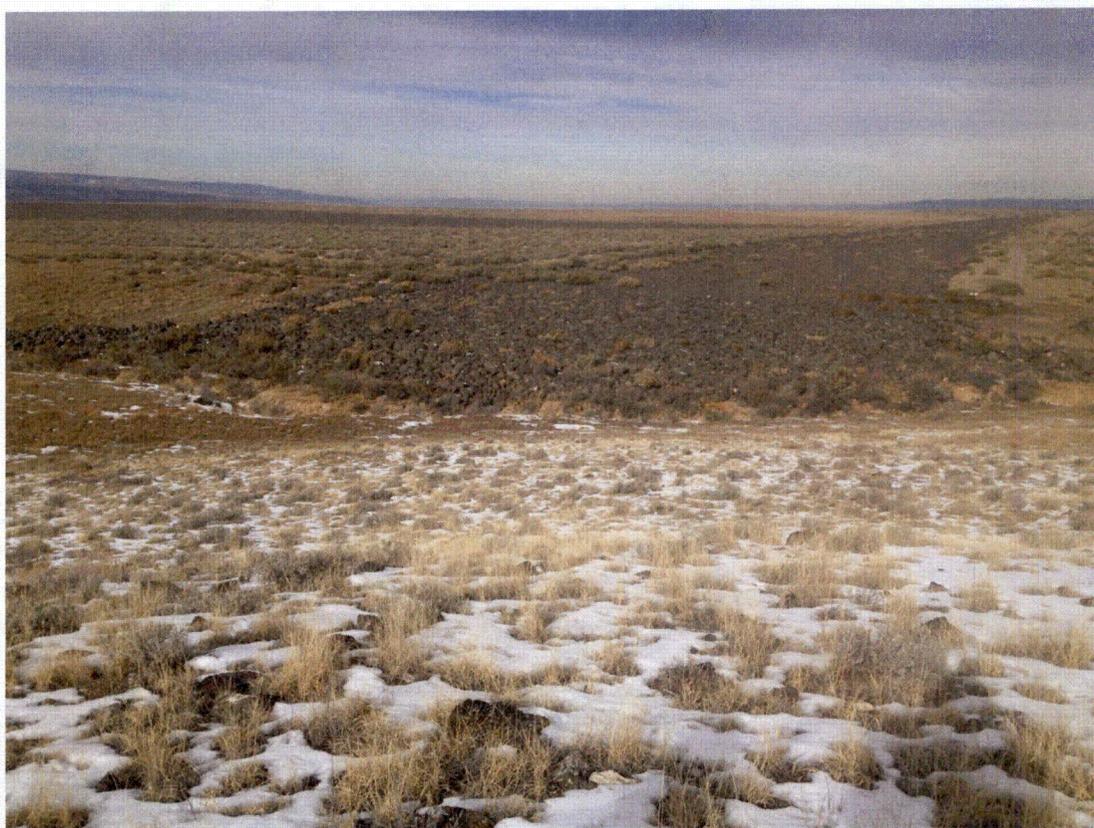
*GRJ 12/2015. PL-6. Outlet of the south diversion channel and surrounding area.*

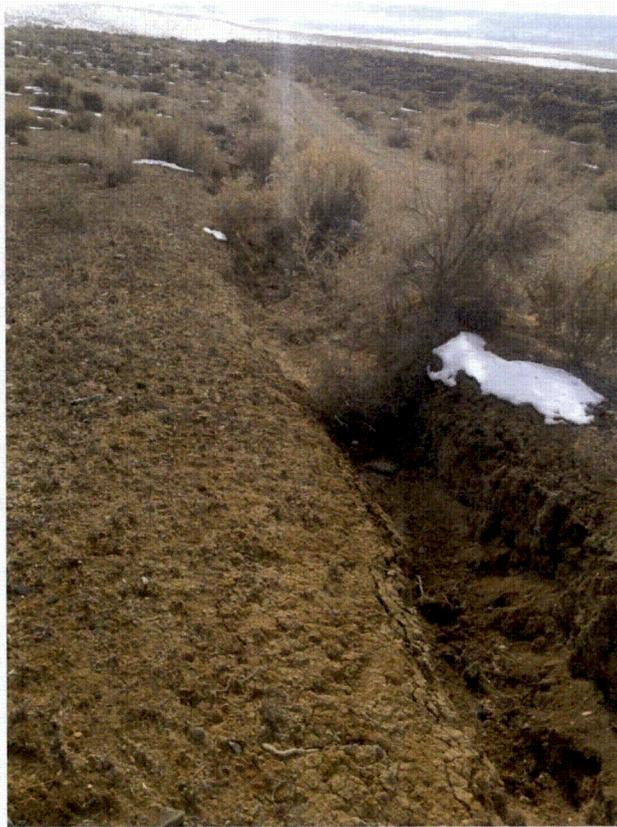
*GRJ 12/2015. PL-7. Erosion rill east of the access road, east of the disposal cell.*

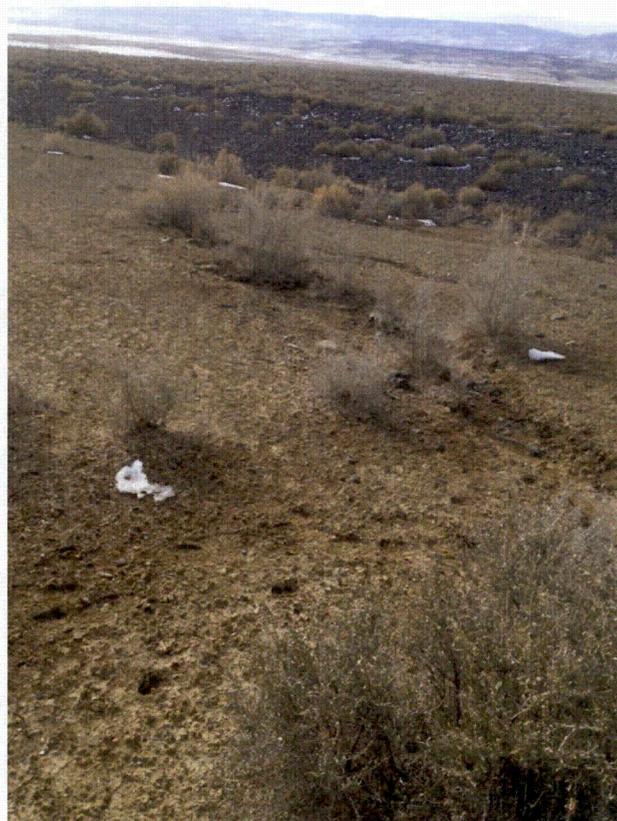
*GRJ 12/2015. PL-8. Erosion rill west of the access road, east of the disposal cell.*

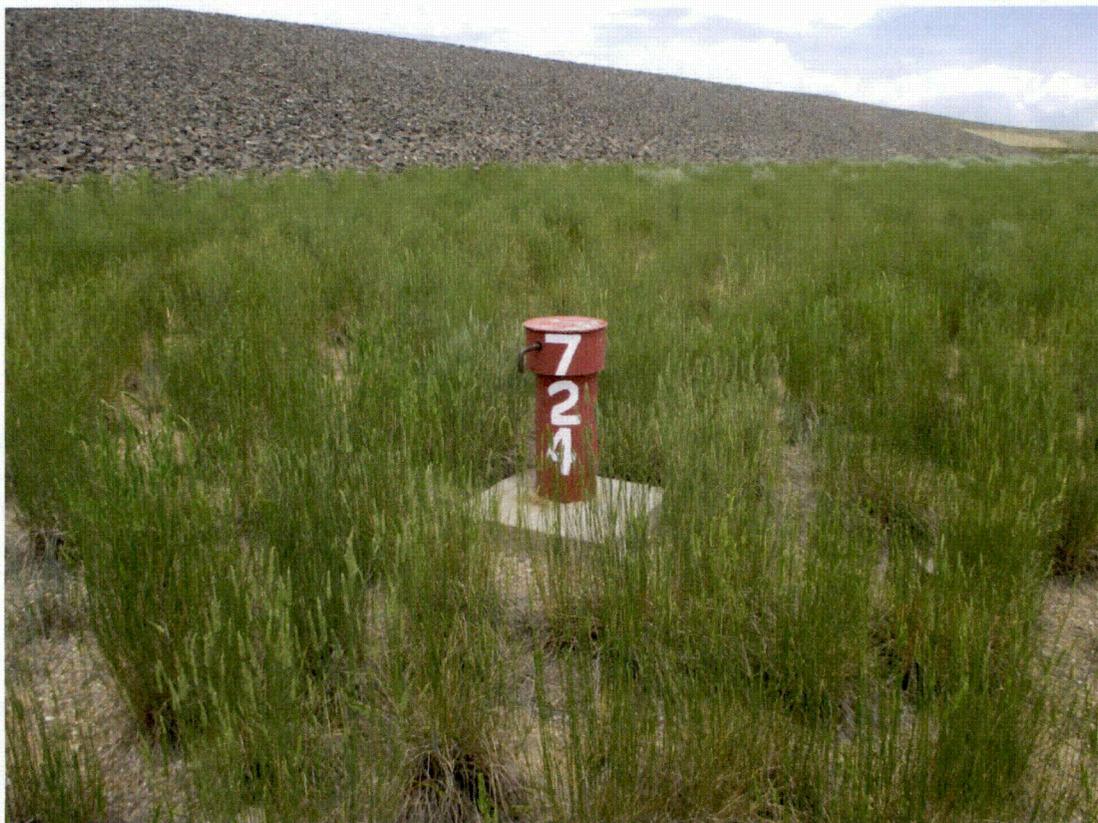
Sixteen wells constitute the groundwater monitoring network for the site. The wells were secure and in excellent condition (PL-4). The Gunnison County landfill operators have placed concrete barriers to protect monitoring well 0716, which is located on landfill property, from landfill activities (PL-5). The edge of the spoil pile was approximately 10 feet from the barriers, and was

*GUD 6/2015. PL-4. Monitoring well 0724 near east side of disposal cell.*

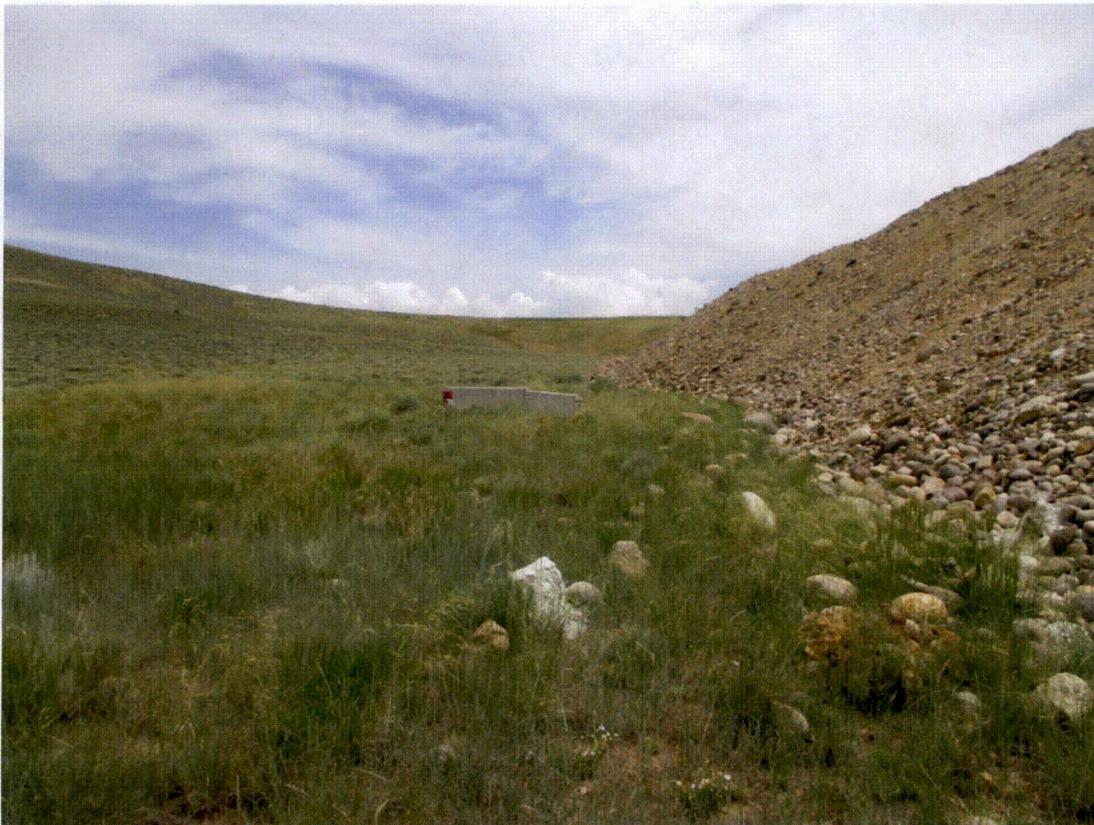
*GUD 6/2015. PL-6. Monitoring well 0716 near west edge of landfill cover material spoil pile.*

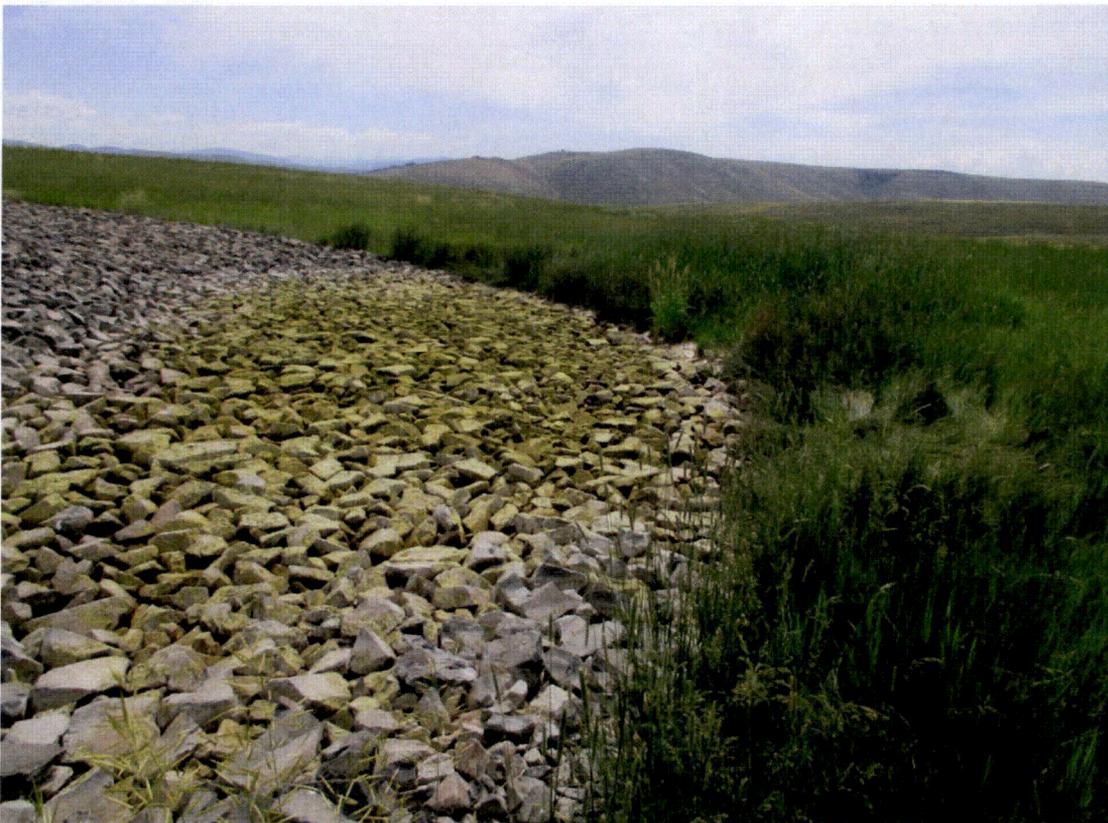
*GUD 6/2015. PL-10. Standing water and moss coverage along the southeast side of disposal cell apron.*

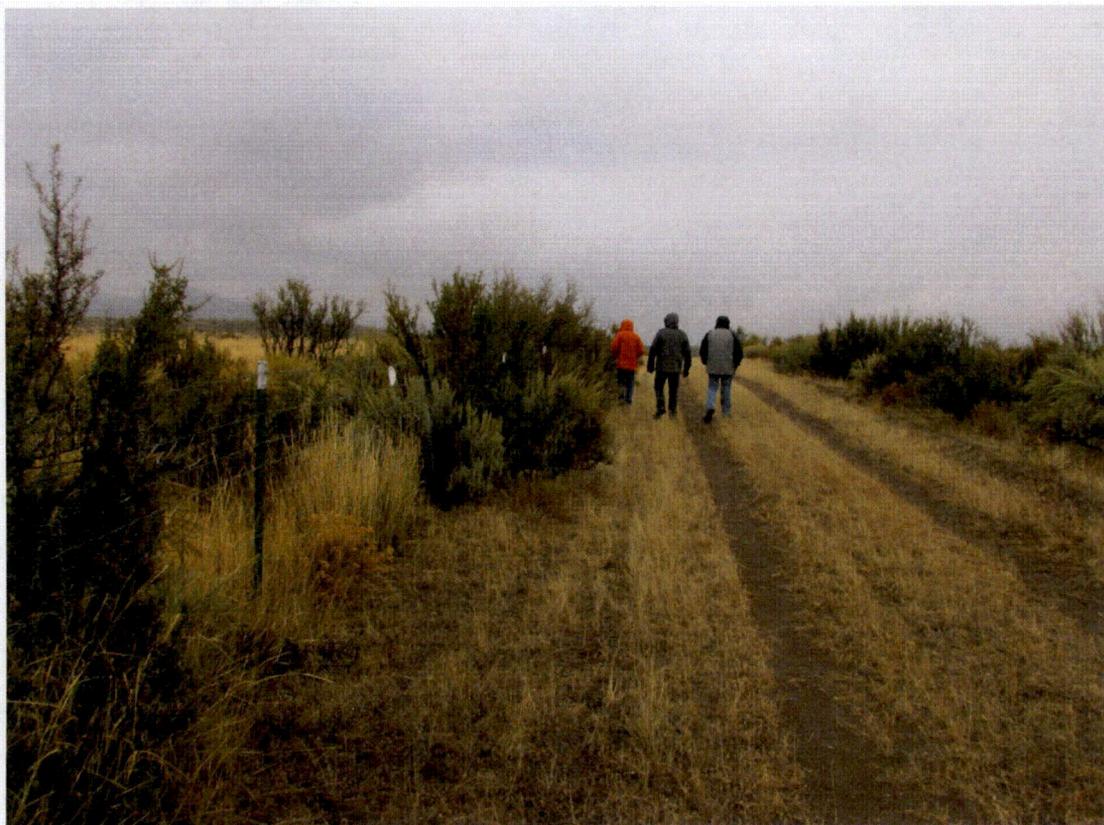
A wire fence is located along the site boundary. The perimeter fence was generally in good condition, but some loose and broken wire strands, and some loose t-posts, were noted. Tightening and minor maintenance of the fence, including the removal of involved vegetation (PL-1), is planned.

LKD 9/2015. PL-1. View north-northeast of vegetation growth along fence.

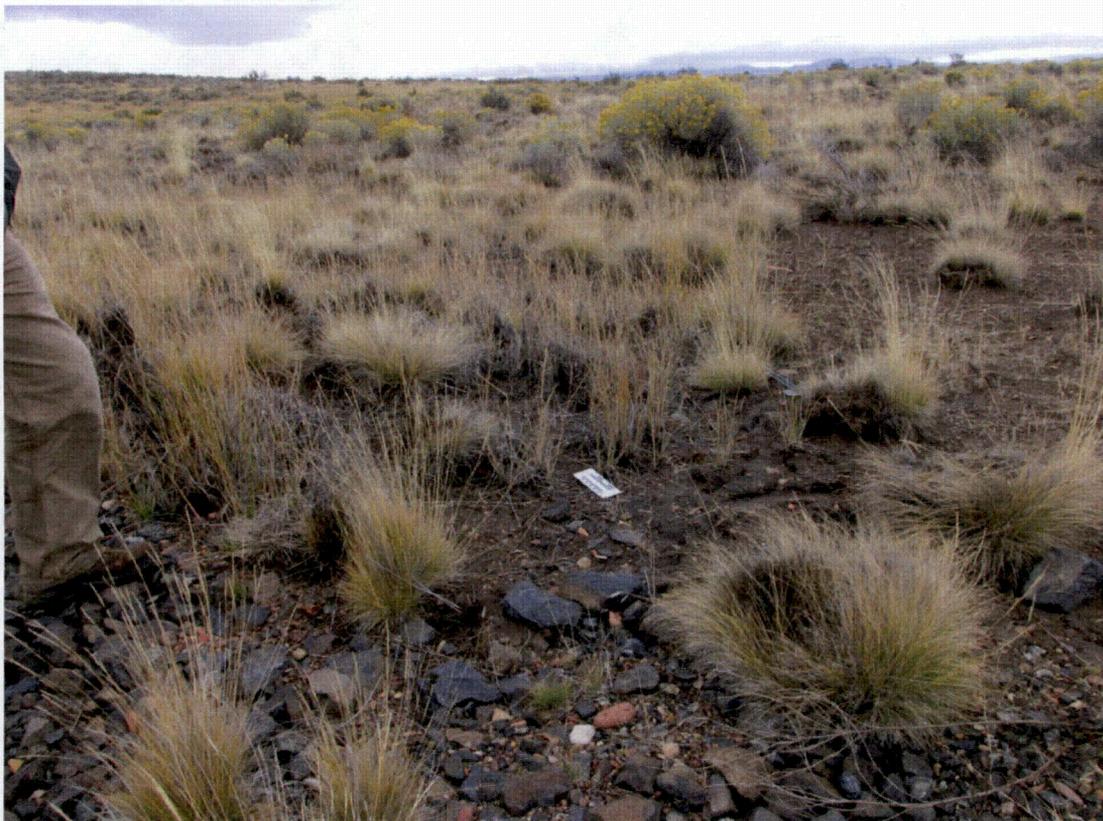
*LKD 9/2015. PL-5. View northeast of shallow rill along transition zone.*
