Calvert Cliffs Nuclear Power Plant, Unit 1  
Facility Operating License No. DPR-53  
NRC Docket No. 50-317

Subject: Report Concerning Dissimilar Metal Weld Indication on Pressurizer Safety Relief Nozzle to Safe End Weld

ISI Weld 4-SR-1006-1, (pressurizer safety relief nozzle to safe end weld), also designated as line 4" CC10-1006 (W1) and 18-405A, was examined as required by the Inservice Inspection (ISI) Program during refueling outage CC1R23 per ASME Code Case N-770-1, Inspection Item E and 10CFR50.55a(g)(6)(ii)(F). The examination was a fully encoded phased array ultrasonic examination (PAUT) and was qualified to ASME Code Section XI, Mandatory Appendix VIII, Performance Demonstration for Ultrasonic Examination Systems, to detect and length and depth size circumferential and axial flaws within the specified examination volume from the outside surface. The examination met all additional industry NEI 03-08 guidance for examination of dissimilar metal piping welds susceptible to Primary Water Stress Corrosion Cracking (PWSCC). Full examination coverage was achieved to meet the requirements of ASME Code Case N-770-1 as conditioned by 10CFR50.55a as indicated in Table 1 below.

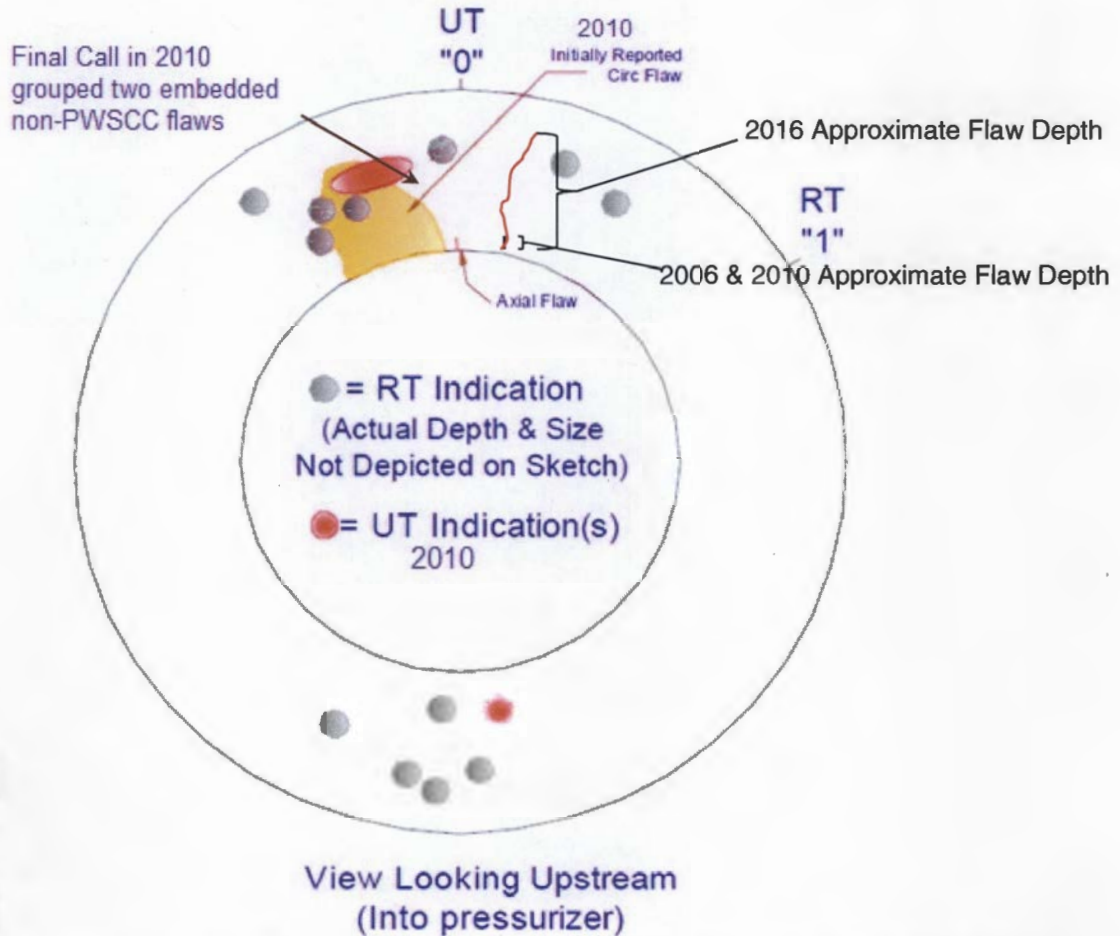
**Figure 1**

The evaluation of the recorded UT data identified one axially oriented defect indication, which is contained within the weld material, exhibiting characteristics indicative of PWSCC. The measured depth of the indication was 81.6% through-wall including clad thickness. In addition, eight indications characterized as embedded fabrication flaws were detected during the data evaluation. See Figure 1 for a graphic representation of the indications in this weld as reported in 2010 along with an approximation of the 2016 flaw characteristics. To confirm that the flaw has changed since the last examination, another NDE vendor performed a manual encoded phased array UT examination and confirmed that the flaw was ID connected and had a through-wall extent of 67.2%.

**Annotated Figure 6-1 from 2010 EPRI Report Showing 2016 Flaw Approximate Size and Location**

This weld was mitigated by a mechanical stress improvement process (MSIP®) application in 2006. UT examination prior to the application of MSIP® identified an axial flaw in the same location as the 2016 flaw but was reported to be 8% through-wall and was acceptable per IWB-3500. UT examination immediately following the MSIP® application confirmed the indication was still present and at the same 8% through-wall depth. Inservice examinations in 2010 also reported the same through wall depth.

The station is examining all twenty-seven (27) dissimilar metal (DM) butt welds within the scope of ASME Code Case N-770-1 during the current refueling outage using Section XI, Appendix VIII UT examination techniques. The affected weld will be repaired by full structural weld overlay during the current outage.

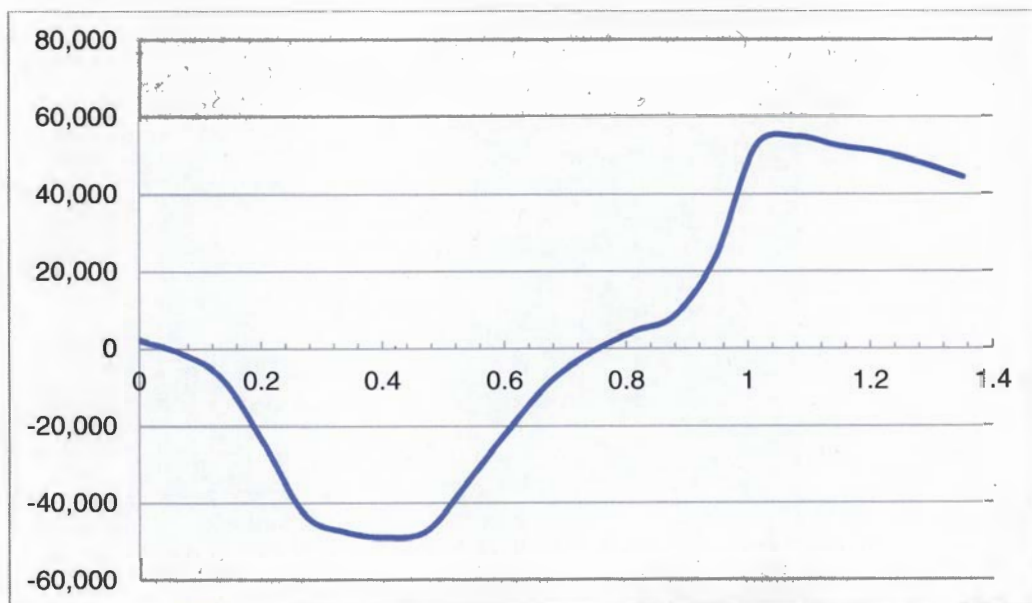
**Figure 2**  
**2006 Post MSIP®+Operating Stress Calculated Hoop Stress Through Wall at Nominal Flaw Position (Path along butter/weld interface)**

the post MSIP® stress profile at operating conditions. The post MSIP® stress profile is compressive from the ID of the pipe wall to an extent of approximately 50% of the through-wall depth. As shown in Figure 2, the hoop stress then becomes tensile out to the OD, reaching tensile stress values of about 55 ksi at 80% through-wall and reducing to about 44 ksi at the OD of the pipe.

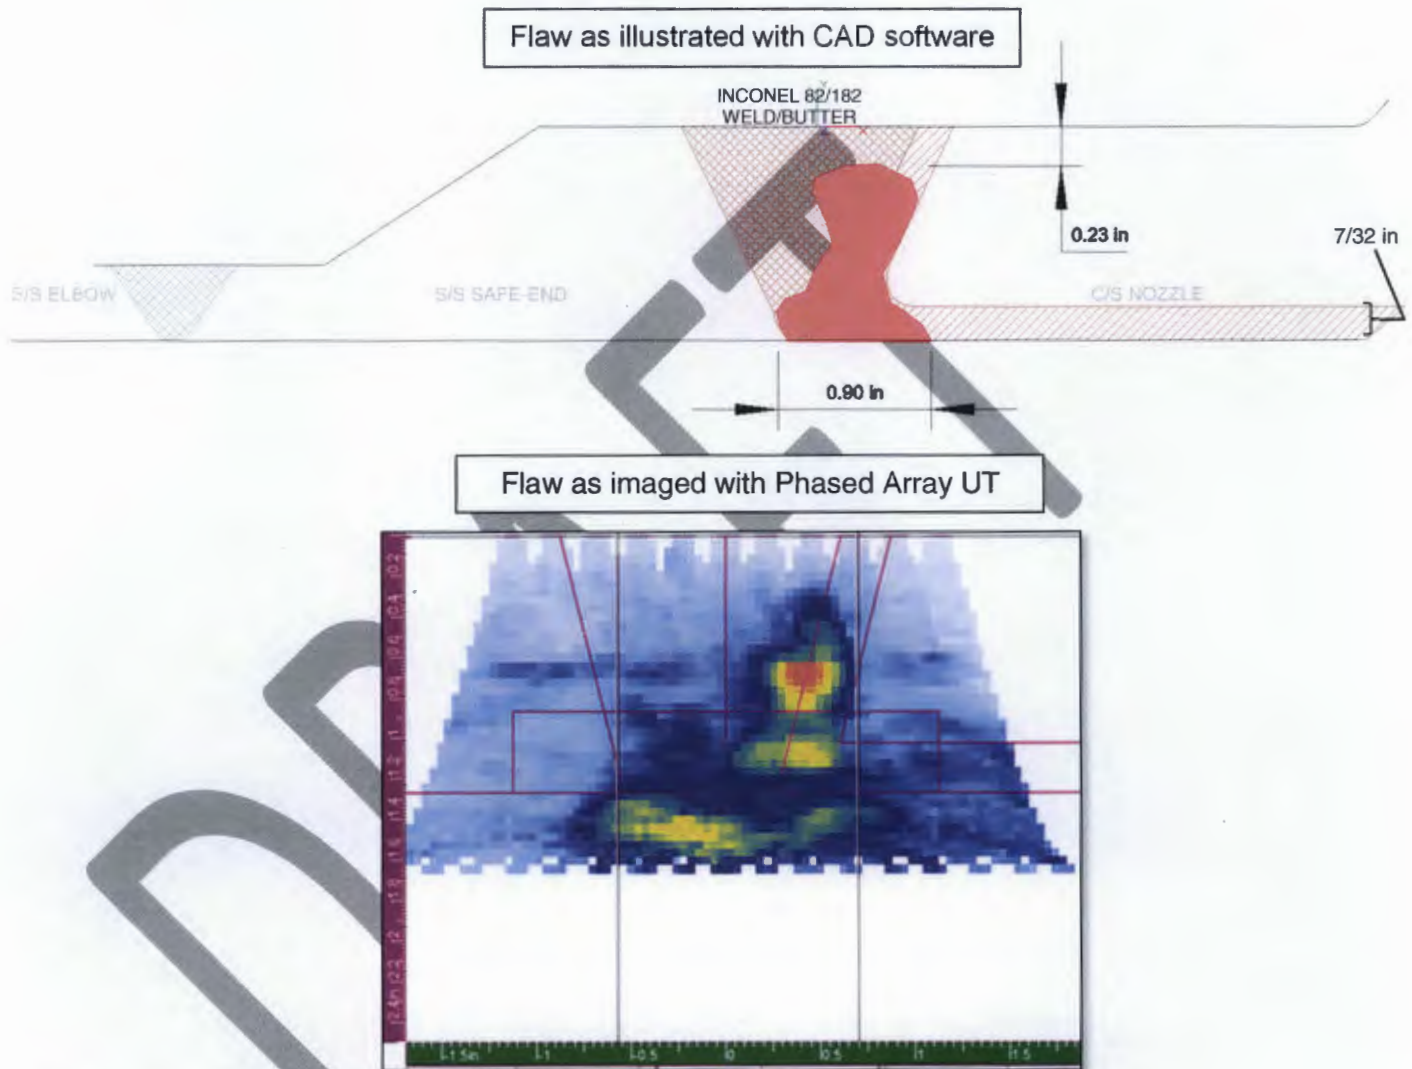
**Figure 3**

The results of the phased array encoded NDE examination performed in 2010 show that the axial flaw is widest at the ID (lower  $\sim 1/3^{\text{rd}}$  of the flaw), narrower in the center  $\sim 1/3^{\text{rd}}$  of the flaw and becomes wider in the top  $\sim 1/3^{\text{rd}}$  of the flaw (see Figure 3 below). The PWSCC flaw indication is narrower and consequently produces a weaker reflection in the middle through-wall range of the flaw where the compressive stress is the highest.

**2016 Axial Flaw Characteristics**
