Calvert Cliffs Nuclear Power Plant, Unit 1  
Facility Operating License No. DPR-53  
NRC Docket No. 50-317

Subject: Report Concerning Dissimilar Metal Weld Indication on Pressurizer Safety Relief  
Nozzle to Safe End Weld

Attachment: Report Concerning Dissimilar Metal Weld Indication on Pressurizer Safety Relief  
Nozzle to Safe End Weld

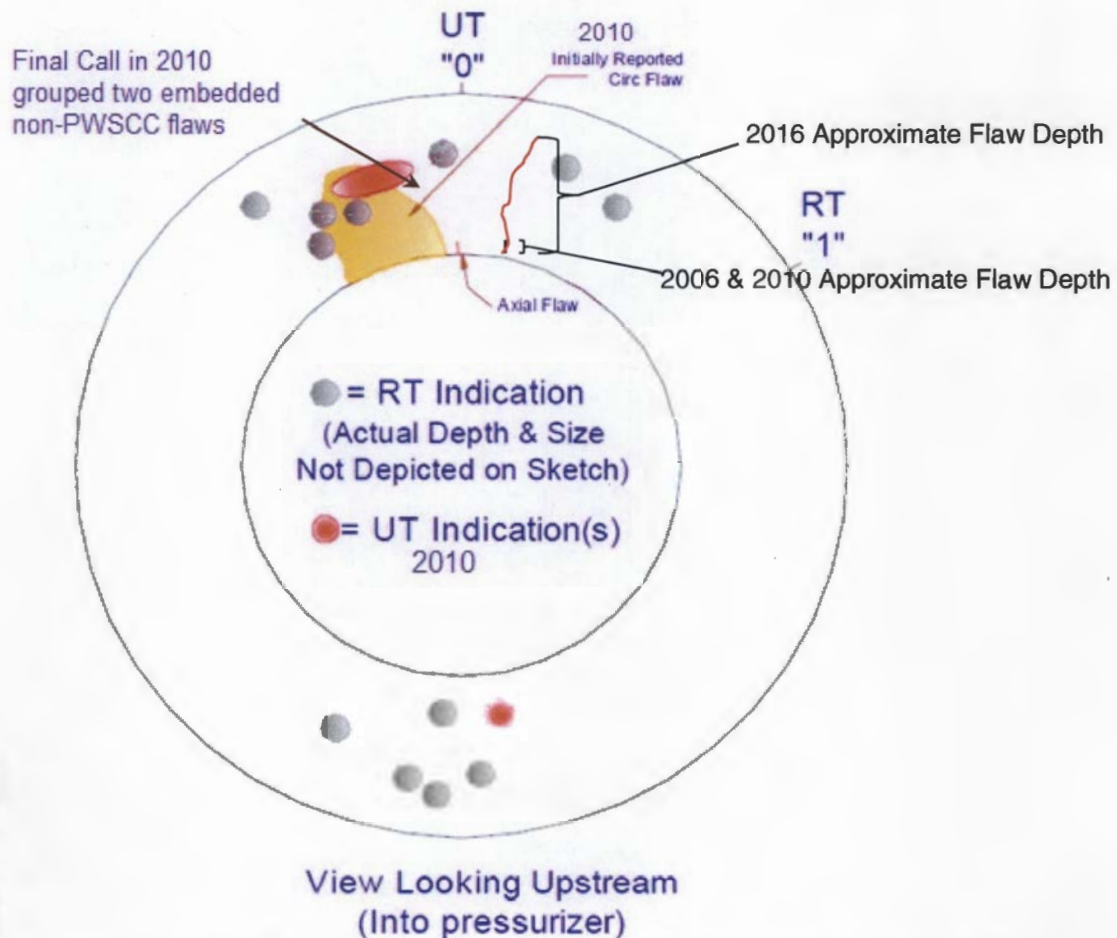
**Figure 1**

The evaluation of the recorded UT data identified one axially oriented defect indication, which is contained within the weld material, exhibiting characteristics indicative of PWSCC. The measured depth of the indication was 81.6% through-wall including clad thickness. In addition, eight indications characterized as embedded fabrication flaws were detected during the data evaluation. See Figure 1 for a graphic representation of the indications in this weld as reported in 2010 along with an approximation of the 2016 flaw characteristics. To confirm that the flaw has changed since the last examination, another NDE vendor performed a manual encoded phased array UT examination and confirmed that the flaw was ID connected and had a through-wall extent of 67.2%.

**Annotated Figure 6-1 from 2010 EPRI Report Showing 2016 Flaw Approximate Size and Location**

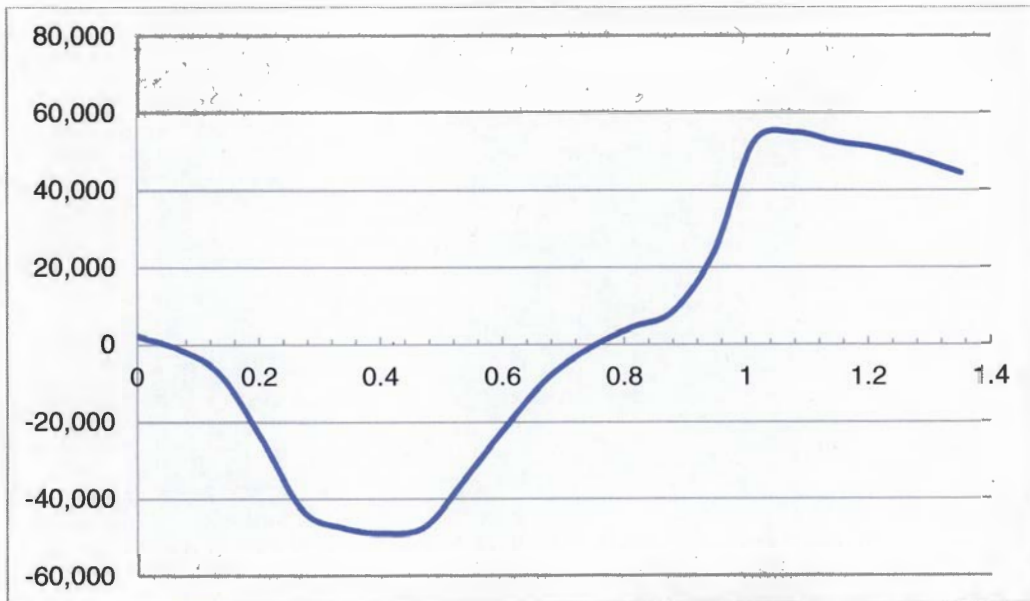
**Figure 2**  
**2006 Post MSIP®+Operating Stress Calculated Hoop Stress Through Wall at Nominal Flaw Position (Path along butter/weld interface)**

the post MSIP® stress profile at operating conditions. The post MSIP® stress profile is compressive from the ID of the pipe wall to an extent of approximately 50% of the through-wall depth. As shown in Figure 2, the hoop stress then becomes tensile out to the OD, reaching tensile stress values of about 55 ksi at 80% through-wall and reducing to about 44 ksi at the OD of the pipe.

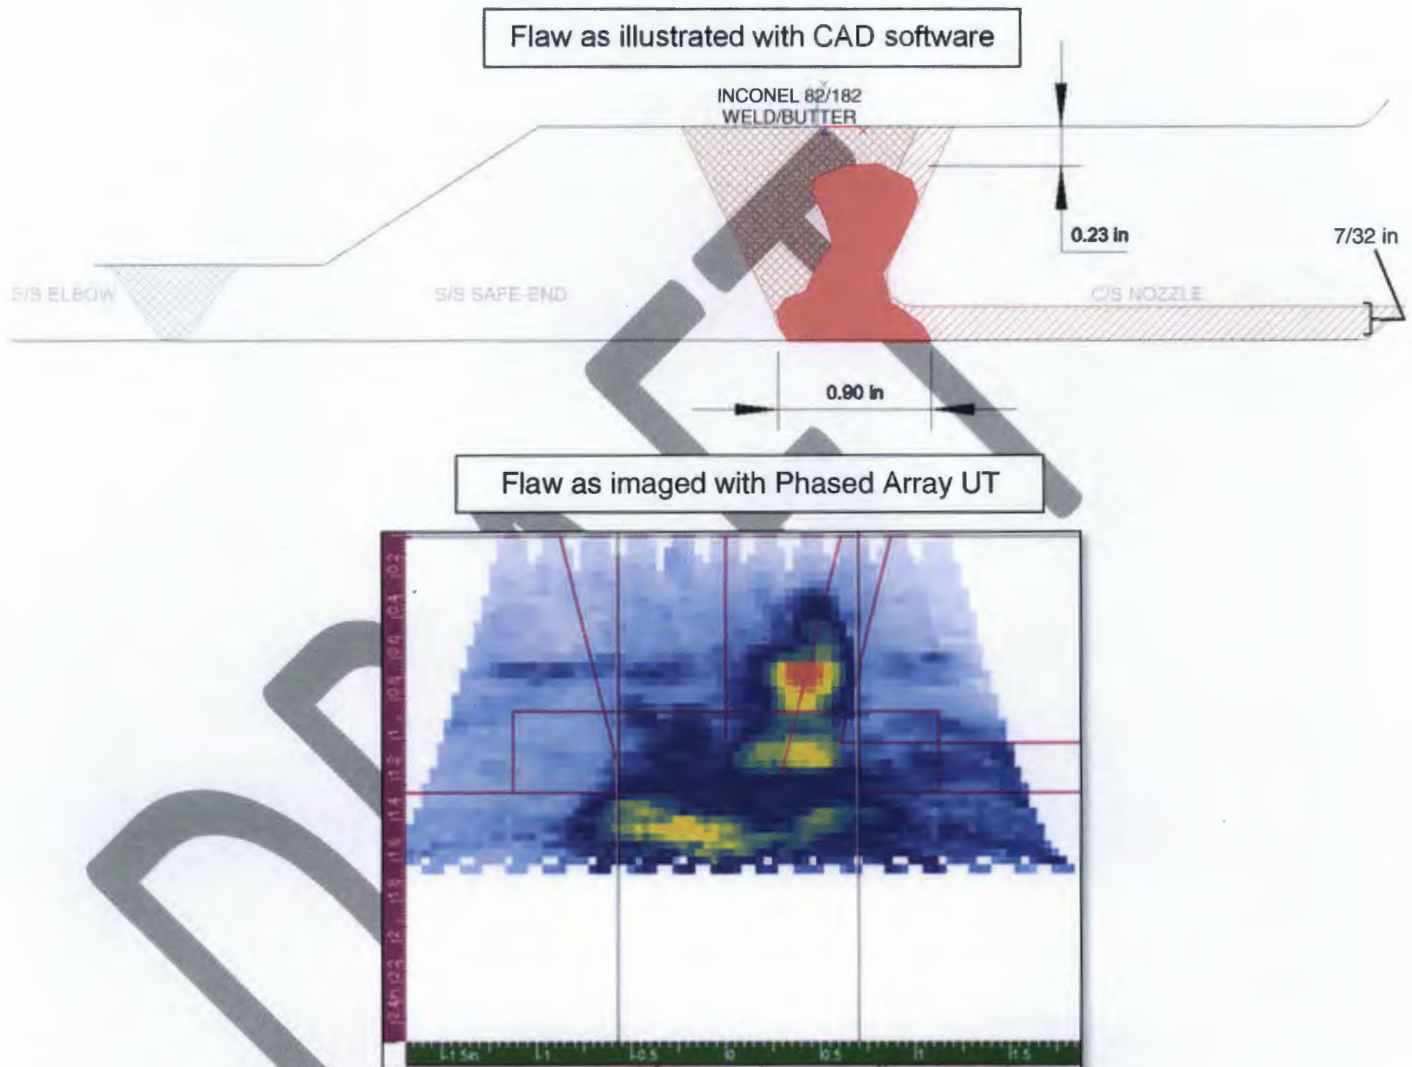
**Figure 3**

The results of the phased array encoded NDE examination performed in 2010 show that the axial flaw is widest at the ID (lower  $\sim 1/3^{\text{rd}}$  of the flaw), narrower in the center  $\sim 1/3^{\text{rd}}$  of the flaw and becomes wider in the top  $\sim 1/3^{\text{rd}}$  of the flaw (see Figure 3 below). The PWSCC flaw indication is narrower and consequently produces a weaker reflection in the middle through-wall range of the flaw where the compressive stress is the highest.

**2016 Axial Flow Characteristics**
