JAFP-16-0047  
March 23, 2016

Subject: LER: 2016-001, System Actuations during Manual Scram in Response to  
Frazil Ice Blockage and Residual Transfer

James A. FitzPatrick Nuclear Power Plant  
Docket No. 50-333  
License No. DPR-59

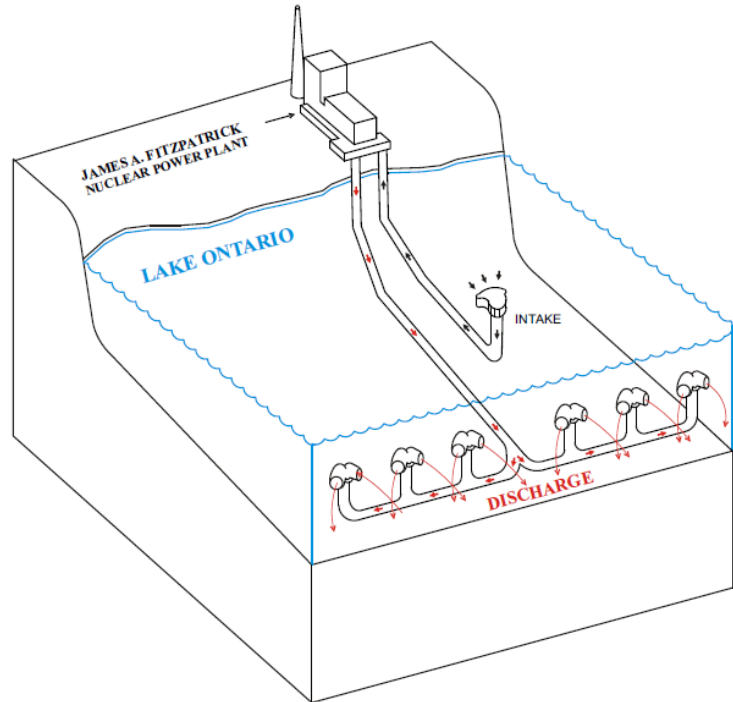
**Frazil ice** is a natural phenomenon in lakes and water ways, including Lake Ontario, when water freezes into loosely formed needle-like crystals. Surface water becomes supercooled when it loses heat rapidly to cold air without freezing. Turbulence, caused by winds, can mix the supercooled water throughout a body of water. The supercooled water encourages the formation of small ice crystals (frazil ice). Ice generally floats, but due to frazil ice's small size relative to current speeds, it can be carried to the bottom very easily. Frazil ice is more likely to occur when air temperatures decrease below freezing and when there is little ice cover on the lake, no cloud cover, winds are present, and the sun has set. Frazil ice has a negative impact on plant operations when it adheres to the intake structure. Supercooled water can reduce the intake structure surface temperatures below freezing then ice forms directly on the surface or frazil ice slush could drift into the structure and adhere to it. Since the intake structure actively draws in water it may draw in frazil ice. The intake structure entrance includes rack bars to screen large debris, consisting of 88 metal bars. These metal bars would normally be an optimal surface for frazil ice accumulation; however, deicing heaters are located in each.

This event was a severe case of frazil ice which caused significant blockage, reducing the amount of water that flows into the screenwell, and effectively reducing the ability of the Ultimate Heat Sink to remove heat. The most likely location for frazil ice accumulation is the bar racks or the concrete surfaces at the intake structure.

The intake structure rack bars are heated to maintain their surface temperature above freezing. If surfaces are above 32 degrees no matter how slightly, ice cannot adhere to the surface. However, the concrete surfaces of the intake structure itself are not heated and may provide a location for frazil ice accumulation and growth. Ice build-up can still occur on the bars if the amount of supercooling exceeds the thermal margin provided by the deicing heaters. The deicing heaters are not adequately sized to prevent frazil ice formation under extreme supercooling conditions, although they will minimize frazil ice formation most of the time. Maintenance and surveillance history of deicing heaters demonstrate that they were Operable during this event.
