Houston Lighting & Power South Texas Project Electric Generating Station P. O. Box 289 Wadsworth, Texas 77483

South Texas Project
Units 1 & 2
Docket Nos. STN 50-498 & STN 50-499
Request for Relief from ASME Boiler and Pressure Vessel
Code, Section XI Requirements, Relief Request RR-ENG-10

REQUEST FOR RELIEF FROM ASME BOILER AND
PRESSURE VESSEL CODE, SECTION XI REQUIREMENTS
RELIEF REQUEST NO. RR-ENG-10

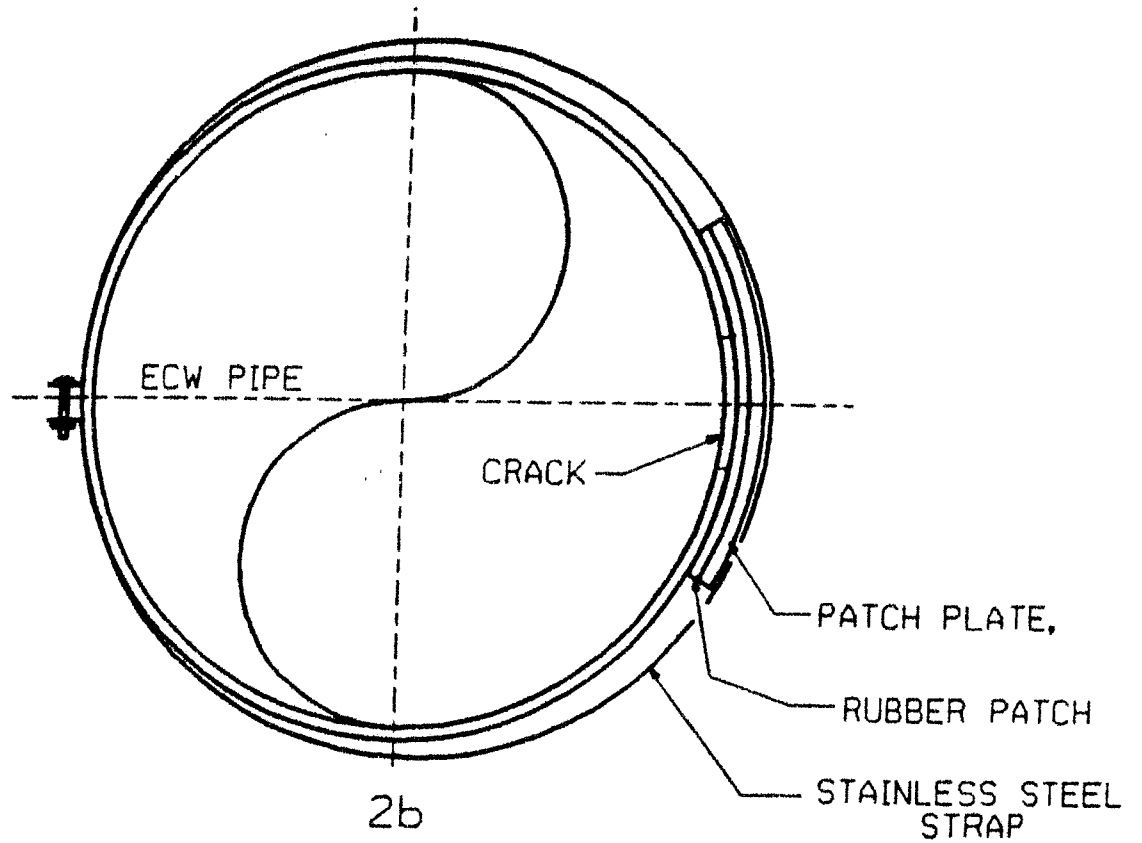
TEMPORARY REPAIRS TO STOP LEAKAGE

- (1) Leave the weld joint as is, subject to monitoring as described above, and subject to meeting the criteria for consequences and for structural integrity as described above.
- (2) Identical to option -1, except that a strap with rubber patch as shown in Attachment 2 may be used as an augmentation to stop the leakage, if deemed desirable for housekeeping reasons. Credit is not taken for such a patch for structural integrity. Daily monitoring will be conducted to assure that the patch is effective in limiting leakage, and the patch will be removed at the time of every monthly walkdown to visually monitor the crack size.
- (3) A welded patch, as shown in Attachment-2 which is used to stop leakage, with no credit for its addition to structural integrity. Monitoring of cracked weld will continue at the repair location outside the patch in the monthly walkdowns.

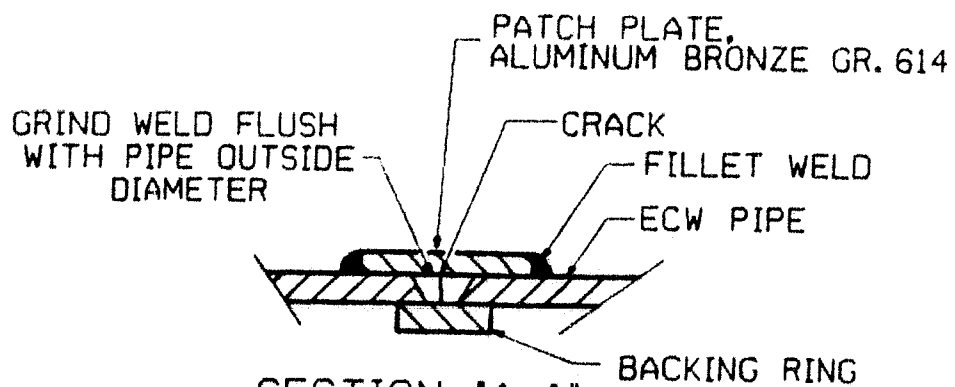
2c

WELDED PATCH
