**Subject: License SUA-1341, Docket No. 40-8502  
Willow Creek Project  
December 7, 2015  
Module 2-4 Production Fluid Release from Restored Mine Unit 2  
Christensen Ranch Mine Unit 2**

**Uranium One USA, Inc. - Willow Creek Project  
Spill Report Summary  
Module Building 2-4 Production Fluid Release**

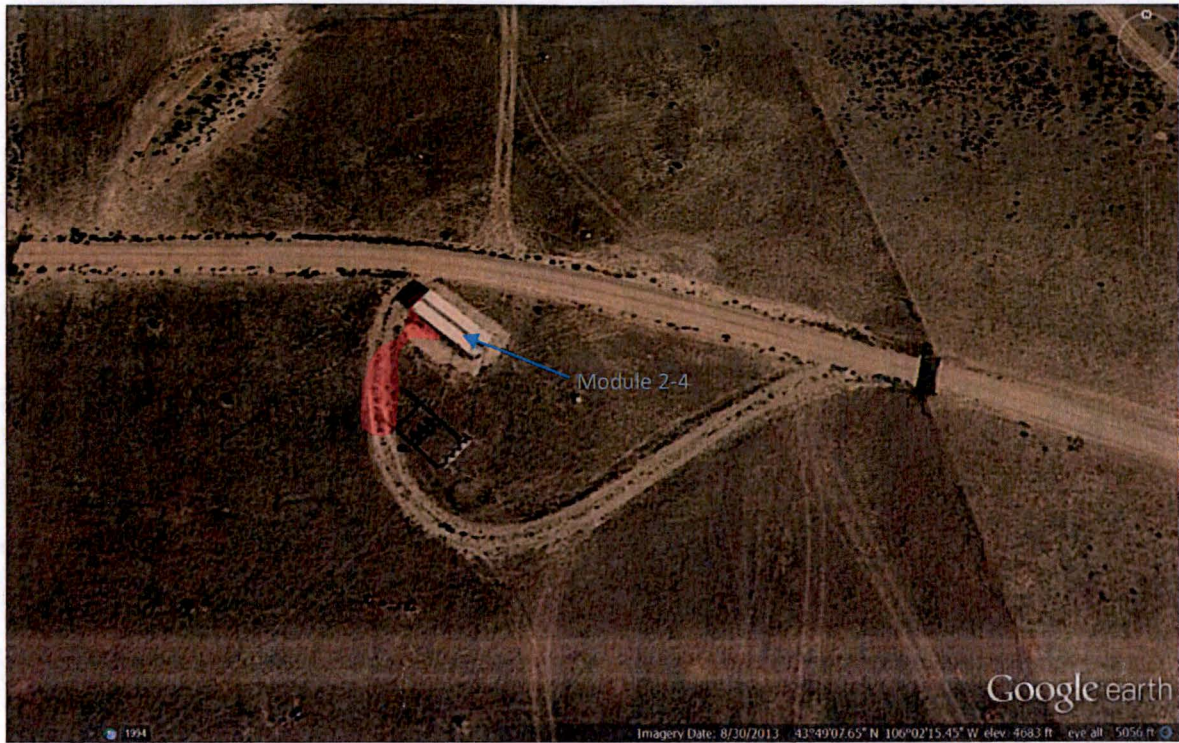
### **Map of Spill Location and Impacted Area**

The release followed the existing grade and ended in a two track road, approximately 80 feet away (see attached photos and map). It is estimated that 765 square feet (0.0178 acres) of soil was impacted. No wildlife, livestock, or surface water was affected. No significant erosion resulted from the spill.

The location and estimated extent of the spill outside the building is shown as light red.

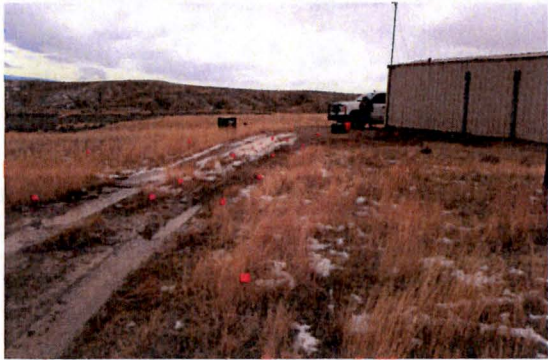
Looking northwest along road. Flags show uR meter locations.

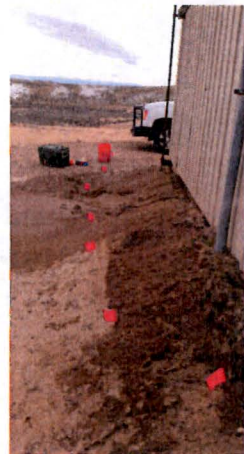
Looking north along west side of building. Flags show uR meter locations.
