SUBJECT: NRC INSPECTION REPORT 40-8905/96-02

Report No.: 40-8905/96-02

Licensee: Quivira Mining Company

Facility: Ambrosia Lake Facility

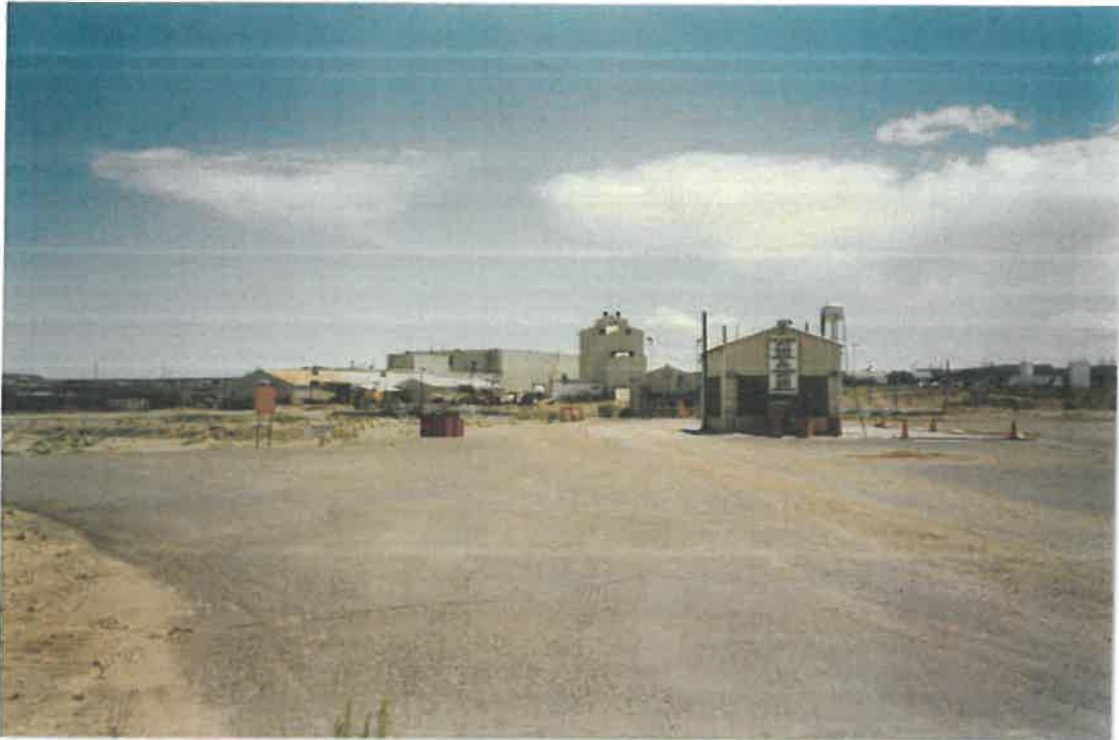
Photograph 1 - Quivira's Ambrosia Lake Facility.

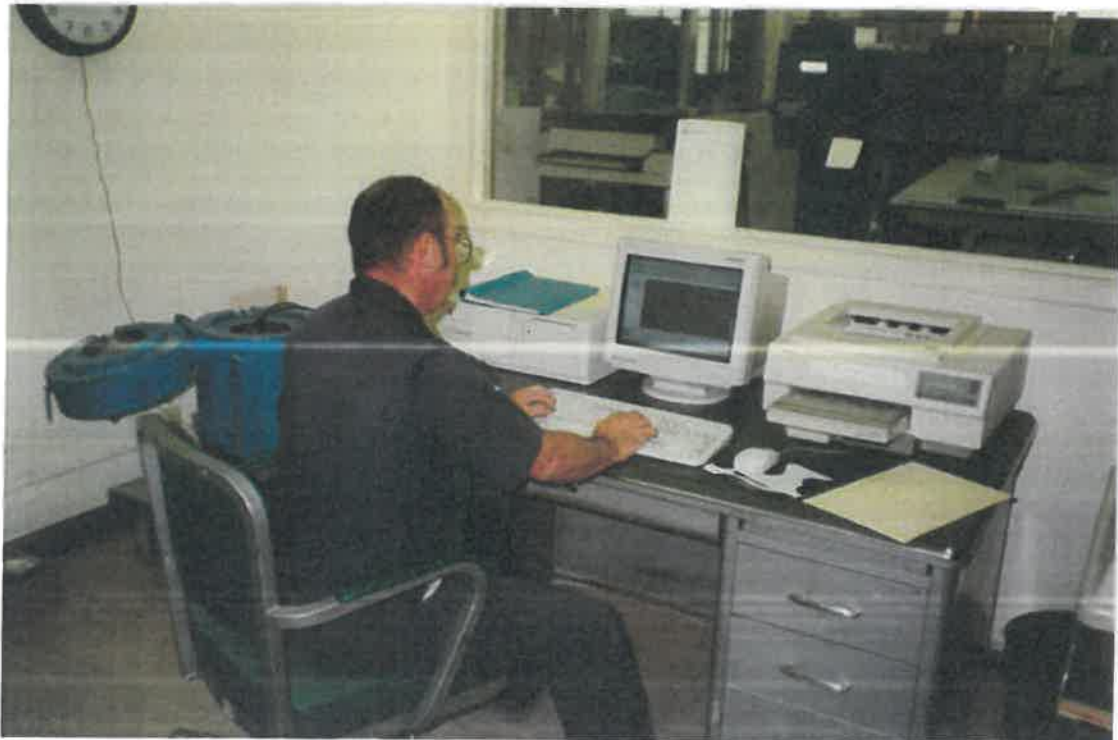
Photograph 2 - Environmental technician performing analysis of exposed charcoal for radon concentration.

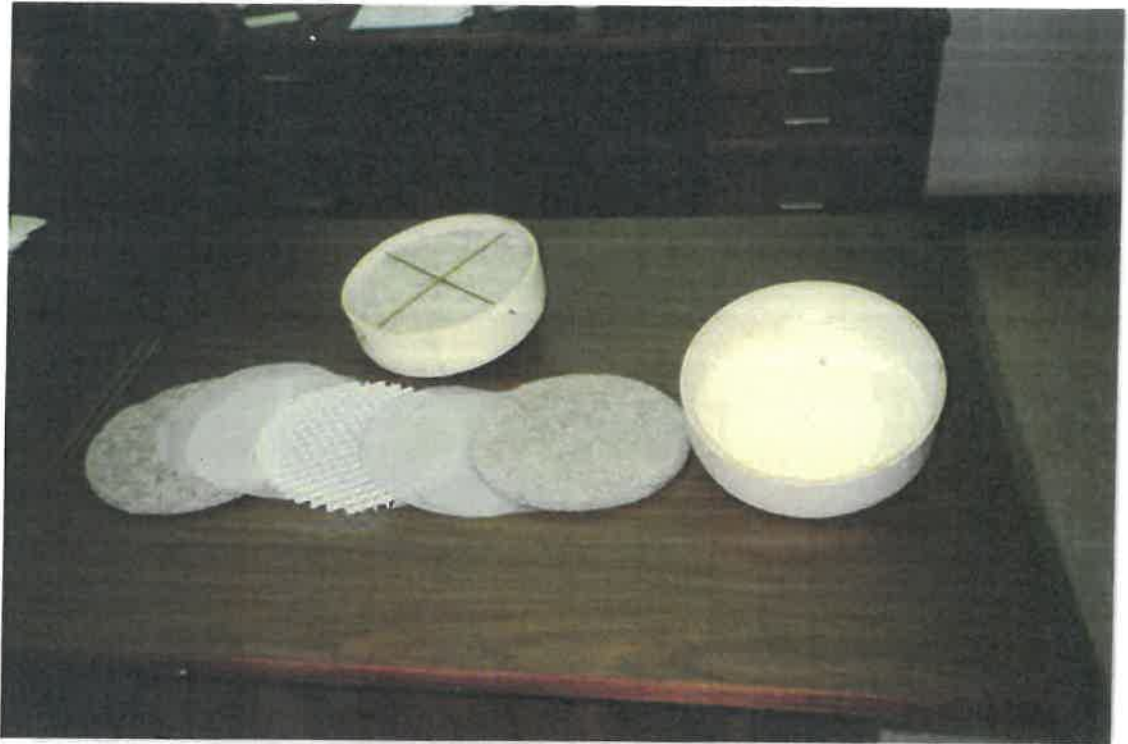
Photograph 3 - Two LAACCs, one assembled and the second disassembled.

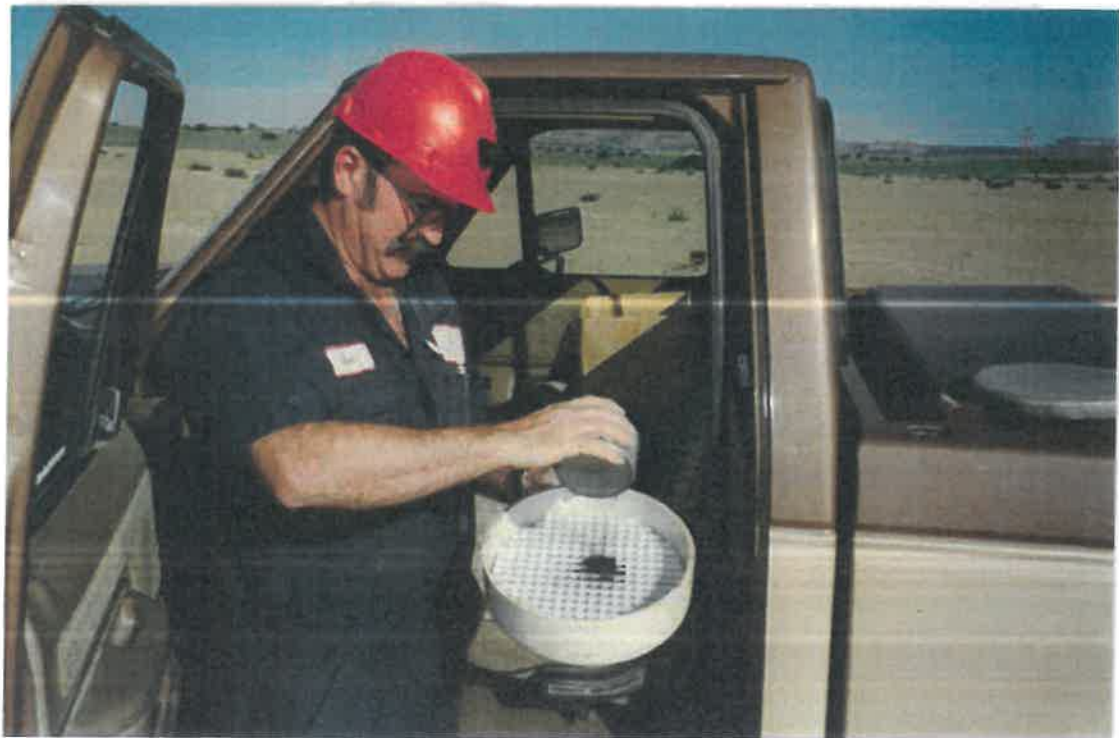
Photograph 4 - Environmental technician pouring charcoal into LAACC.

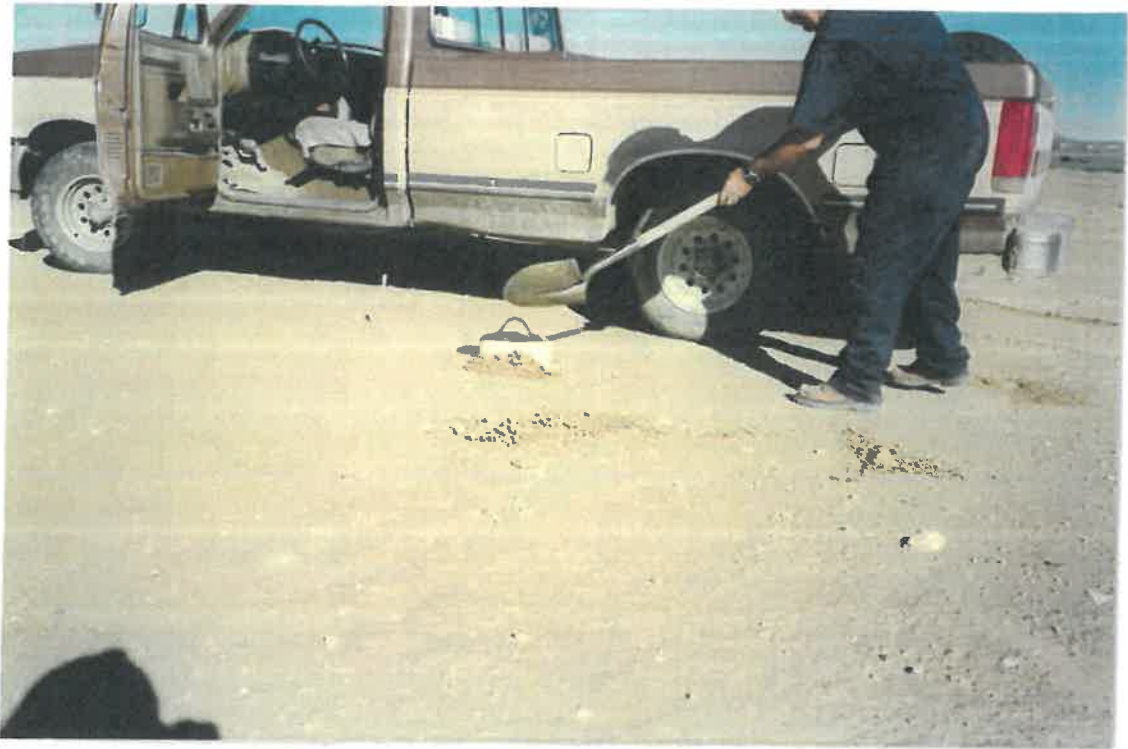
Photograph 5 - LAACC being installed on Pond 2.

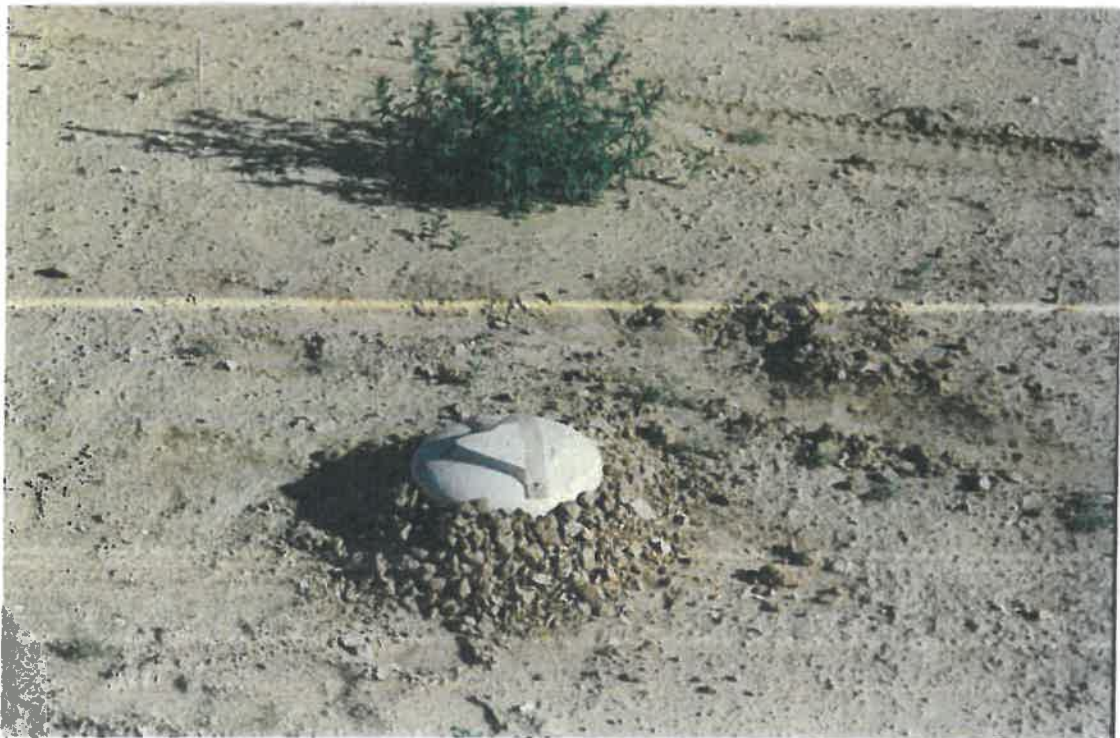
Photograph 6 - LAACC installed on Pond 2 for 24-hour time frame.
