UNITED STATES
NUCLEAR REGULATORY COMMISSION

SUBJECT: NRC INSPECTION REPORT 40-8905/96-02

Report No.: 40-8905/96-02

Facility: Ambrosia Lake Facility

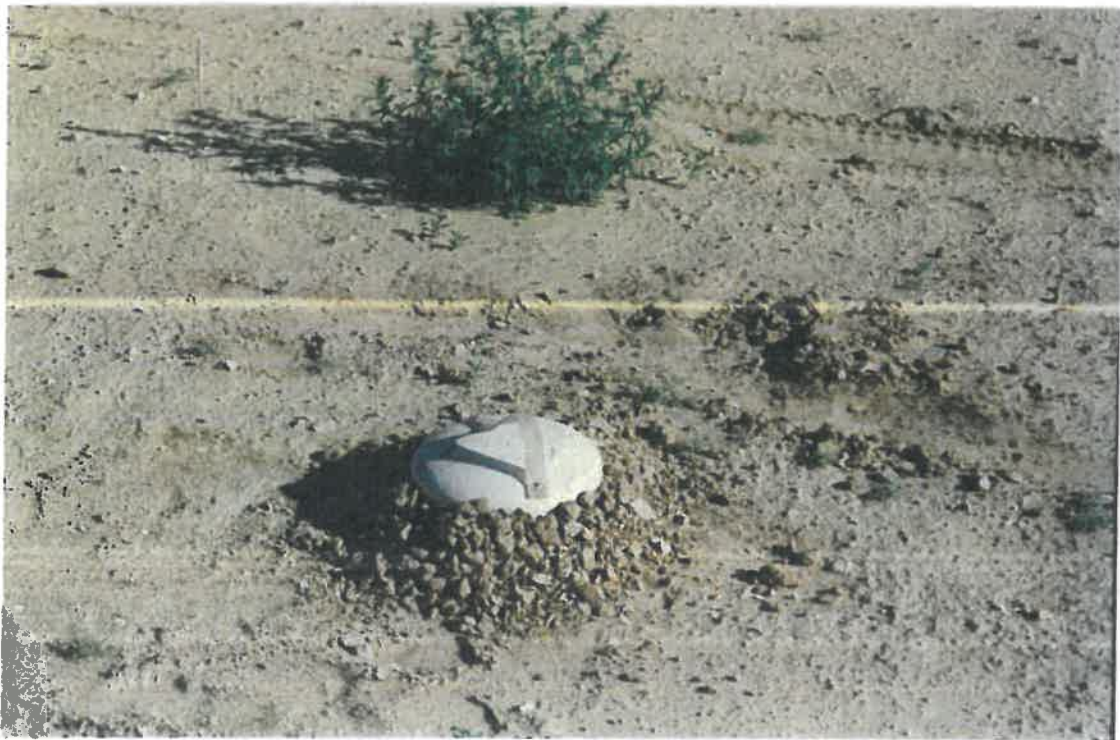
Following placement on the tailings impoundment surface, the charcoal was exposed to the radon flux being emitted from that specific location for 24 hours. After the 24-hour exposure period, the charcoal was removed from the LAACC and returned to its original metal container. The metal container was then resealed. A 4-hour delay was required between the removal of the charcoal from the field and the final analysis of the exposed charcoal to allow for equilibrium of the radon and radon daughter products. Following the final analysis, the charcoal was typically recycled by reheating the charcoal to eliminate the radon from the charcoal.

Photograph 6 - LAACC installed on Pond 2 for 24-hour time frame.
