SUBJECT: NRC INSPECTION REPORT 40-8905/96-01

Inspection Report: 40-8905/96-01

Licensee: Quivira Mining Company
P.O. Box 218
Grants, New Mexico 87020

Facility Name: Ambrosia Lake Facility

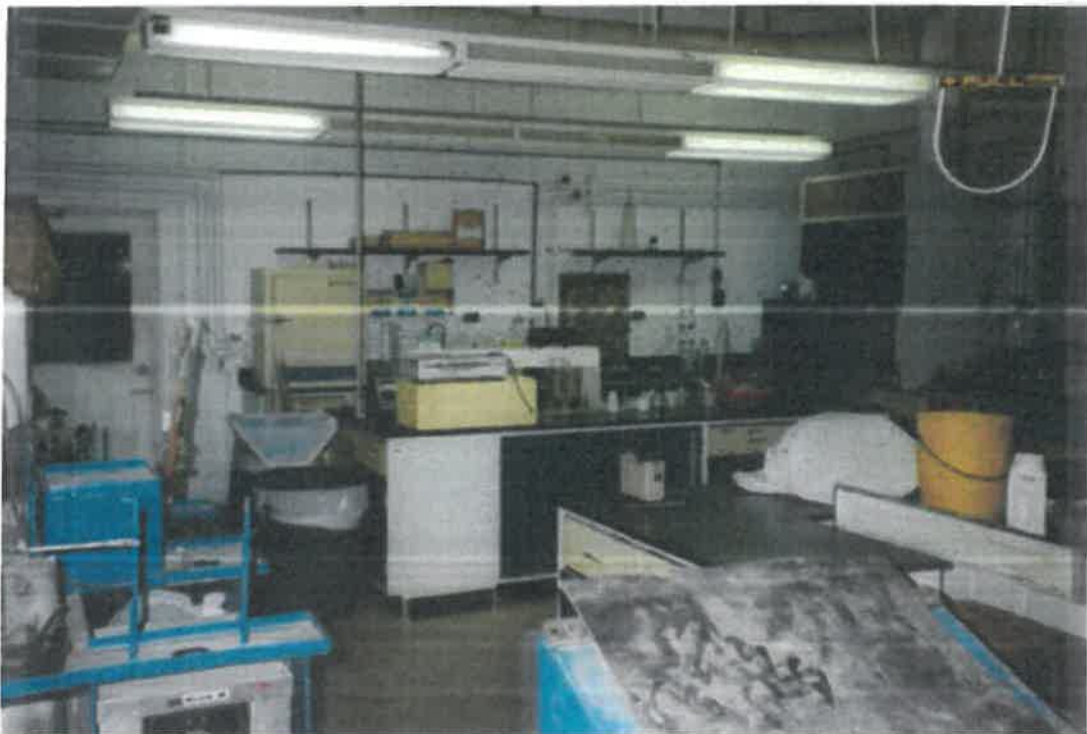
Photograph 4 - The Met Lab.

The manual specifies that non-routine radon daughter sampling will be performed in the "Met Lab," as well as other locations throughout the facility, on a quarterly basis. Records indicated that the licensee apparently had not performed radon daughter sampling in the Met Lab for approximately 7 years. However, the inspector noted that the area was not normally used by plant personnel and that other surveys had been performed in this area. This failure constitutes a violation of minor significance and is being treated as a non-cited violation consistent with Section IV of the NRC Enforcement Policy.

Although the root cause for the violation was not clearly identified, a contributing factor involved the development of the plant implementing procedures. The requirement to perform radon daughter sampling in the Met Lab had been inadvertently left out of the applicable implementing procedure. In response to the discussion of this finding, licensee representatives confirmed that they would perform radon daughter sampling in the Met Lab during subsequent routine site sampling evolutions.

The licensee had implemented a radiation protection program that met the requirements established in 10 CFR Part 20 and the license, with one exception. A non-cited violation was identified involving the licensee's failure to perform radon daughter air sampling in a laboratory identified for non-routine sampling in the license. However, the laboratory was not normally used by plant personnel.

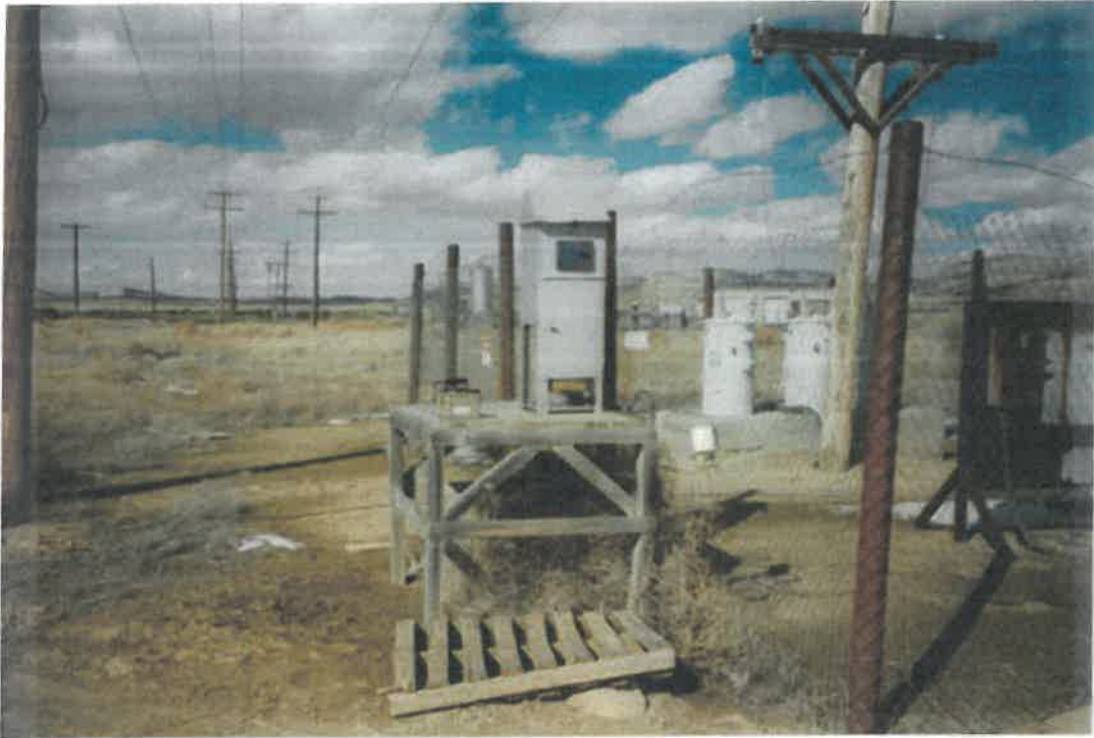
Photograph 5 - Sample Station 30W - VH6.

Soil and sediment sampling were required on an annual basis. Soil samples were taken at the five sample stations, and sediment samples were taken at four creek locations. The samples were analyzed for natural uranium, radium-226, thorium-230, and lead-210. The highest concentration measured was 10 picocuries per gram of thorium-230 at two locations, including the Mill Diversion station. The highest concentration measured for radium-226 was 5.1 picocuries per gram at the station designated as Section 30W-Vent Hole 6.
