SUBJECT: NRC INSPECTION REPORT 40-8905/96-01

Inspection Report: 40-8905/96-01

Licensee: Quivira Mining Company
P.O. Box 218
Grants, New Mexico 87020

Facility Name: Ambrosia Lake Facility

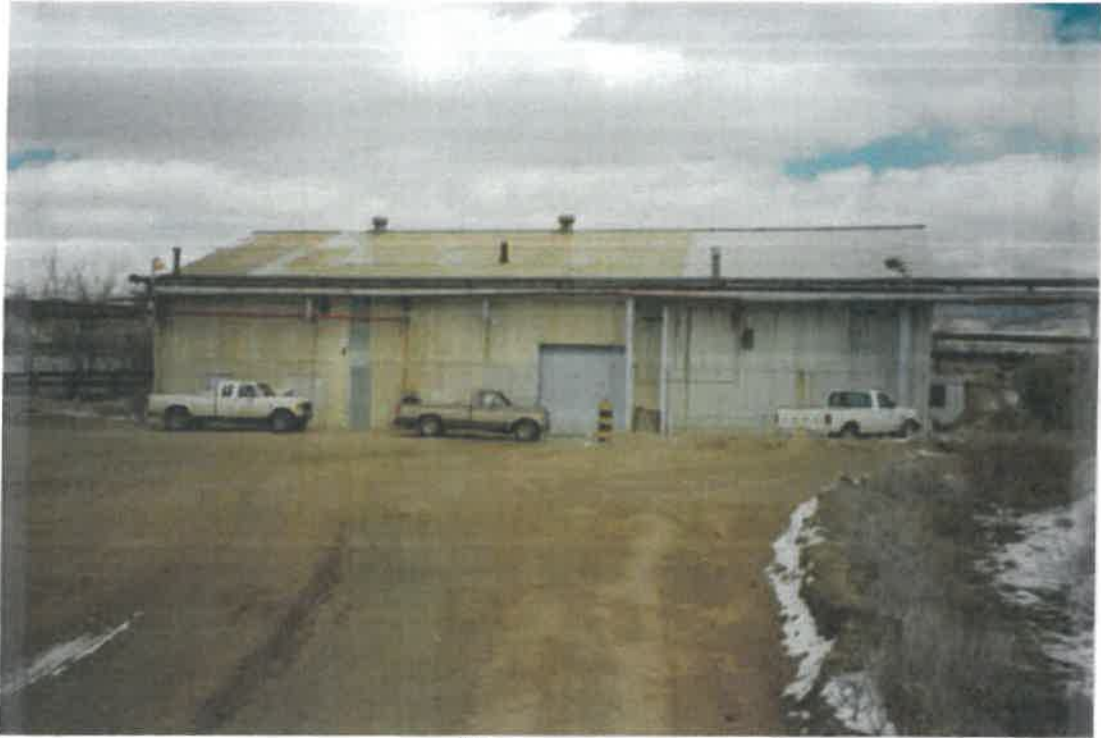
Photograph 3 - IX Plant Building, Currently in Use.
