SRR-LWE-2013-00214

February 10, 2014

Engineering Path Forward – Tanks 5 & 6: Record of Additional Grouting Actions

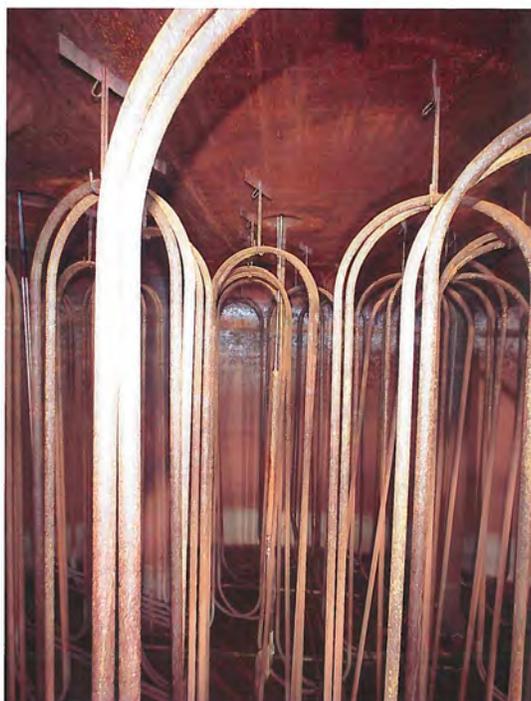
Prior to the approval of the *Grout Strategy for Tanks 5 and 6 Closure* document [1], in August 2013, the facility performed evaluations using approved documentation (DCFs, DCPs, Tank Relevant Historical Documents, etc.) and/or in-tank camera/video inspections to confirm expected conditions and equipment configuration. These evaluations identified the Tank 6, Riser 4 Transfer Jet as disassembled and suspended approximately 24 feet above the tank floor. In November 2013, several months later, photographic evidence identified the Tank 6, Riser 4 Transfer Jet as intact and suspended several feet above the tank floor.

The configuration in P-DCF-F-00390 was not recognized. Furthermore, obstructions such as cooling coils and columns hindered efforts to accurately document the field state of the transfer jet. The in-tank video inspection was unsuccessful at capturing this condition and having it properly reflected in the document². Figure 2.1.2-1 gives a view of the obstructions looking toward the Tank 6 Riser 4.

Figure 2.1.2-1: Obscured Jet in Tank 6, Riser 4
(View Looking toward Tank 6 Riser 4)

- The Tank 6, Riser 4 Transfer Jet has been grouted internally to the extent practical [2].
- The Tank 6, Riser 4 Thermowells have been grouted internally to the extent practical [2].
- The Grout Strategy Document, SRR-LWE-2012-00087, was revised to reflect the noted conditions. (See STAR Item 2013-CTS-015144)

Upon discovery of the new configuration, C&WDA was notified. A decision was made to grout the equipment and eliminate any potential for a vertical fast flow path. Subsequently the jet riser and thermowells have been grouted per WO# 001199254 [2].

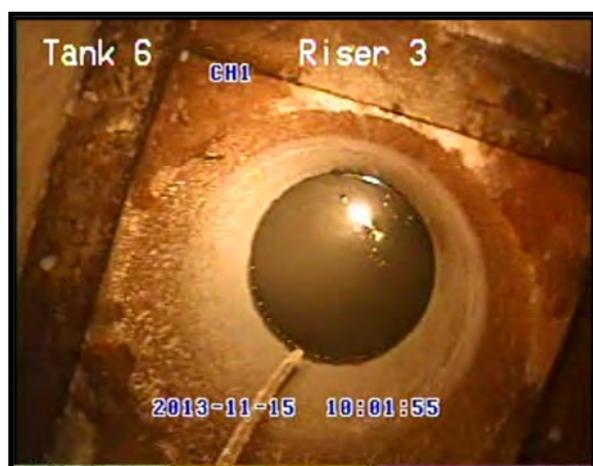
At the completion of the tank grouting, it was discovered that liquid was displaced by the tank fill grout and had been forced up into several of the risers associated with the two tanks. This liquid must be safely dispositioned before completing tank grouting to ensure there is not a spread of potential liquid contamination as the grout levels continue to rise. Figure 2.2-1 gives a typical example of what has been seen in these instances.

Figure 2.2-1: Liquid Present in Tank 6, Riser 3
(View Looking Down Into Riser)

The liquid present in the risers is a direct result of the addition of liquid intended to lubricate the tank grout addition lines, thus ensuring the grout flowed continuously into the Waste Tanks. The amount of liquid present in the identified risers varies from “minimal” (less than a few inches) to “high” (12 inches or greater)³. A sufficient volume of liquid could have become a hindrance during the grouting process. For this reason, work packages were issued to allow the option to remove the liquid from the riser [6]. However, as a result of liquid reconstitution during grout addition and evaporation, the liquid level was deemed negligible and its removal unnecessary.

- A new Work Order Task was issued for Tanks 5 and 6 to allow, if required, the liquid in the riser to be removed [6].
