**CAMECO RESOURCES  
CROW BUTTE OPERATION**

April 22, 2016

On April 20, 2016, during routine 5-year Mechanical Integrity Testing (MIT), well number I-1133 in Mine Unit 5, Wellhouse 17 failed the MIT criteria at the Crow Butte Resources (CBR) mine site. Isolation procedures indicated that the failure was the casing joint at the 20-foot level. Dave Carlson, of the NDEQ Chadron field office, and Ron Burrows, NRC Project Manager, were notified concerning this well on April 21, 2016.

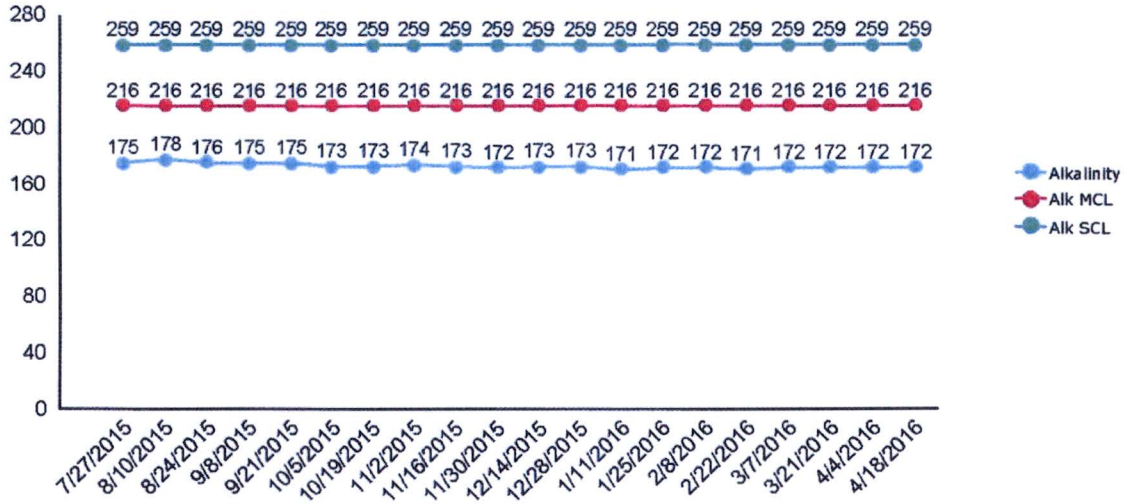
Alkalinity

A graph of the sampling results for the nearest Shallow Monitor Well, SM 5-18, is included for your review. This well is located 150 feet north of I-1133.
