Duke Power Company

May 21, 1997

Oconee Nuclear Station, Units 1, 2, and 3

SUMMARY OF THE MAY 14, 1997 MEETING ON THE HIGH PRESSURE
INJECTION SYSTEM (TAC NO. M98454)

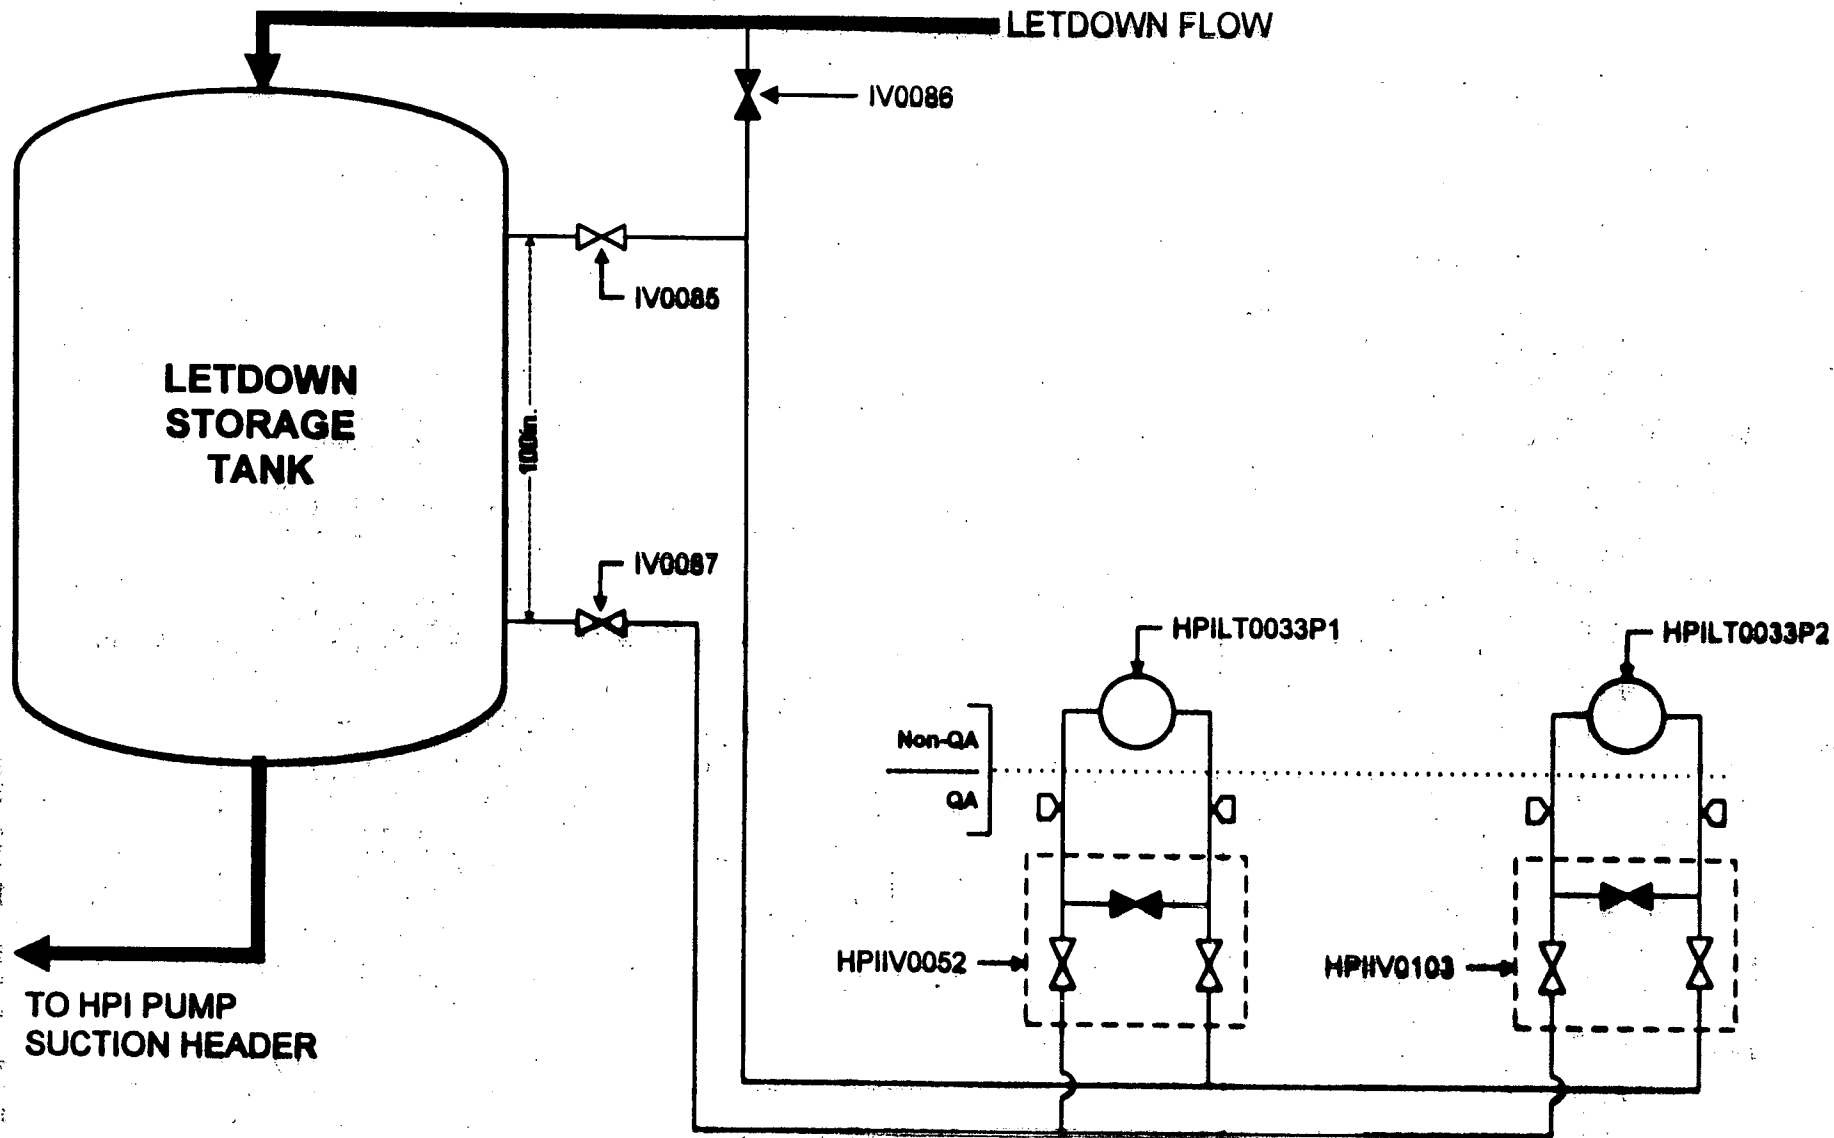
LETDOWN STORAGE TANK LEVEL
INSTRUMENTATION SKETCH

- » Design weakness of a common reference leg for LDST level instruments combined with a leaking instrument fitting that resulted in inaccurate LDST level indication
- » Failure of Control Room team to properly monitor and detect the inaccurate level indications given the existing plant conditions.

- » Perform Modifications on Units 2 and 3 to:
 - add separate reference legs for LDST level transmitters
 - add a redundant LDST pressure transmitter
- » Repair, inspect, flush, and test Unit 3 HPI system as required
- » Assess applicability of this event to other tank level instruments
- » Short-term Operations training on this event, and on LDST modifications
- » Improve Abnormal Procedure on Loss of HPI makeup

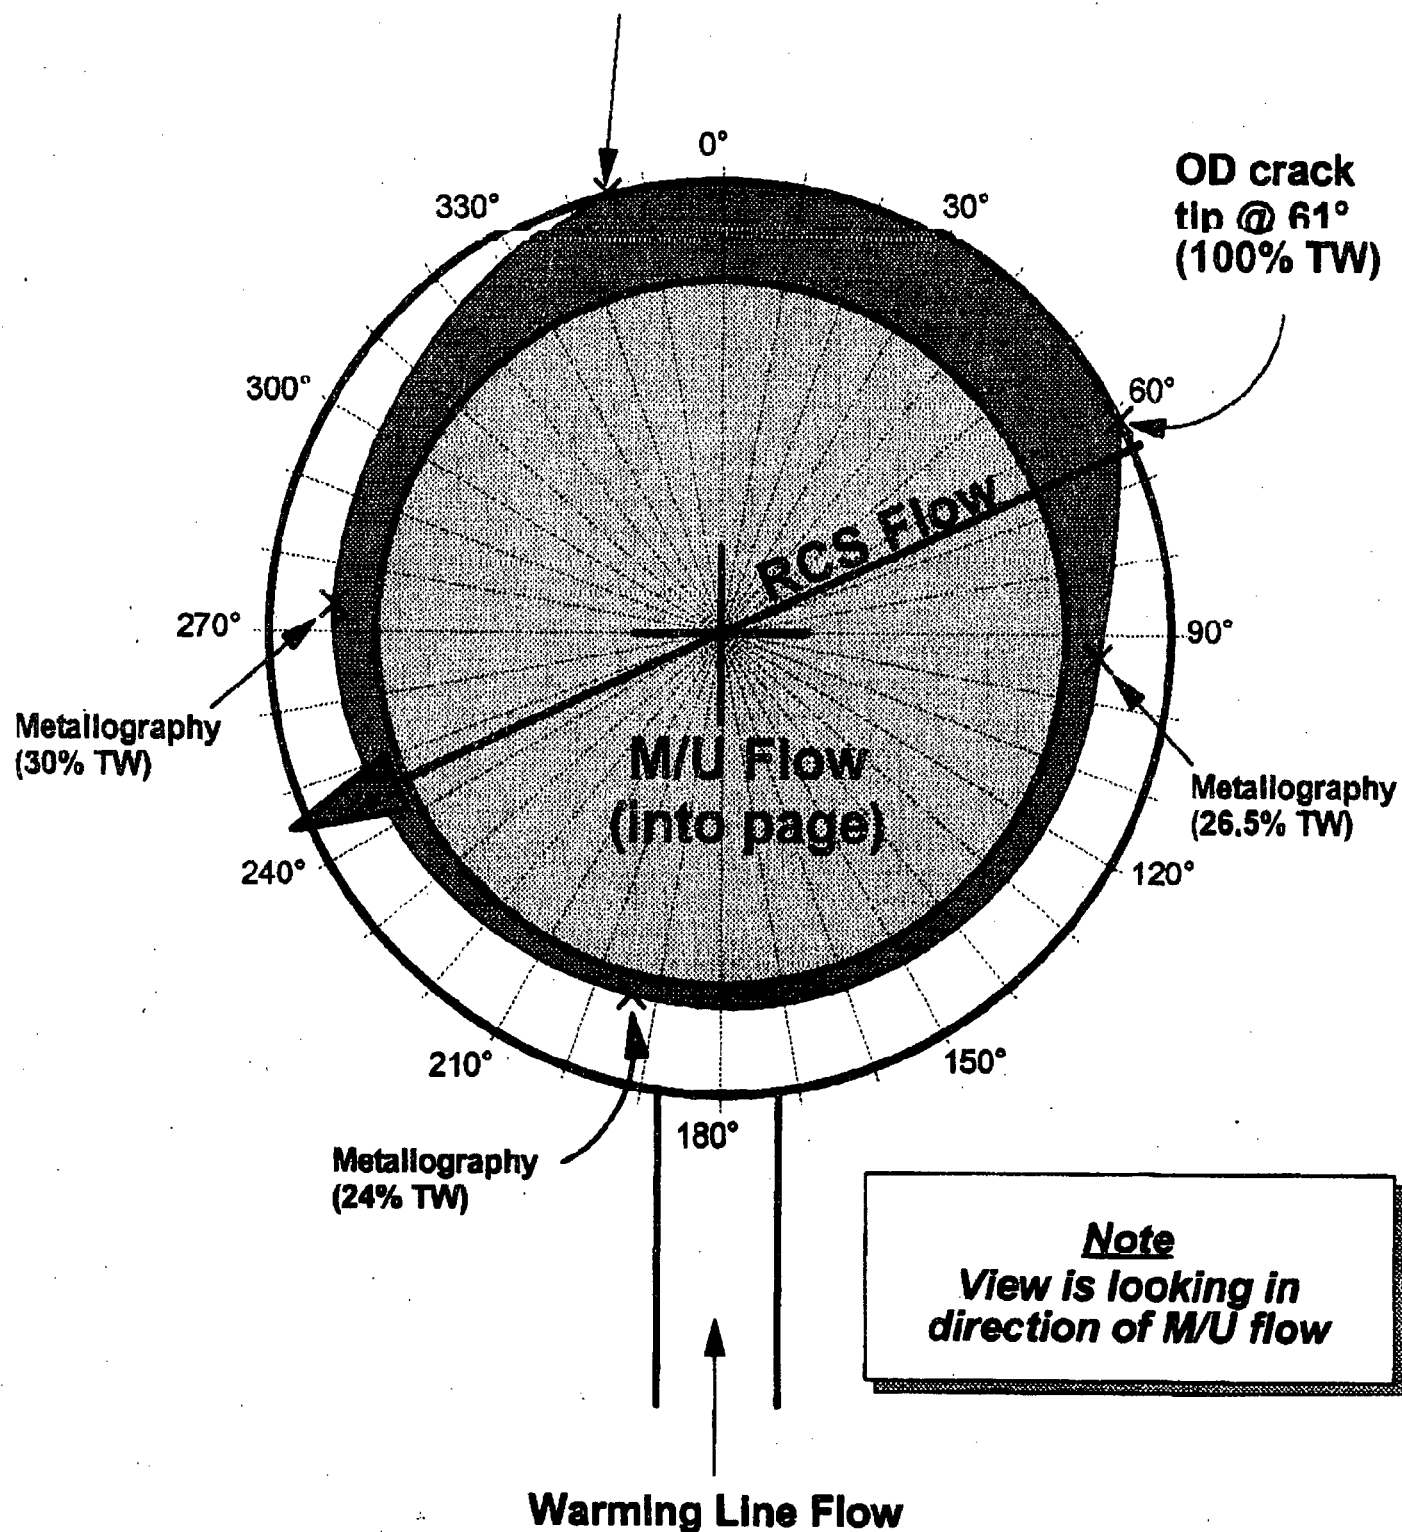
- » A leak occurred in the pipe to safe end connection weld at the 2A1 HPI nozzle
- » Crack in weld was circumferential, with a portion being through-wall
- » Crack propagated slowly
- » Details of crack described in JCO for Unit 1

- » High cycle low / stress thermal fatigue initiated failure in weld
- » Flow induced vibration contributed to thermal sleeve failure after loosening

OD crack tip @ 344° (100%TW)
