SUBJECT: LER 80=003/03L=0:on 800205, during routine tour, main feeder bus 1 was isolated when smoking bus connection was discovered, Apparently caused by differing secondary voltages resulting in transformer 3T carrying excessive load.

## DUKE POWER COMPANY OCONEE UNIT 3

Report Number: RO-287/80-3

Identification of Occurrence: Main Feeder Bus Isolated

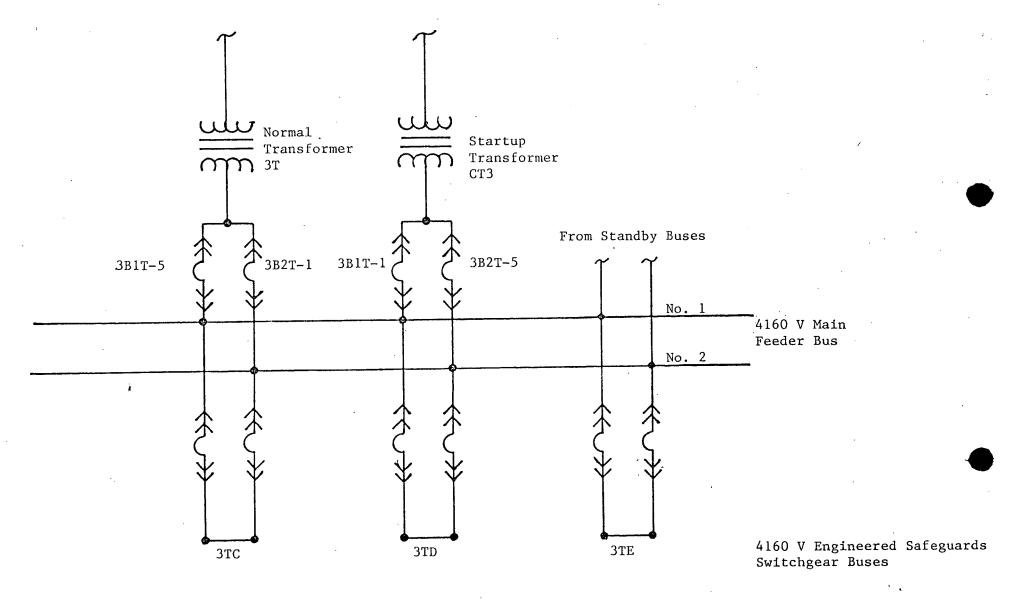
Figure 1

On February 4, 1980, breaker 3B2T-1, the 4160 volt normal feeder breaker to Oconee 3 Main Feeder Bus (MFB) 2, failed to close during performance of the monthly breaker operability test. Breaker 3B2T-5 was then closed, energizing MFB 2 from startup transformer CT-3. At 0620 on February 5, 1980, smoke was observed to be coming from a connection in cabinet 3B1T-3 during a routine tour of the Oconee 3 Blockhouse. MFB 1 was isolated, and the connection stopped smoking. An hourly firewatch was established since the smoke detectors had not alarmed. At 0010 on February 6, 1980, breaker 3B1T-5 was closed, energizing MFB 1 from transformer 3T. The breaker from MFB 1 to switchgear group 3TC was then closed, but tripped on overcurrent approximately 5 seconds later. Breaker 3B1T-5 was reopened, and the breakers energizing switchgear groups 3TC, 3TD, and 3TE from MFB 1 were closed. Breaker 3B1T-5 was then reclosed, and no problems were observed. However, a review of hourly megawatt readings indicated that during the period that MFB 1 was energized by transformer 3T and MFB 2 was energized by transformer CT3, transformer 3T was reading approximately 15 megawatts higher than normal, and transformer CT3 was supplying no power. Breaker 31T-1 was closed and breaker 3B2T-1 was opened, so that MFB 1 was energized by transformer CT3. On February 7, 1980 investigation of the problems with breaker 3B2T-1 was completed, and it was returned to service. A simplified schematic of the power distribution system is attached.

During the period that MFB 1 was energized by the normal transformer and MFB 2 was energized by the startup transformer, both transformers were feeding the same loads in parallel. This should only be done if both transformers have the same characteristics. It appears that approximately 15 megawatts was flowing from transformer 3T through transformer CT3 back into the 230 KV switchyard, possibly due to differing secondary voltages for the two transformers. The resultant excessive current caused the bus connection in cabinet 3B1T-3 to overheat and burn off the adjacent epoxy insulation. With no flame present, the smoke produced was of very low thermal energy and would tend to stratify, so that it did not reach a smoke detector located on the ceiling. In addition, the detector in the area had a somewhat lower sensitivity than others in use.

Investigation of the problem with breaker 3B2T-1 revealed a ground on the DC system. When the ground was cleared, the breaker operated properly. The overheated bus connection was inspected and cleaned thoroughly after it was determined that no damage had occurred. The overcurrent trip protective relaying, which should have prevented the overheating, are being investigated. The possibility of welding all aluminum-to-aluminum connections in the 4160 volt switchgear is also under review. In addition, consideration is being given to installing an electrical interlock to prevent the main feeder buses from being energized by the normal and startup transformers in parallel. The 4160 volt breaker operability test may be revised to avoid placing the transformers in parallel. The existing smoke detector will be replaced, and an ionization detector will be installed above each switchgear cabinet to identify overheating problems.
