### **FINAL REPORT: CRACKED LPI PIPE AT OCONEE-3**

PREPARED FOR  
DUKE POWER COMPANY

LTC:92:0017-01:01

JANUARY 1992

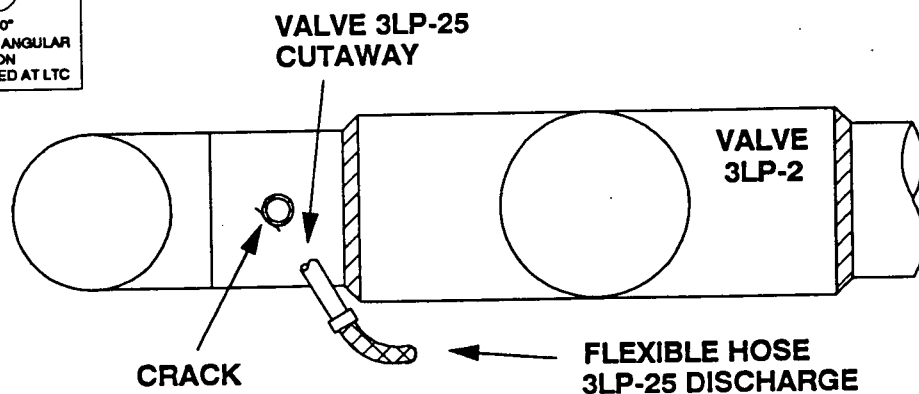
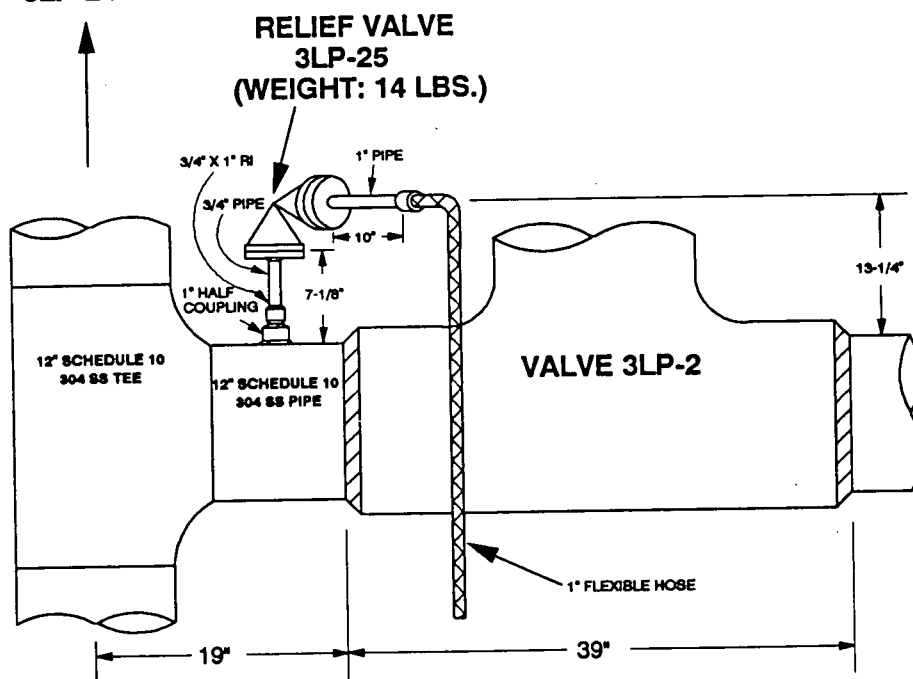
FIGURE 1: LPI PIPING ARRANGEMENT, SHOWING CRACK LOCATION AND ORIENTATION

The Oconee 3 Nuclear Plant is a B&W designed 846 MWe pressurized water reactor plant owned and operated by Duke Power Company (DPC). The plant has been in commercial operation since December 1974. A recent loss of coolant accident (LOCA) resulted in a forced shutdown of the unit. The LOCA was caused by the failure of a 3/4 inch compression fitting in the reactor vessel level indicating system (RVLIS). After repairs were completed on the RVLIS system and preparations were being made for heatup, a throughwall crack was discovered in a twelve inch Schedule 10 pipe in the low pressure injection (LPI) system. The crack was located at a welded half coupling, joining a one inch Schedule 40 pipe to the twelve inch pipe. The one inch pipe consisted of a seven inch long vertical run to relief valve 3LP-25. The relief valve weighed about 14 pounds. Details of the piping arrangement and crack location and orientation are shown in Figure 1. The principal material of construction was 304 stainless steel.

The subject pipe section was received at the LTC on December 23, 1991 at 10:00 PM. The pipe section was packed in a wooden crate and had been shipped LSA via Roberts Express. Shortly after receipt, the part was unpacked, surveyed and visually inspected. Contact radiation levels were 300 mRad/hr  $\beta$  and 36 mR/hr  $\gamma$ . Smearable contamination on the ID surface was 50 mRad/hr  $\beta$ . The entire assembly is shown as received in Figure 2. An arbitrary orientation and angular convention was established for the assembly as shown in Figure 1.

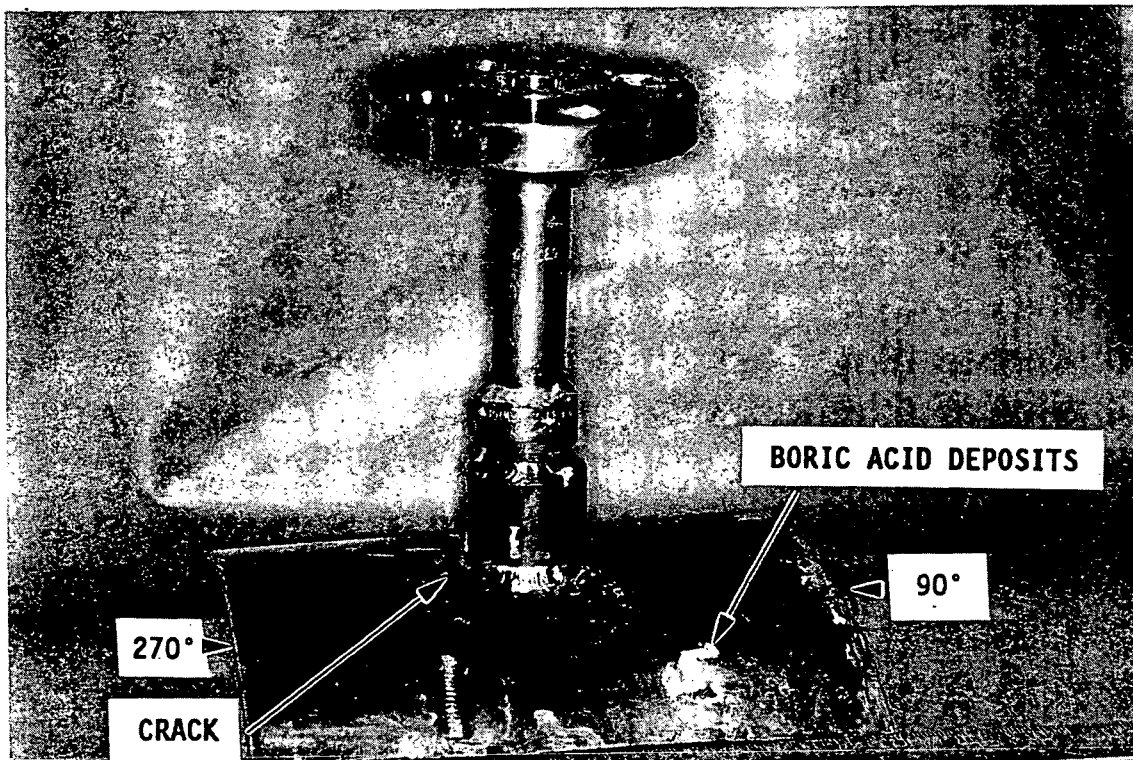
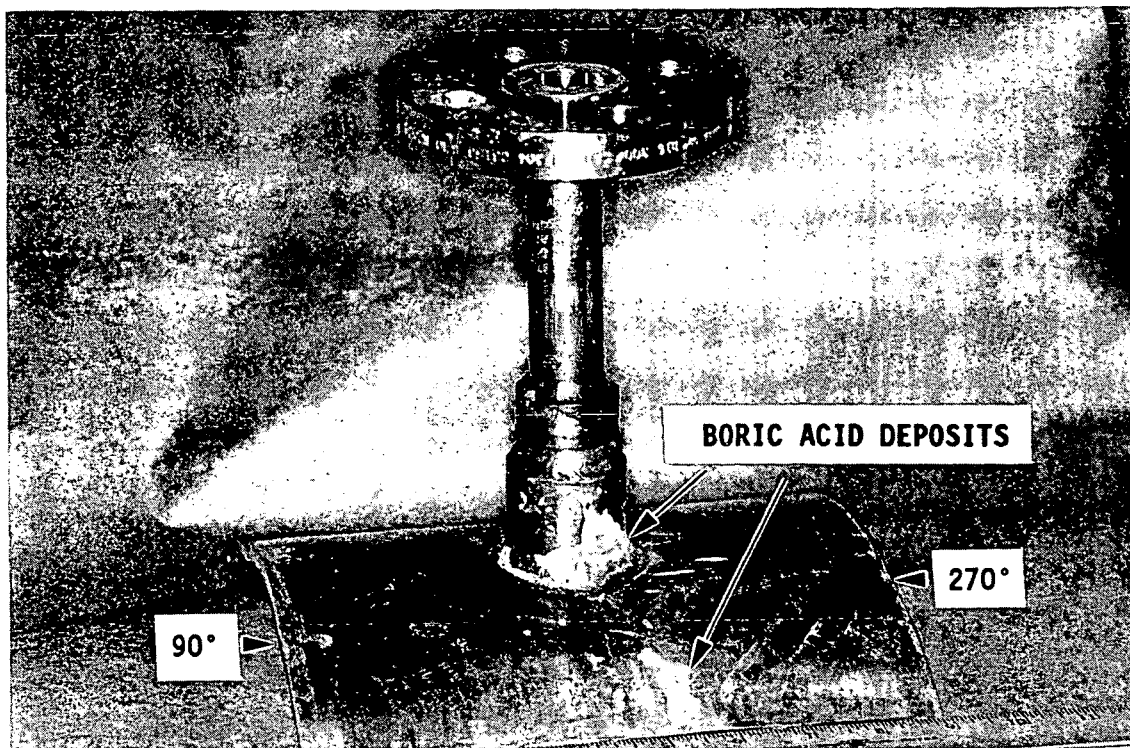
FIGURE 2: LPI PIPE SECTION AND ATTACHED PIPE STUB, AS-RECEIVED (0.4X)

RUST COLORED DEPOSITS

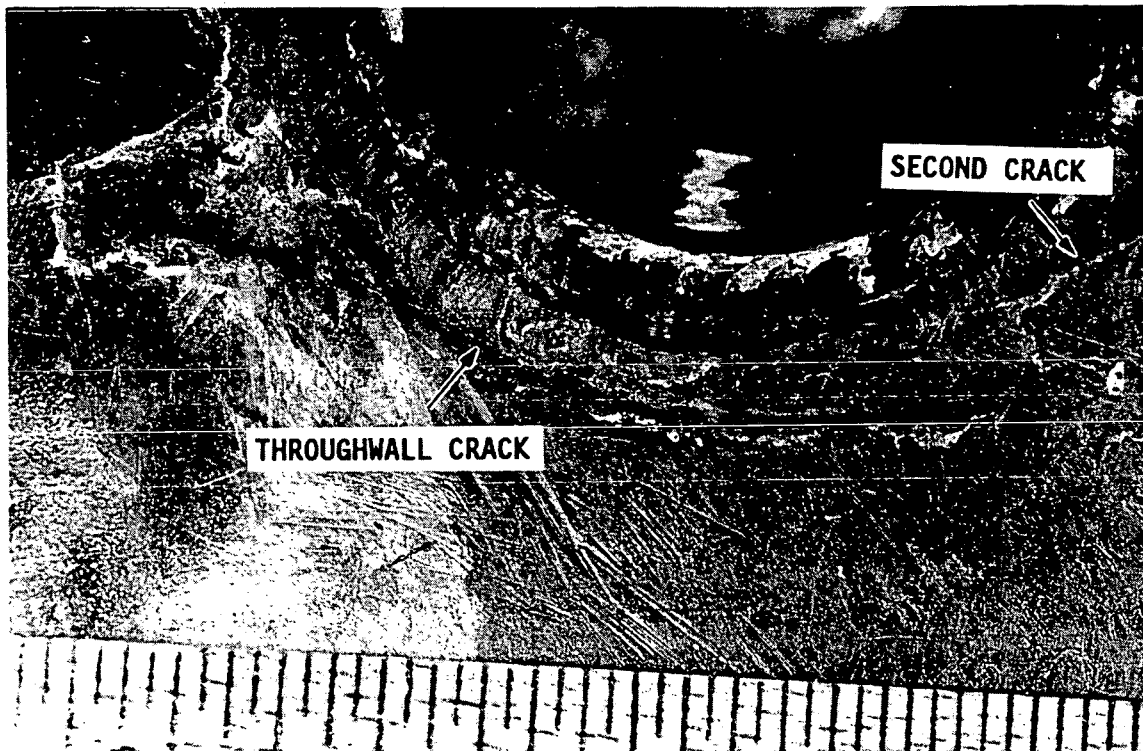
The central portion of the throughwall crack was located at the toe of the half coupling weld. In this region, the crack extended approximately 50° around the circumference of the weld (from 180° to 230°) and followed the contours of the weld toe (see Fig. 3). Near the ends, the crack had propagated into base metal and had turned such that the crack was oriented nearly parallel to the axis of the twelve inch pipe. The overall length of the crack on the OD surface was approximately 2-1/2 inches. As a result of leakage, a rust colored stain had developed below the crack and boric acid deposits had formed in several locations (see Fig. 2). An ID view of the assembly and the crack is shown in Figure 4. The crack was located within the heat tinted region caused by the welding operation. The crack was shorter on the ID surface, measuring about 1-1/2 inches long.

Another crack was observed on the OD surface adjacent to the throughwall crack at about 150° (see Fig. 3). One end of this crack from 140° to 160° was located at the toe of the half coupling weld. Similar to the larger crack, the end of the crack had propagated into base metal and had started to reorient itself parallel to the axis of the twelve inch pipe.

FIGURE 3: OD VIEW OF THROUGHWALL CRACK; NOTE SECOND CRACK ADJACENT TO THROUGHWALL CRACK

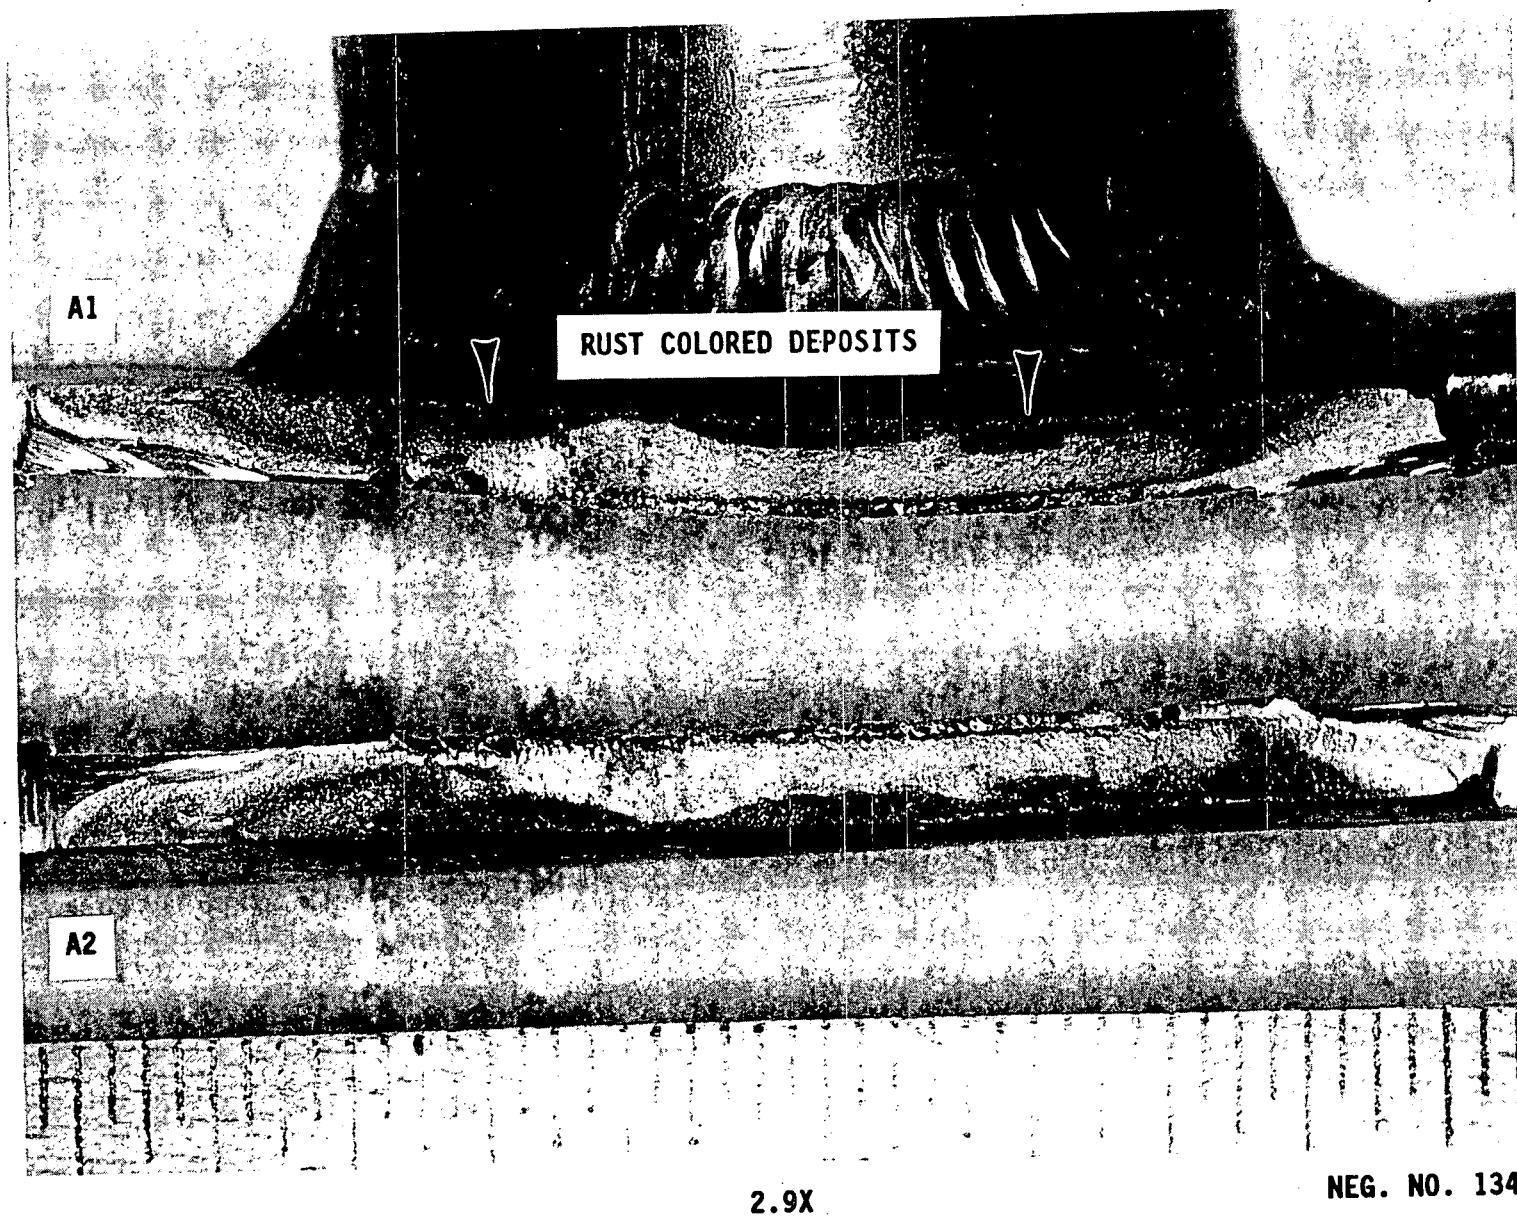
The exposed fracture surfaces are shown at higher magnification in Figure 7. The crack face had a classic thumbnail shape, with the concave side of the crack tip oriented toward the OD. The fracture surface was oriented essentially perpendicular to the surface of the twelve inch pipe and there was no evidence of necking near the fracture. Near the ID surface, however, there was an abrupt change in crack direction producing a lip oriented at a finite angle to the pipe surface. Rust colored deposits were noted on the fracture surfaces along the OD edge, although the main portion of the fracture was essentially free of deposits. These deposits were heaviest near the central portion of the crack. At higher magnifications, ratchet markings on the fracture surfaces indicated crack propagation from OD to ID with the origin located in the central portion of the crack along the weld toe, where the rust colored deposits were heaviest (see Fig. 8). There was no evidence of ductile rupture, except near the ends of the crack and at isolated points along the crack tip; these were most likely ligaments of solid metal which were torn apart upon bending the crack open in the laboratory. Also, there was no evidence of intergranular failure. In some small isolated areas it appeared as if there were some cleaved grains (see Fig. 9).

FIGURE 7: CRACK FACE, SPECIMENS A1 (TOP) AND A2 (BOTTOM) AFTER BENDING;  
ARROWS INDICATE LOCATION WHERE CRACK DEVIATED FROM WELD TOE

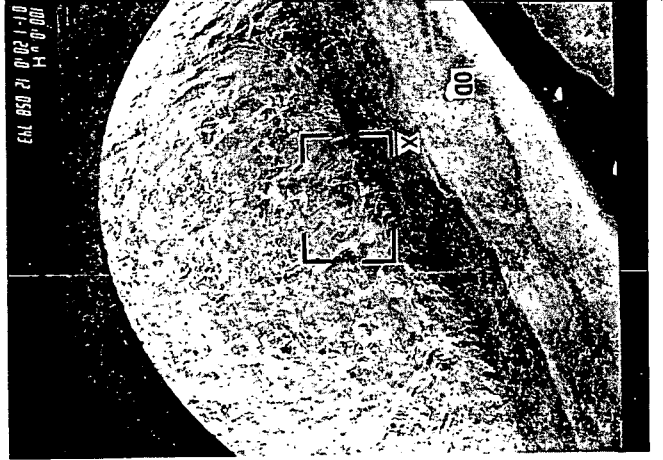
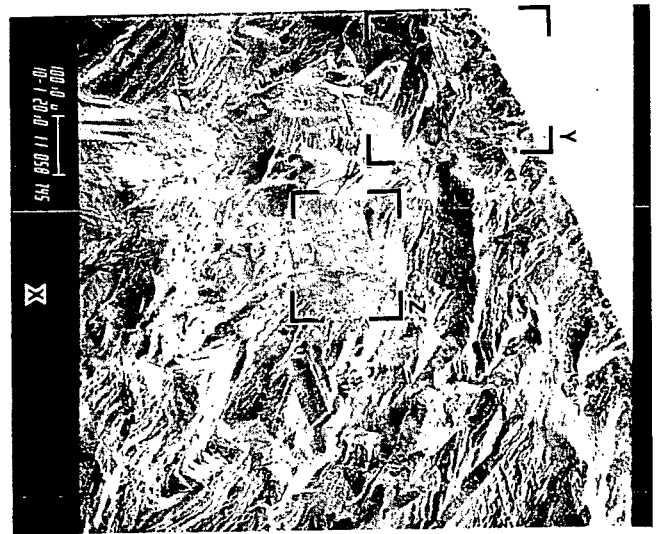
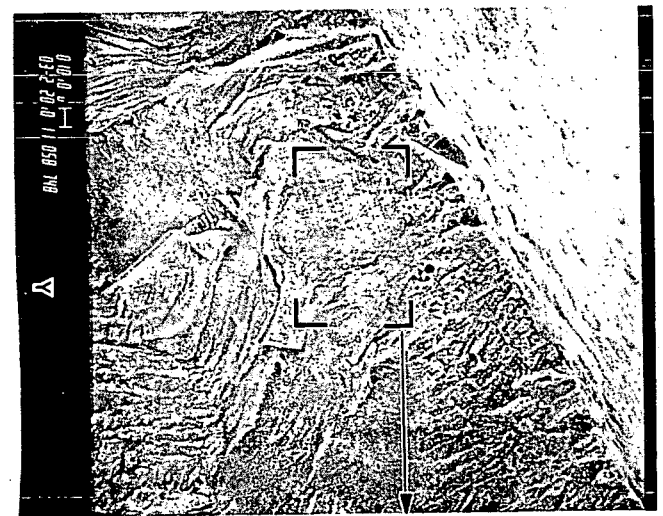
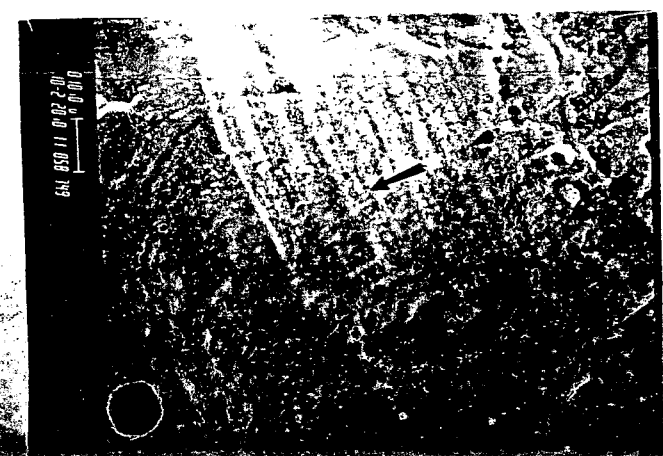
SEM examination of Specimens A1.4A and A1.4B indicated the crack had propagated in a transgranular mode. Possible fatigue striations were observed near the crack origin, but the fracture surface was covered with a light deposit in this region, which obscured fine surface detail (see Figs. 10 and 11). The deposits in this region were most likely the rust colored deposits noted previously along the OD edge of the fracture. There was no evidence of any weld defects which may have initiated the crack.

FIGURE 10: SEM RESULTS ON A1.  
NOTE LIGHT DEPOSIT  
TO OBSCURE STRIAT

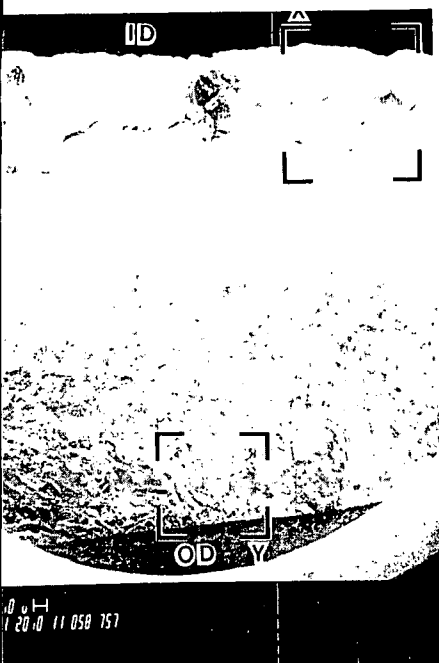
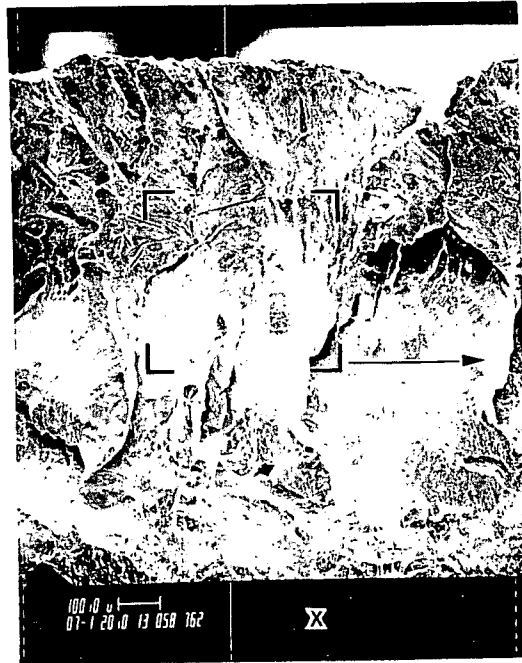
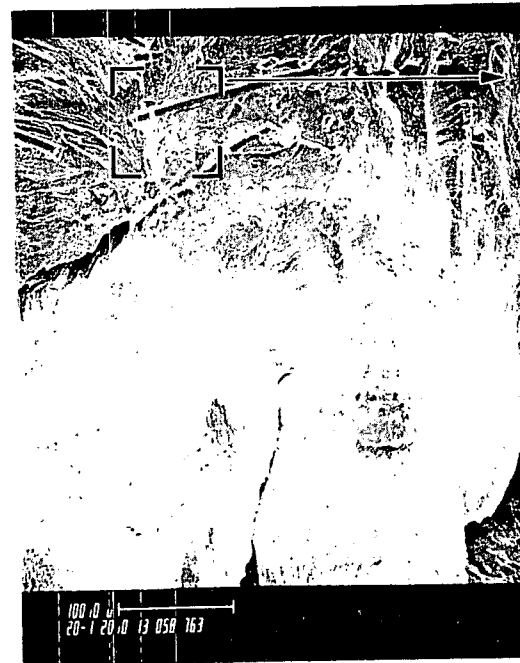
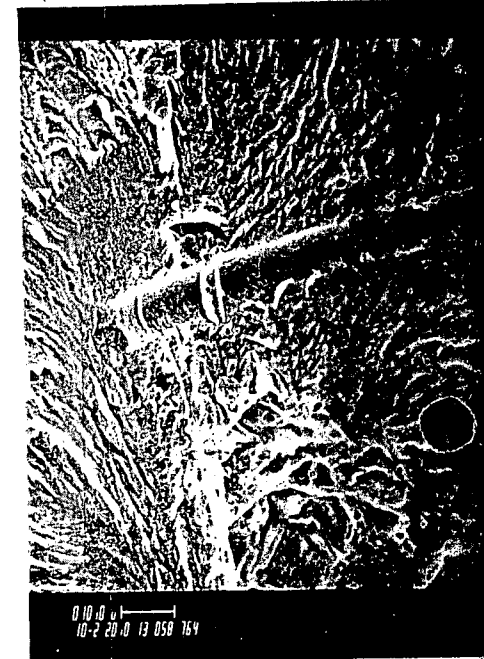
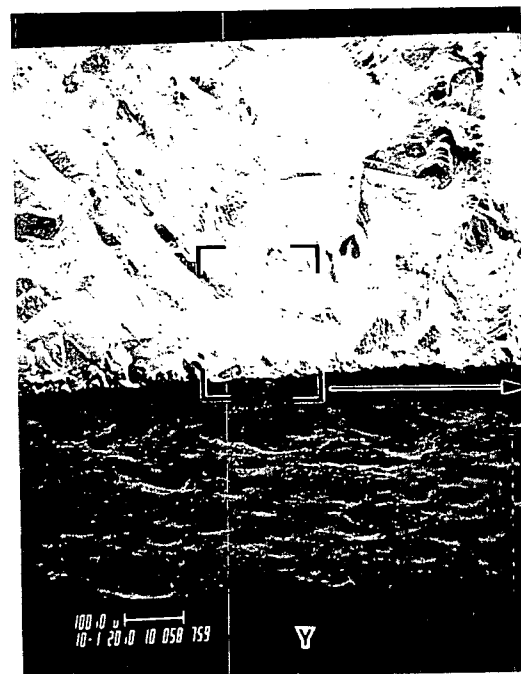
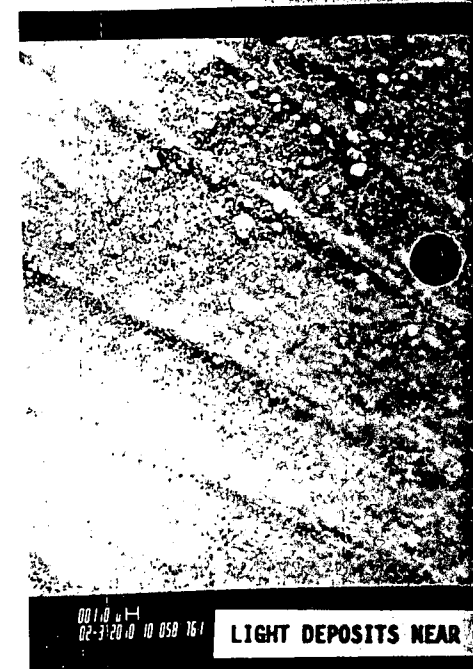
FIGURE 11: SEM RESULTS ON AND NEAR ID EDGE

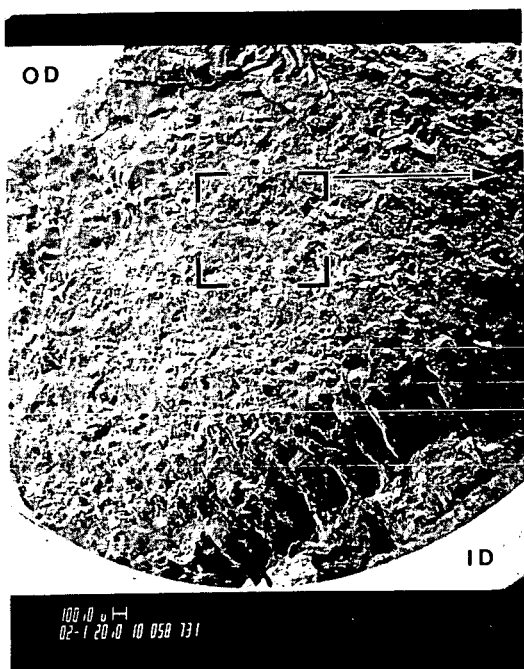
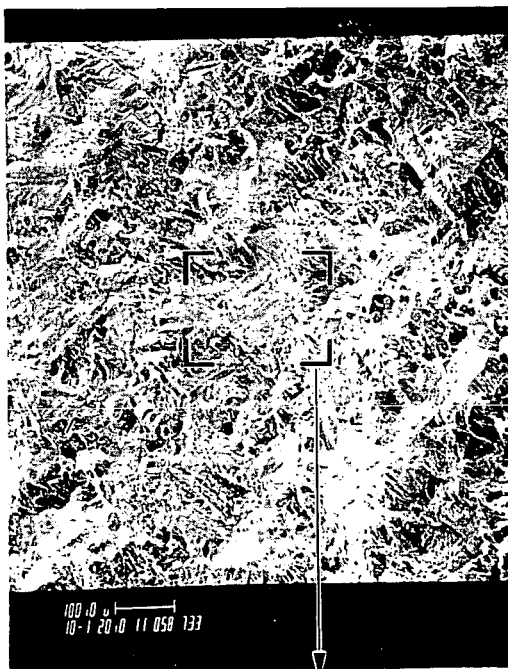
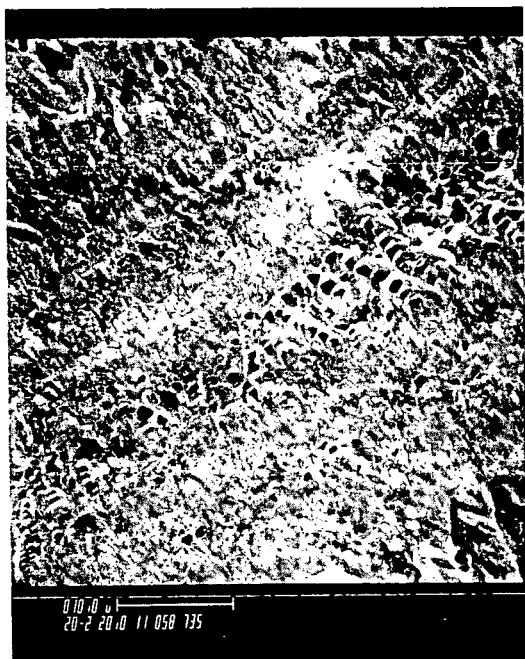
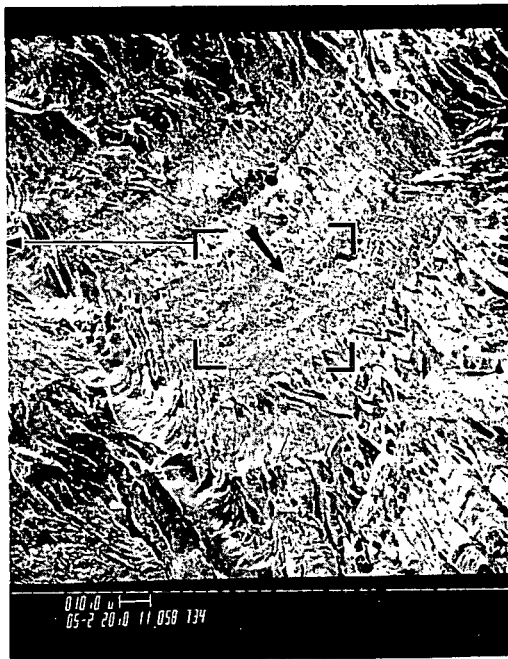
Examination of the main part of the fracture, which was essentially deposit free, revealed the presence of fine fatigue striations in several locations (see Figs. 12 - 14). Although the striations were poorly developed, in most cases, they were visible in small isolated areas over much of the main fracture surface. In general, the striations were bowed away from the OD and were oriented perpendicular to ratchet markings in the fracture surface. Striation spacings were typically less than 1 micron. There was no evidence of any significant corrosion on the fracture surface.

**FIGURE 12: SEM RESULTS ON A1.4A NEAR CENTRAL PART OF FRACTURE MID-WAY BETWEEN OD AND ID; BLACK ARROW INDICATES DIRECTION OF CRACK PROPAGATION**

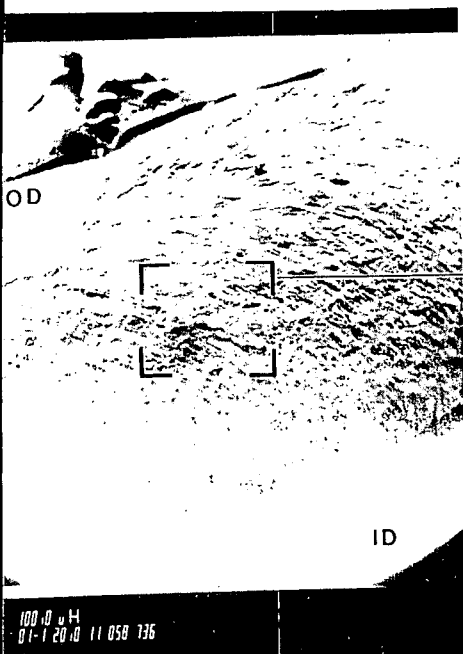
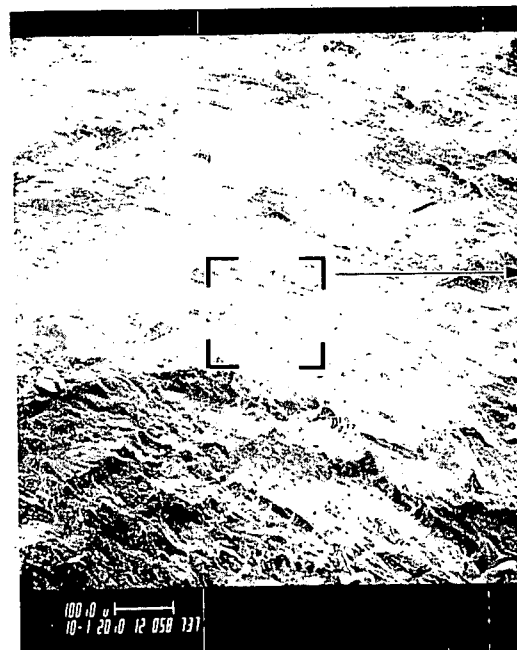
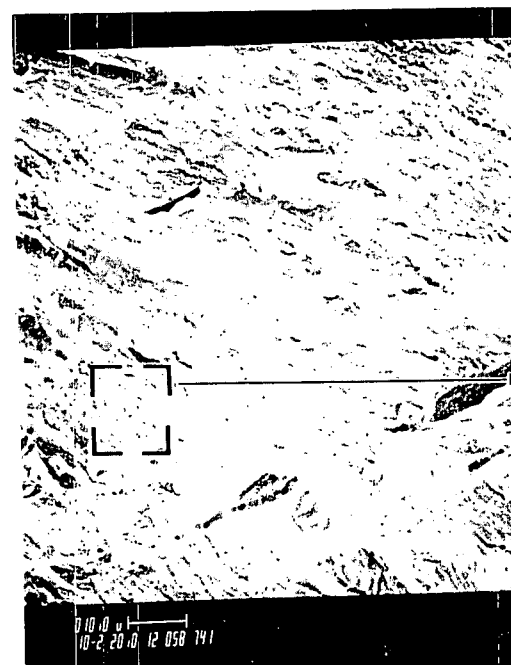
FIGURE 13: SEM RESULTS ON A1.4A NEARER END OF FRACTURE MID-WAY AND ID; BLACK ARROWS INDICATE DIRECTION OF CRACK PRO

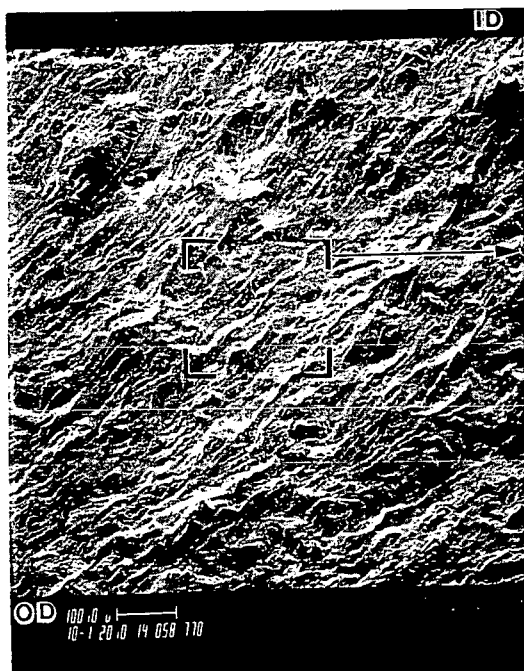
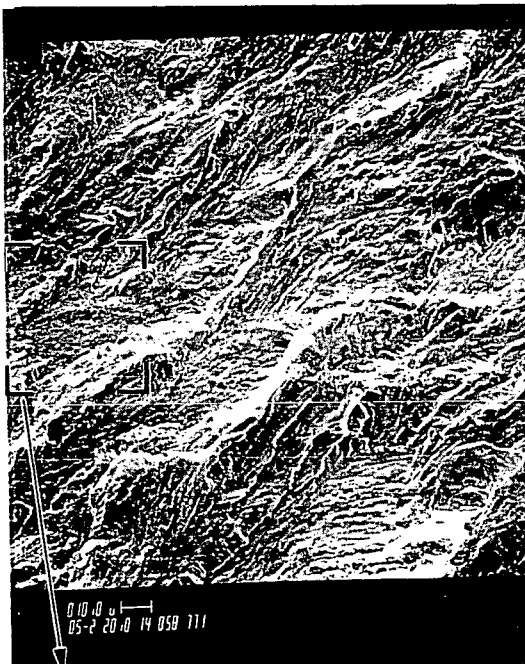
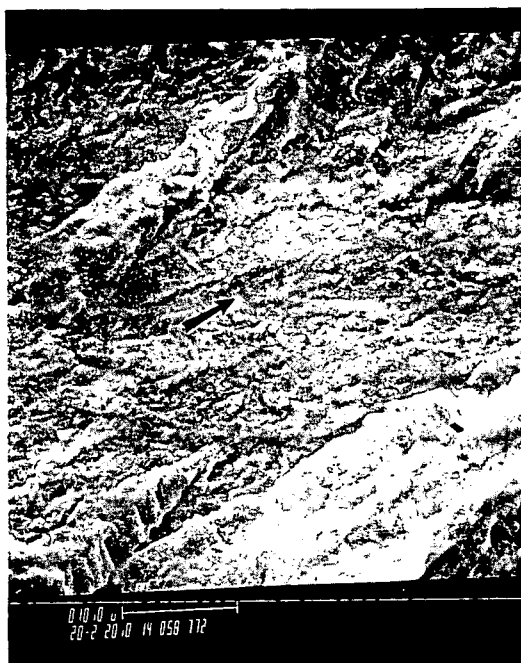
**FIGURE 14: SEM RESULTS ON A1.4B NEAR CENTRAL PART OF FRACTURE MID-WAY BETWEEN OD AND ID; BLACK ARROW INDICATES DIRECTION OF CRACK PROPAGATION**

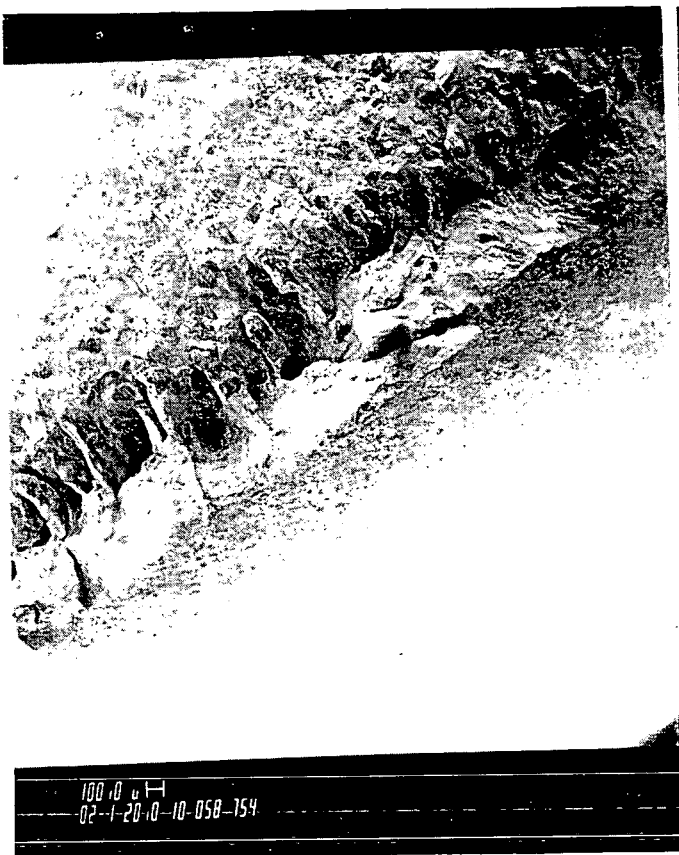
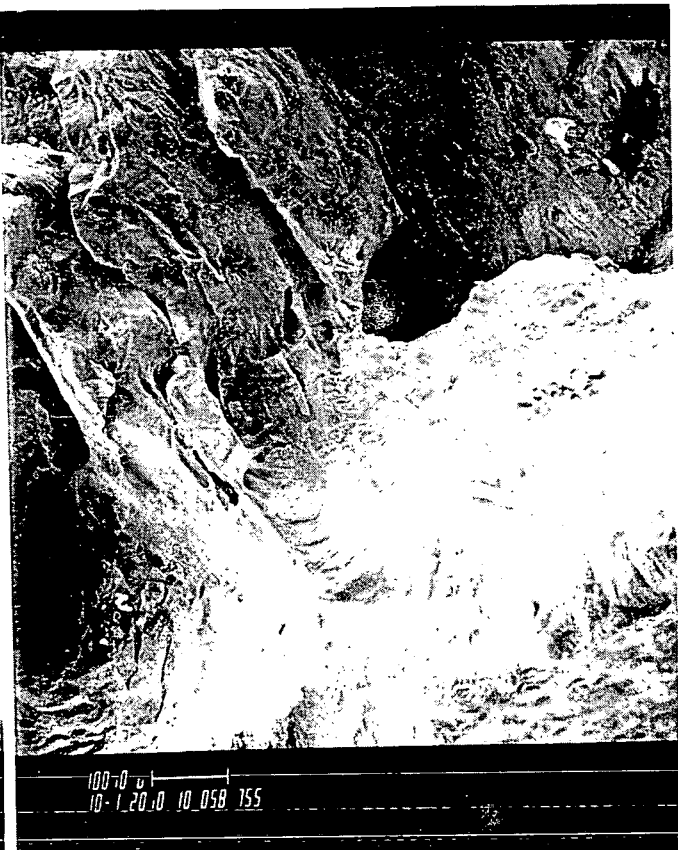
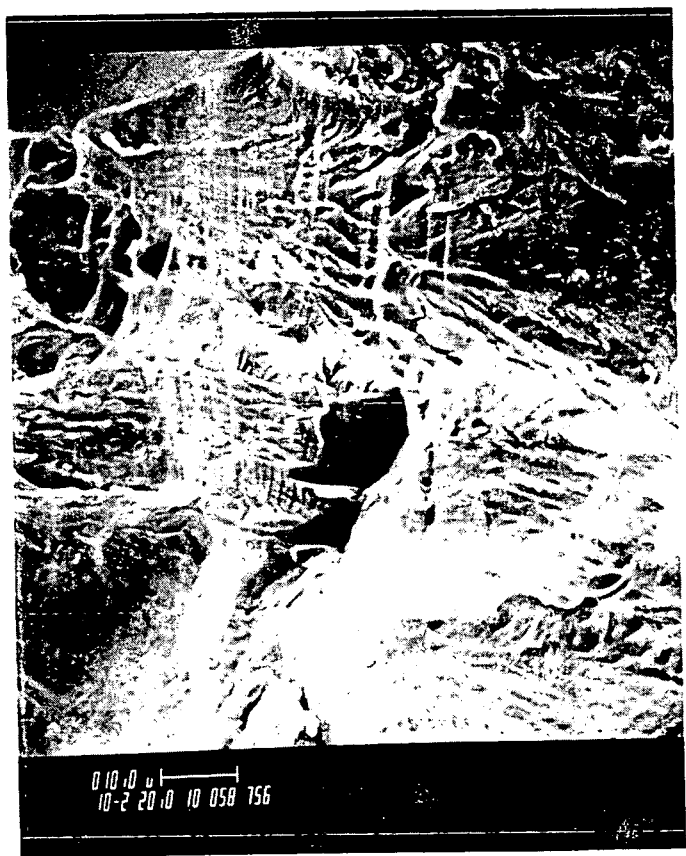
For the most part, the lip observed near the ID edge did not fail in a ductile manner. The general topography and some areas with possible fatigue striations indicated the predominant fracture mode along the ID edge was fatigue (see Fig. 15). Near the ends of the crack and at isolated points along the crack tip, dimpled rupture was observed however (see Fig. 16). As stated previously, these areas were most likely ligaments of solid metal which were torn apart upon bending the crack open in the laboratory.

**FIGURE 15: SEM RESULTS ON A1.4A SHOWING TYPICAL FRACTURE SURFACE APPEARANCE NEAR THE ID EDGE; NOTE ABSENCE OF DIMPLED RUPTURE AND POSSIBLE FATIGUE STRIATIONS**

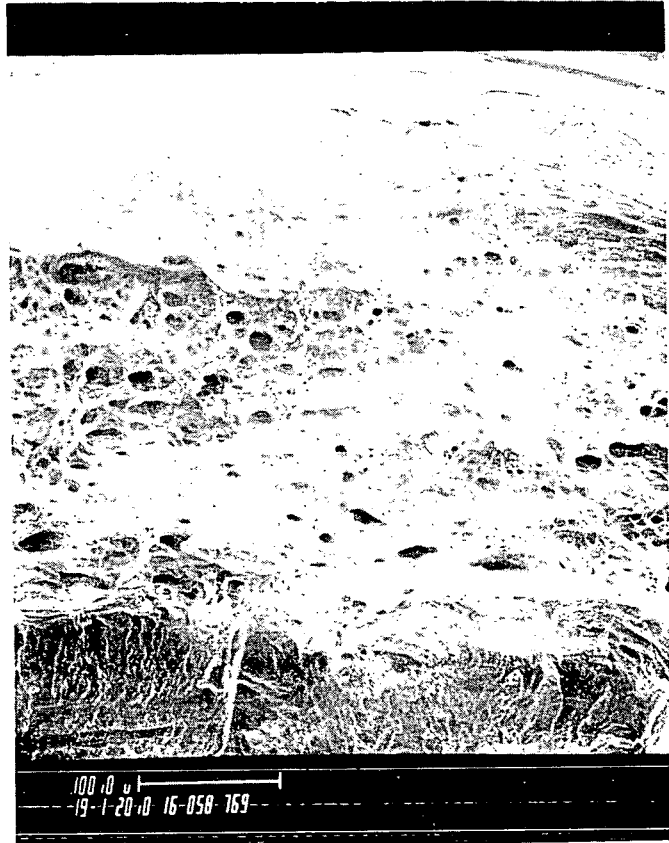
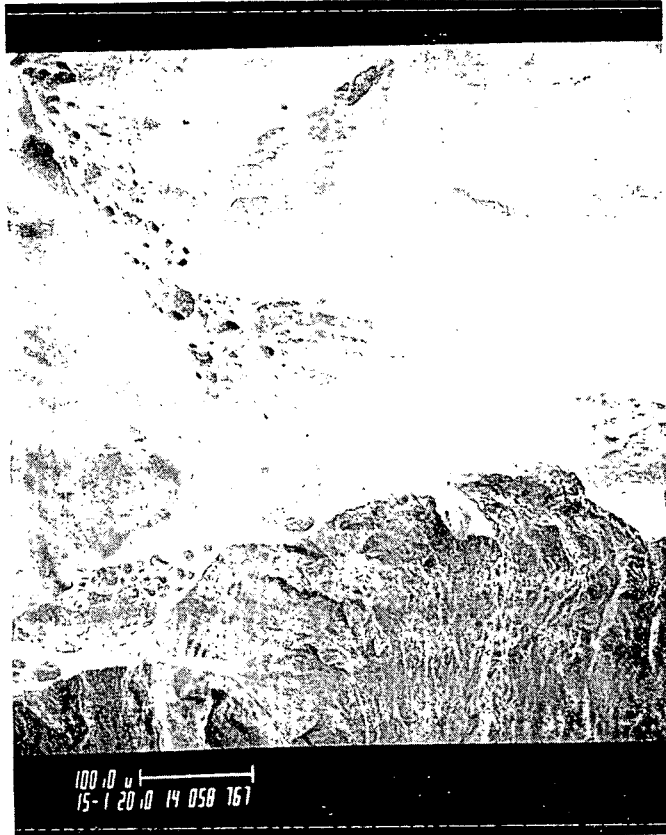
**FIGURE 16: SEM RESULTS ON A1.4B SHOWING DIMPLED RUPTURE NEAR THE END OF THE CRACK (TOP PHOTOS) AND OF SMALL LIGAMENTS ALONG ID EDGE (BOTTOM PHOTOS)**

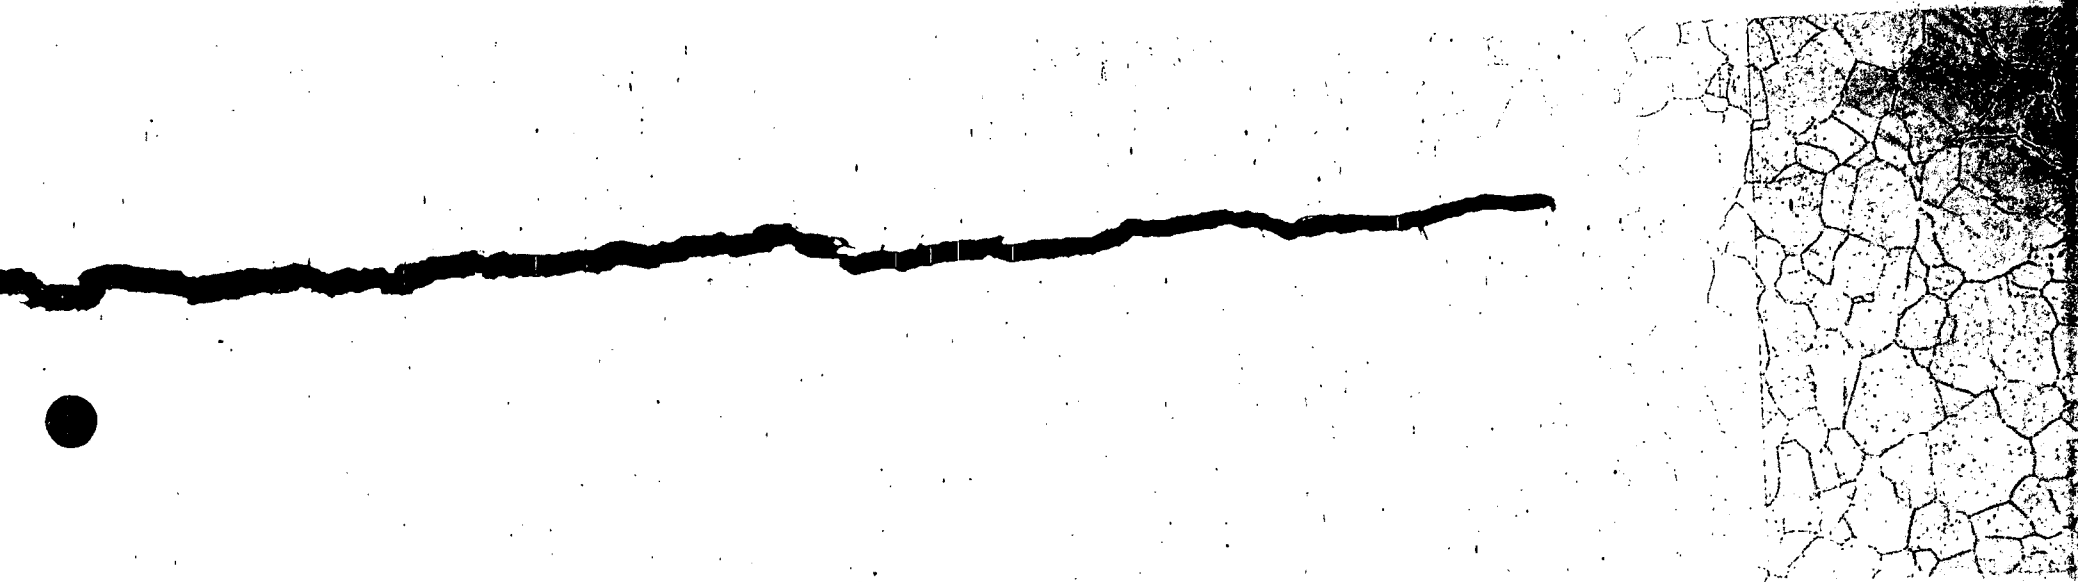
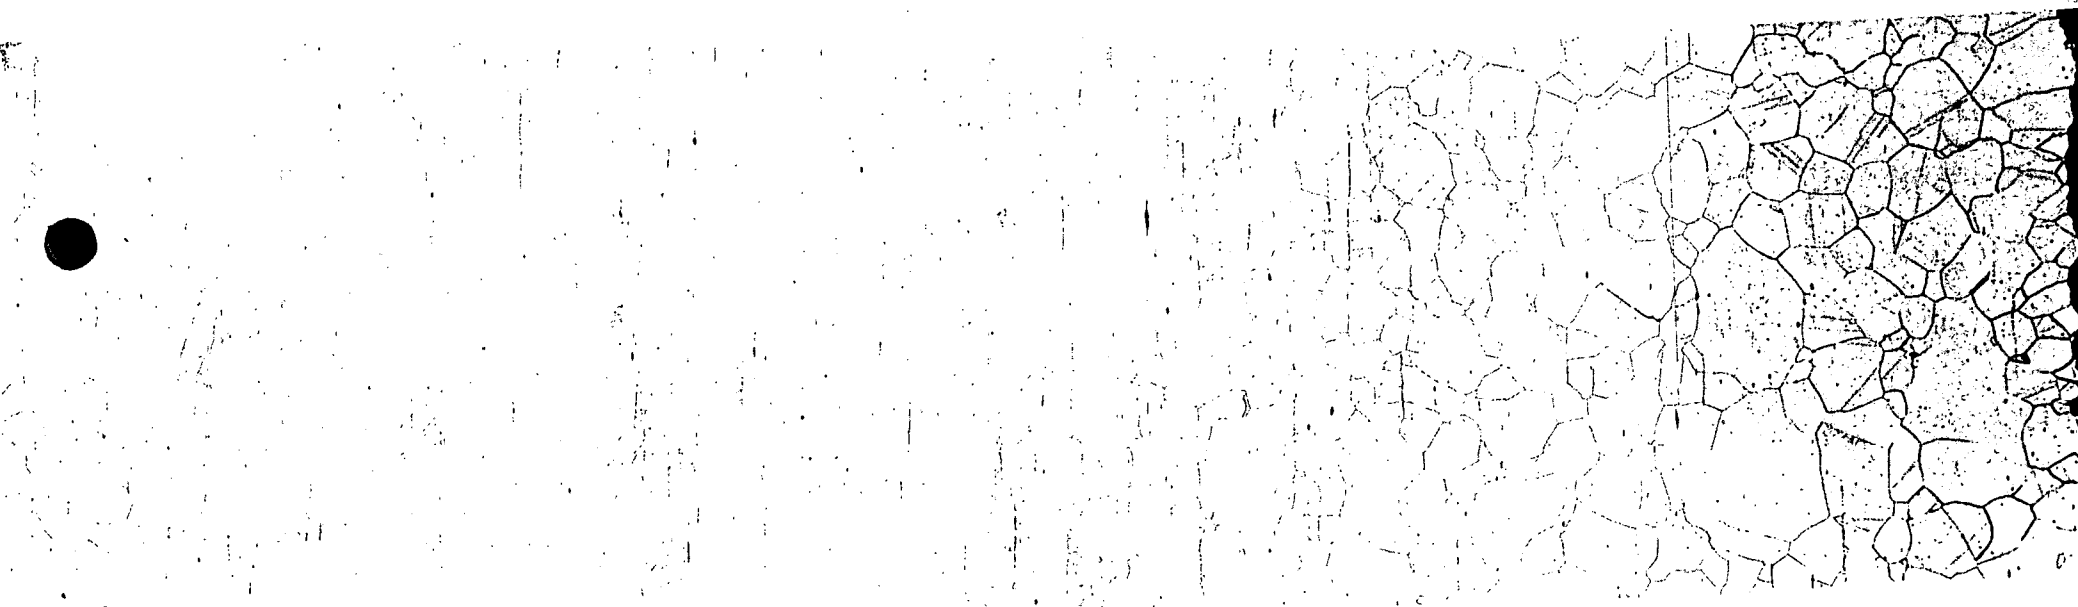
FIGURE 17: METALLOGRAPHY RESULTS ON A1.  
AND A1.3 (BOTTOM)

The microstructures of both specimens exhibited relatively equiaxed grains and significant numbers of annealing twins, which is typical of an annealed austenitic stainless steel. Some residual cold work was present in the mid-wall portion of the pipe. The microstructure of specimen A1.3 indicated there was no significant heat affected zone associated with the weld. The crack in specimen A1.5 was about 75% throughwall. This crack was verified to be entirely transgranular and essentially no crack branching was observed. Crack propagation was apparently not influenced by the material microstructure. A small crack was noted at the weld toe in specimen A1.3; this crack also appeared to be transgranular.

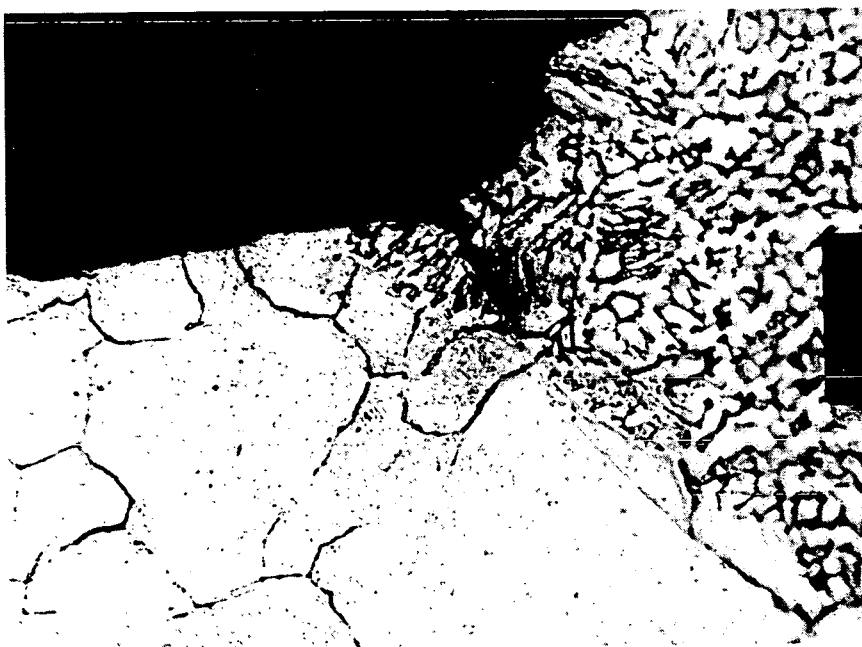
**FIGURE 18: METALLOGRAPHY RESULTS ON A1.3 SHOWING SMALL CRACK AT WELD TOE**
