DUKE POWER COMPANY  
OCONEE NUCLEAR STATION

UNIT 3  
REACTOR BUILDING  
POST-TENSIONING SYSTEM  
SIXTH SURVEILLANCE

July 1995

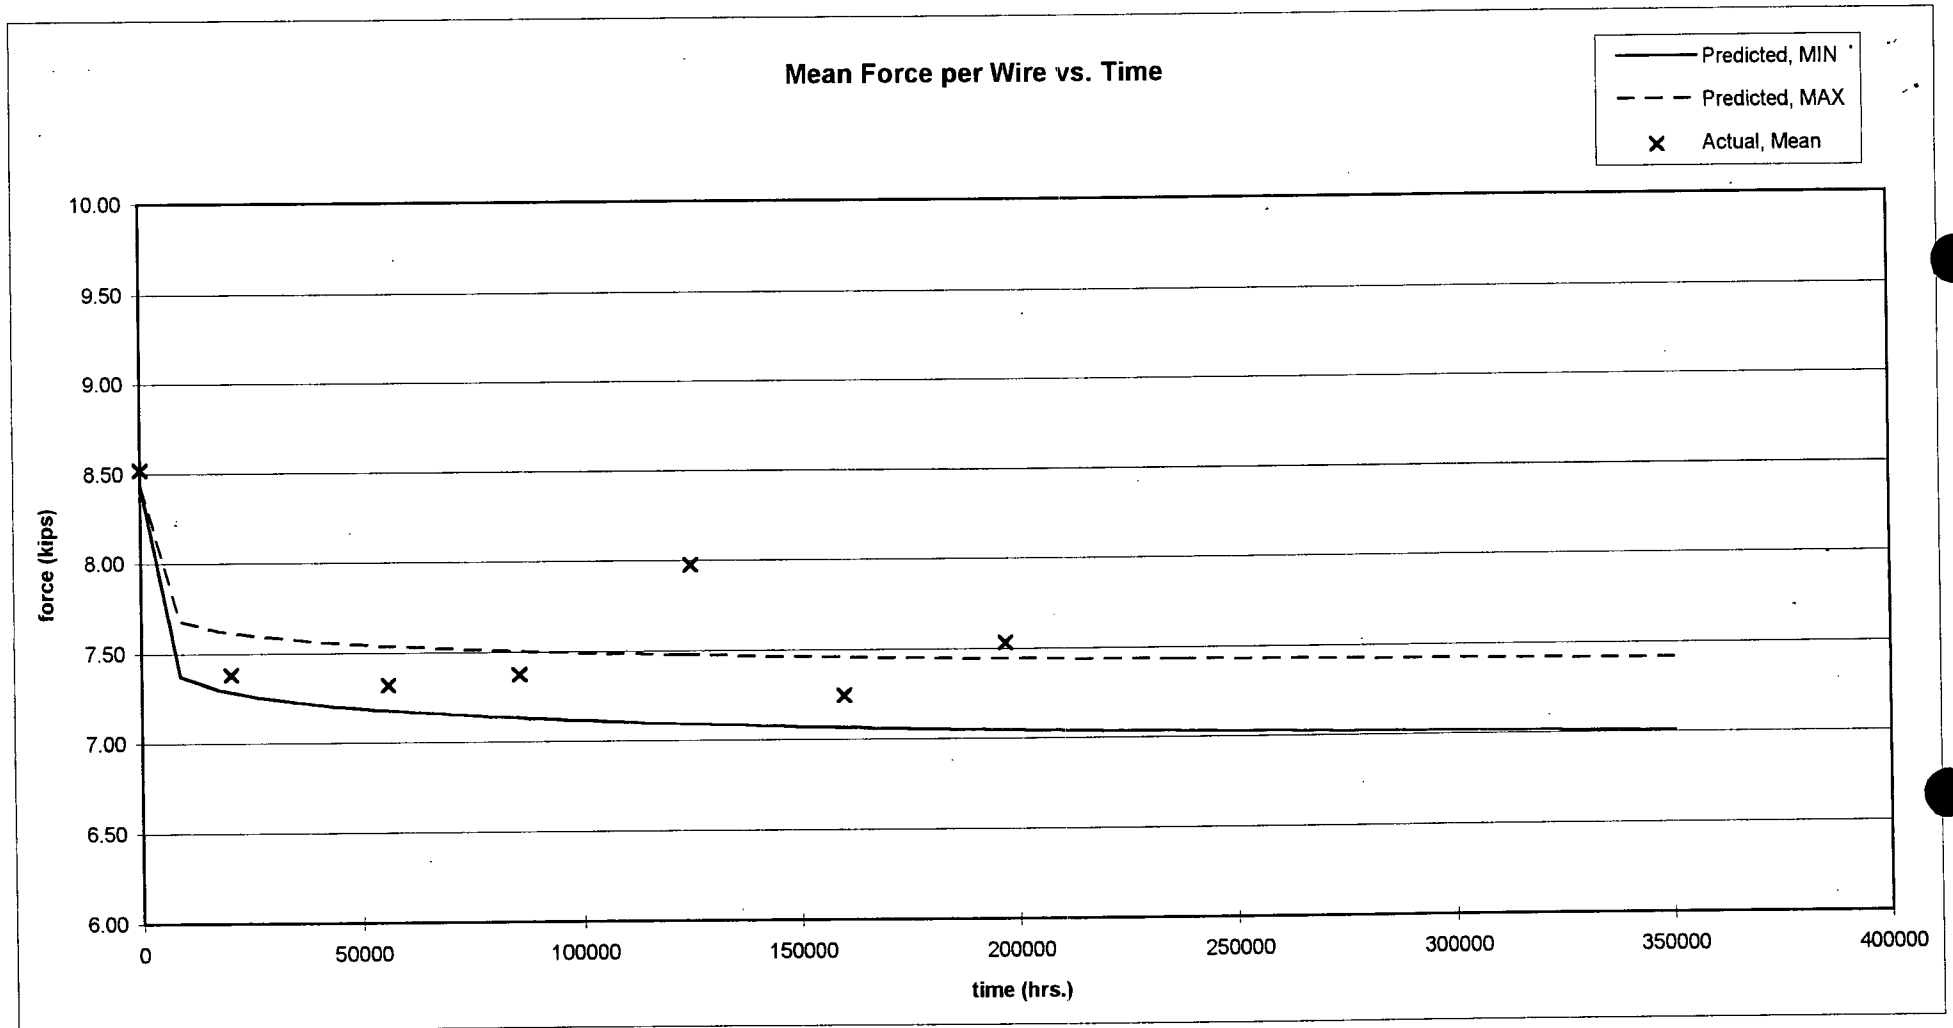
Figure 1

Lift-off forces were obtained for each inspected tendon - see Table 3. From these readings an average force per wire was determined. Long-term trends of these wire forces, considering effects of elastic shortening, steel relaxation, and concrete creep and shrinkage, are shown graphically in Figures 1, 2, and 3. Mean lift-off force for each surveillance tendon group - hoop, vertical, and dome - exceeded required values.

Dome Tendon Group Force-Time Plot

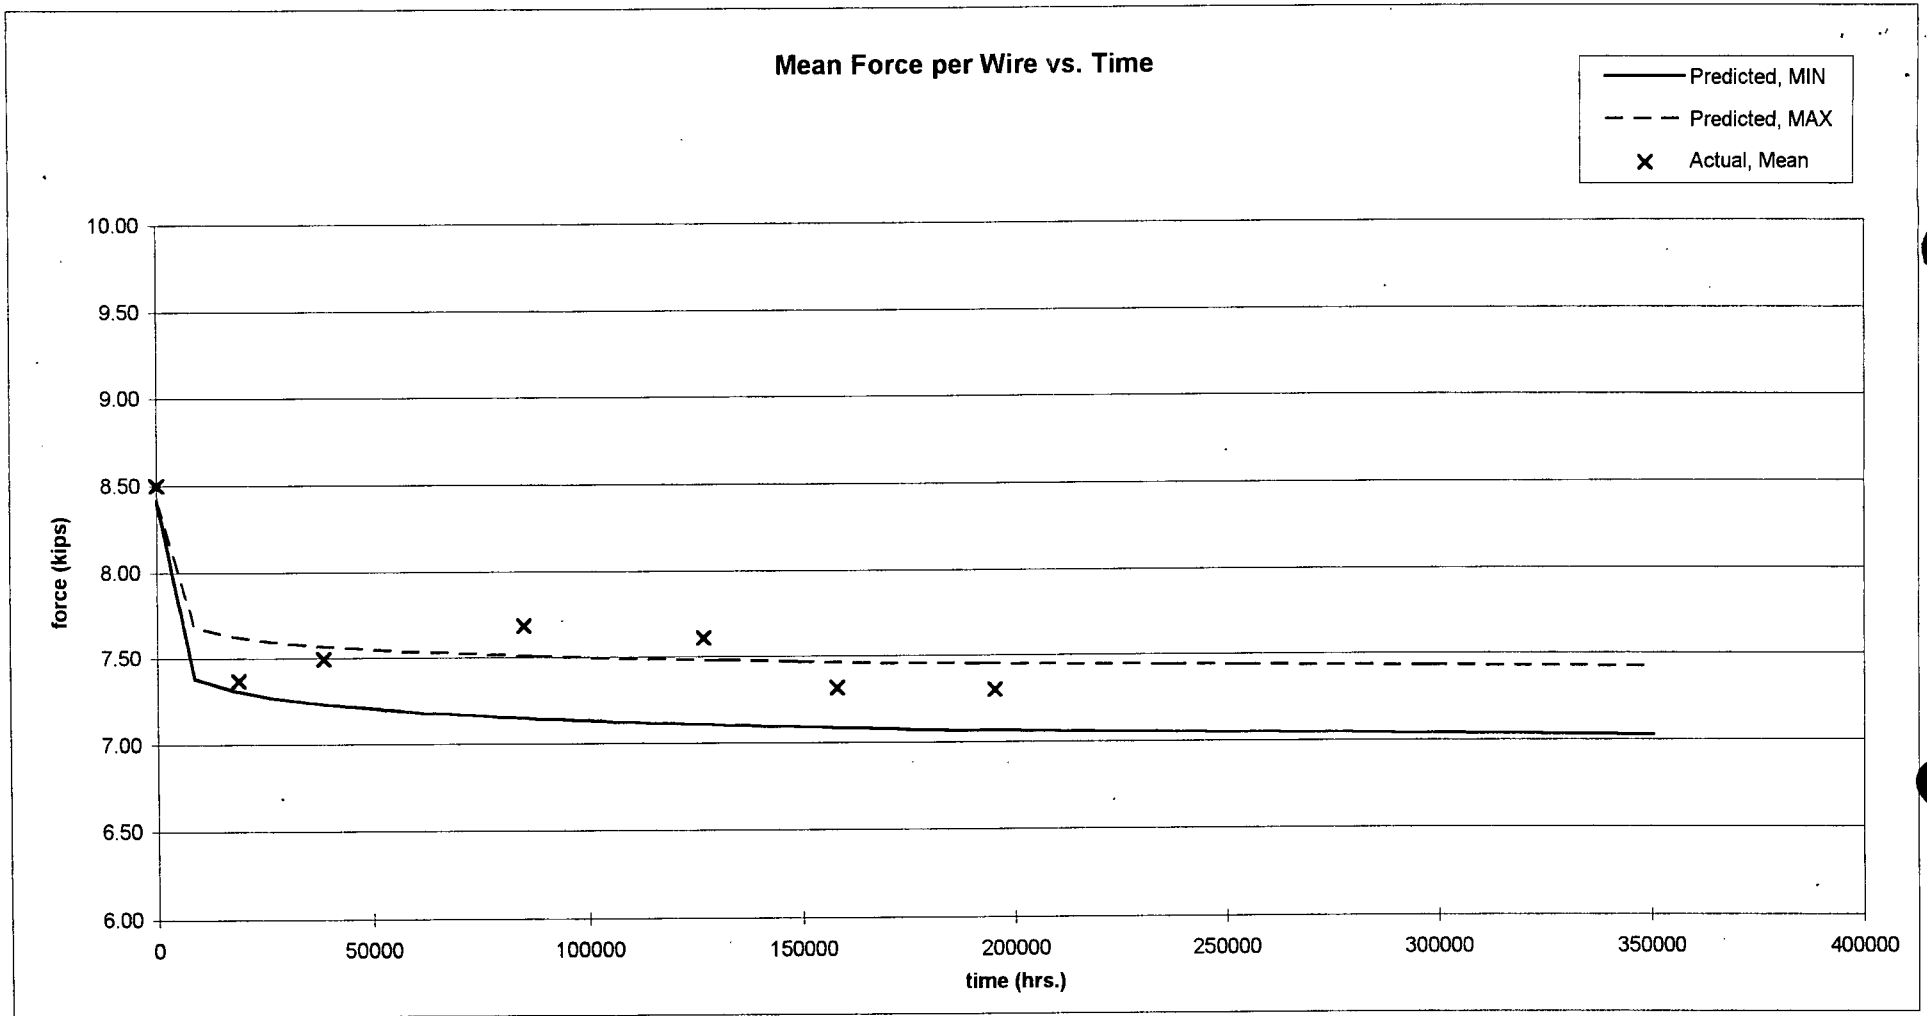
Figure 2

Hoop Tendon Group Force-Time Plot

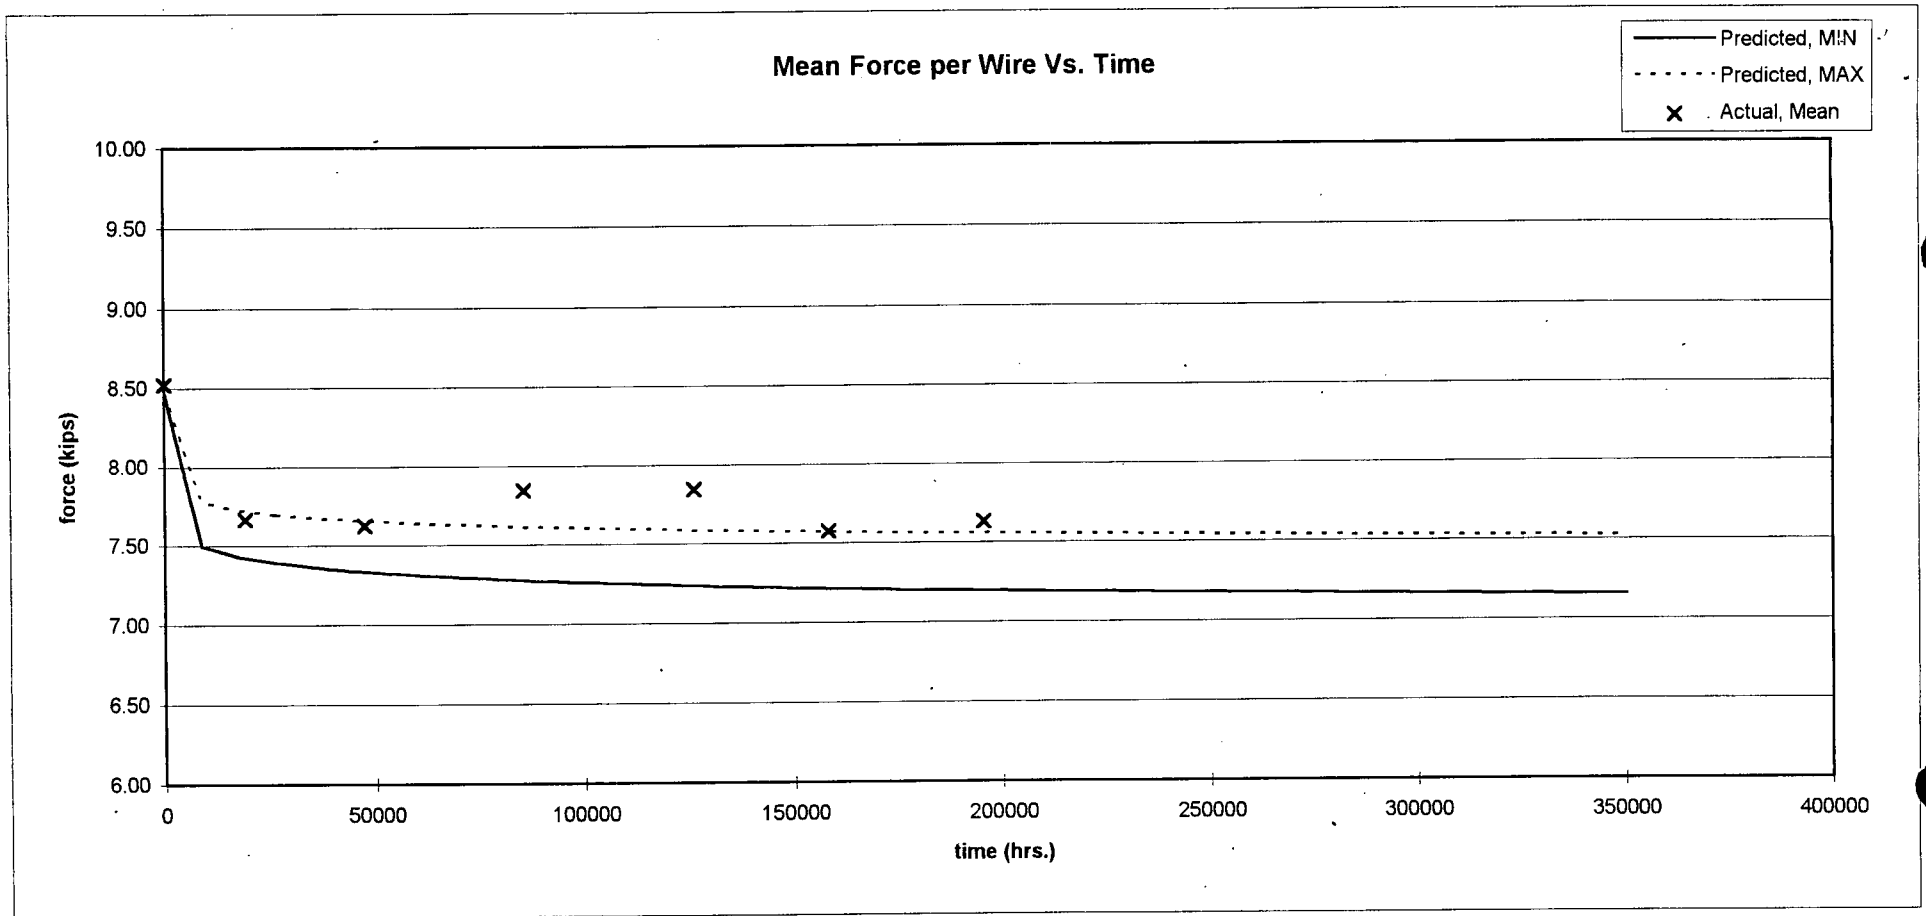
**Figure 3**

**Vertical Tendon Group Force-Time Plot**
