SUBJECT: Forwards technical evaluation of reactor coolant pump 2A2 hydraulic snubber operability, per 830919 visual insp. Snubber determined operable. Next visual insp required prior to 850214.

Subject: Oconee Nuclear Station
Docket No. 50-270

Duke Power Company
Oconee Nuclear Station
Technical Evaluation of RCP 2A2 Hydraulic Snubber Operability

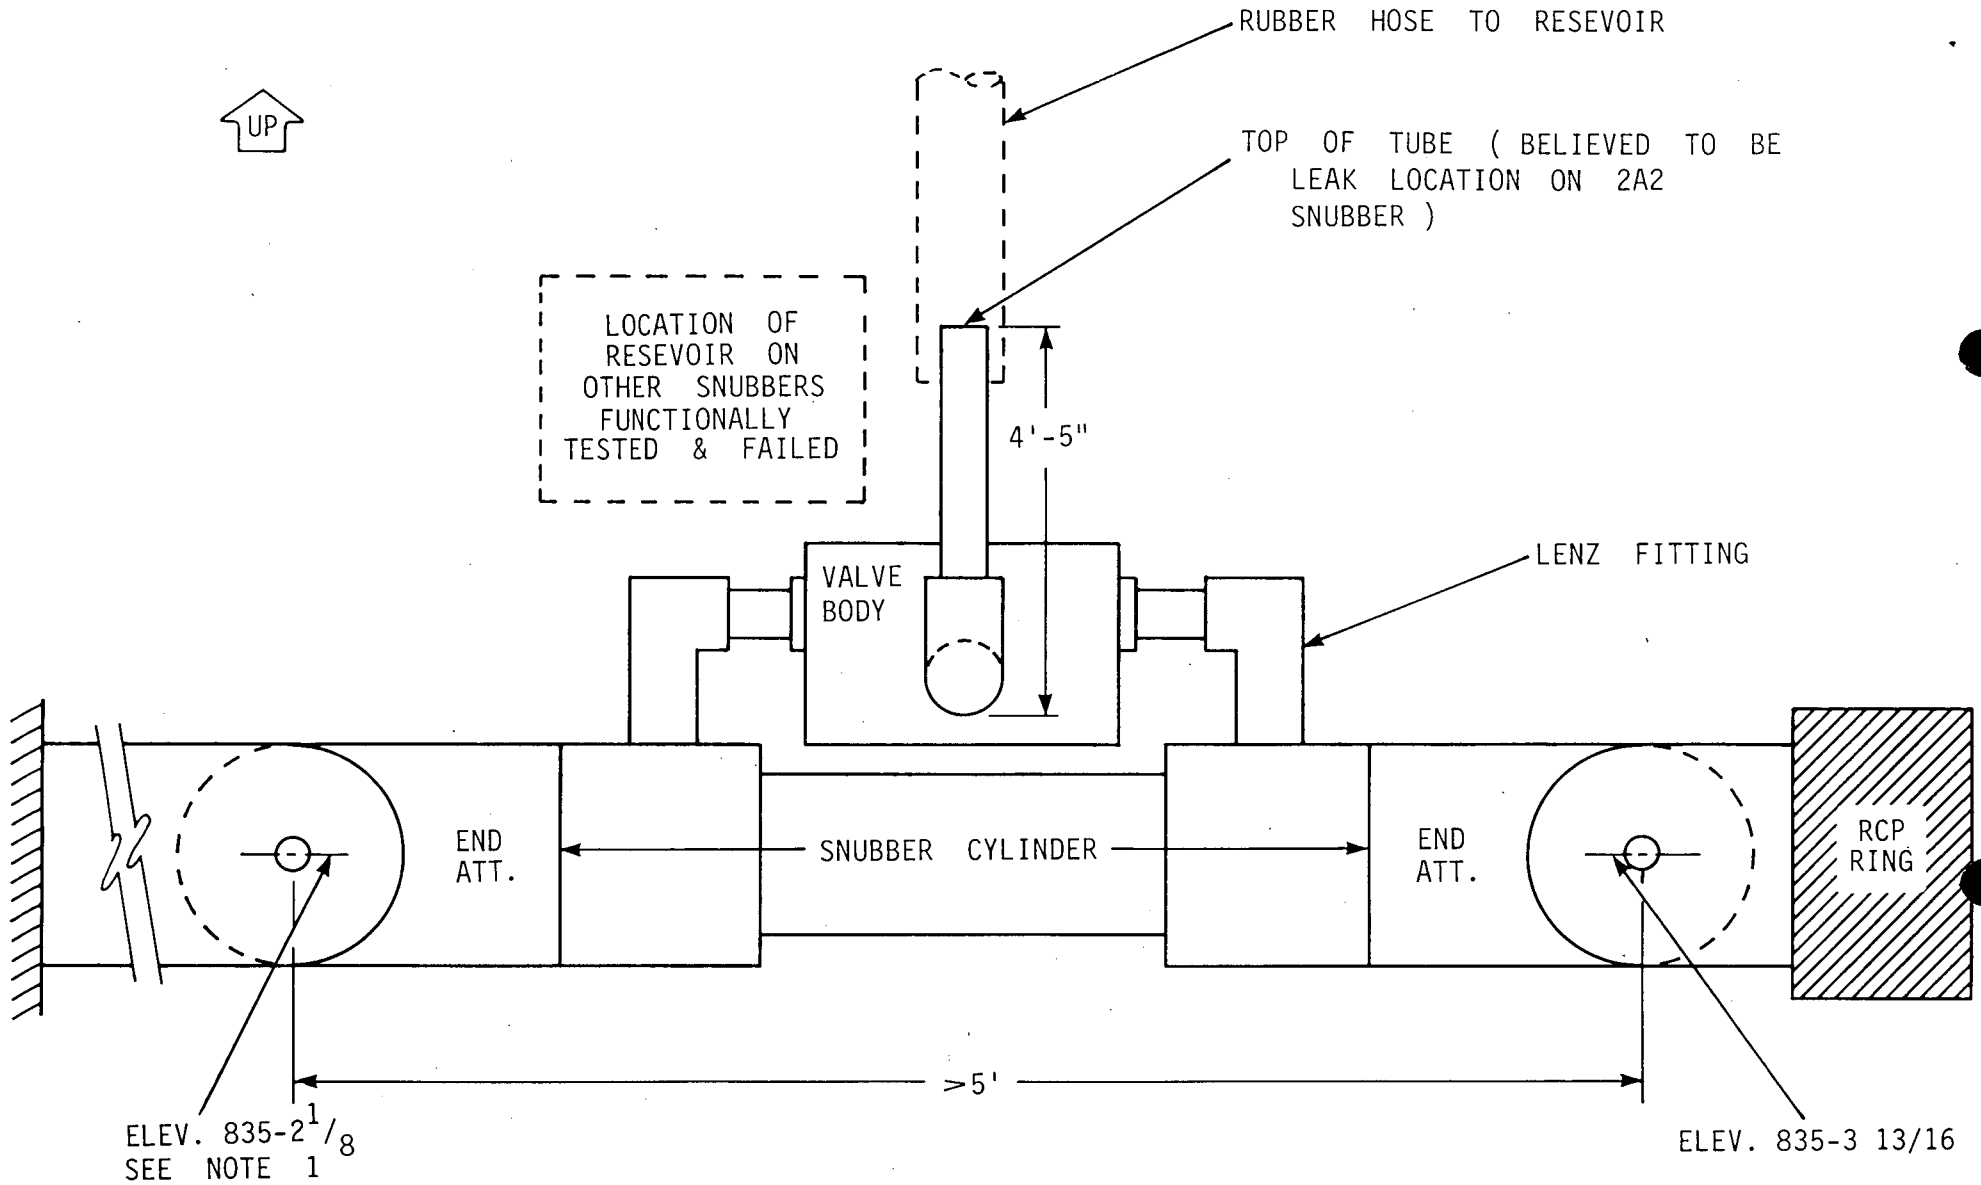
Thus, it is reasonable to expect that the higher the location of the leak in a snubber, the less fluid will leak out, and the more likely that the snubber remains functional. In the case of the 2A2 snubber (see sketch), the location of the leak is believed to be at the connection of the rubber hose (from the reservoir) to the tube coming from the valve body. There is no contrary evidence, and during functional test, no significant leaks were observed at any other location.

In contrast, a "high point" leak which occurs above the valve and cylinder would leave these internals fluid filled even if no fluid from a reservoir were available. Snubber 2A2-SS2 is concluded to have had a "high point" leak. In fact, in comparing the design of this hydraulic snubber to others¹ it is apparent that its high leak point would have given it a probability of passing equal to or greater than other snubbers with high point leaks which have been tested with empty reservoir and passed.

¹ See attached sketch. All snubbers which have failed this functional test had the integral reservoir illustrated, with the bottom of the reservoir relatively lower than the top of the tube on the 2A1 snubber.

NOTE 1: THE 2A2 SNUBBER IS VERY CLOSE TO HORIZONTAL. THE <2" DIFFERENCE IN ELEVATION OVER >5' LENGTH IS NOT SIGNIFICANT TO FLUID LEVELS IN THE SNUBBER VALVE BODY.

The type of fittings that had been utilized was the slip-on type, where the hose is slipped over a metal tube and secured with a hose clamp. When the hose clamp is not adequately secured, hydraulic fluid will leak out from the tubing above that point due to gravitational effects. To remedy this, the fittings on all nine of the generically susceptible hydraulic snubbers with remote reservoirs were replaced during the Unit 2 refueling outage with a crimp type fitting. The hoses were also replaced. These modifications should prevent the loss of fluid through the fittings for all of these snubbers.
