SUBJECT: Responds to NRC 930507 ltr containing findings in EDSFI Repts 50-269/93-02, 50-270/93-02 & 50-287/93-02. Corrective actions: detailed single failure analysis of Keowee governor sys will be performed & procedures will be upgraded.

Subject: Oconee Nuclear Site  
Docket Nos. 50-269, -270, -287  
Inspection Report 50-269, -270, -287/93-02  
Reply to Findings

By letter dated May 7, 1993 the NRC issued Electrical Distribution System Functional Inspection Report No. 50-269/93-02, 50-270/93-02, and 50-287/93-02. Within this report, six findings were designated as requiring a sixty day response.

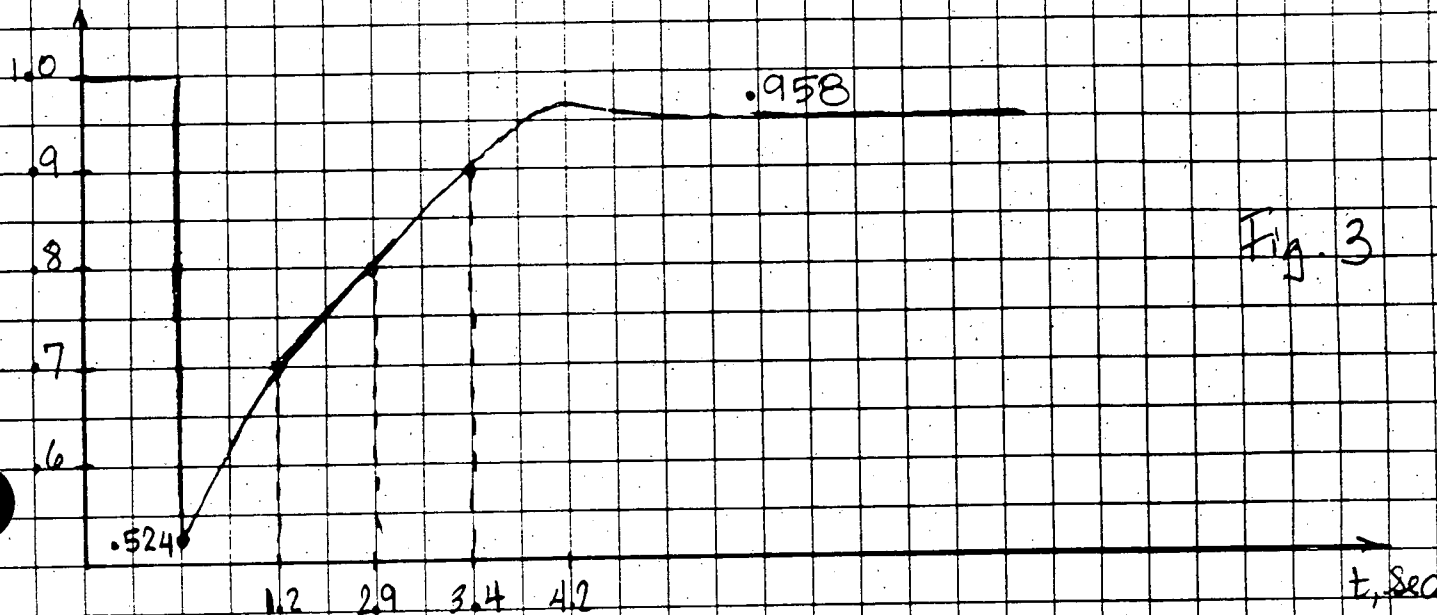
Fig. 3

660V 1XS1, 1XS2, 1XS3, 1XSF }  
 2XS1, 2XS2, 2XS3, 2XSF }  
 3XS1, 3XS2, 3XS3, 3XSF } (Worst one)

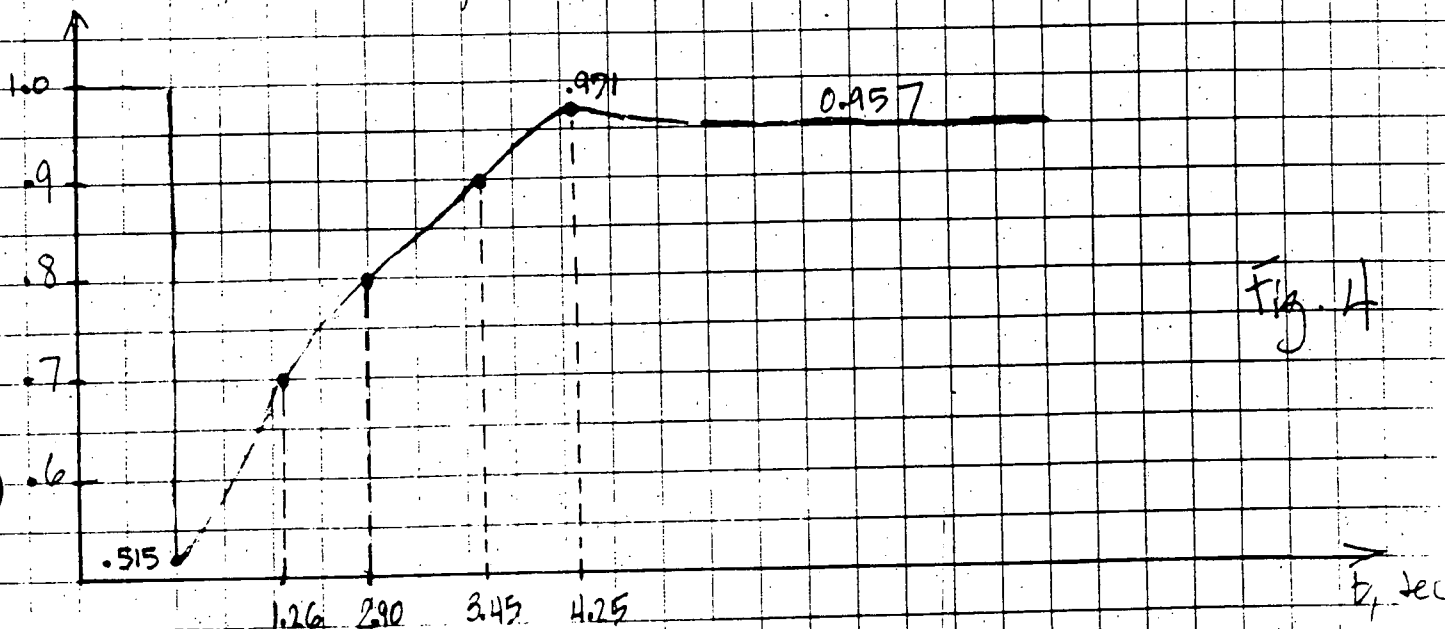
Fig. 4

288V 1XS1, 1XS2, 1XS3, 1XSF }  
 2XS1, 2XS2, 2XS3, 2XSF } (Worst one)  
 3XS1, 3XS2, 3XS3, 3XSF }
