SUBJECT: LER 92-014-01: on 920929, relay found to have failed results in inoperability of Keowee Hydro Unit 2 over head emergency power path. Caused by equipment failure. Degraded grid & switchyard isolation functional test performed. W/940105 ltr.

Subject: Oconee Nuclear Station
Docket Nos. 50-269, -270, -287
LER 269/92-14, Revision 1

TITLE (4) **Equipment Failure Results In The Inoperability of Keowee Hydro Unit 2 Overhead Emergency Power Path and a Technical Specification Violation**

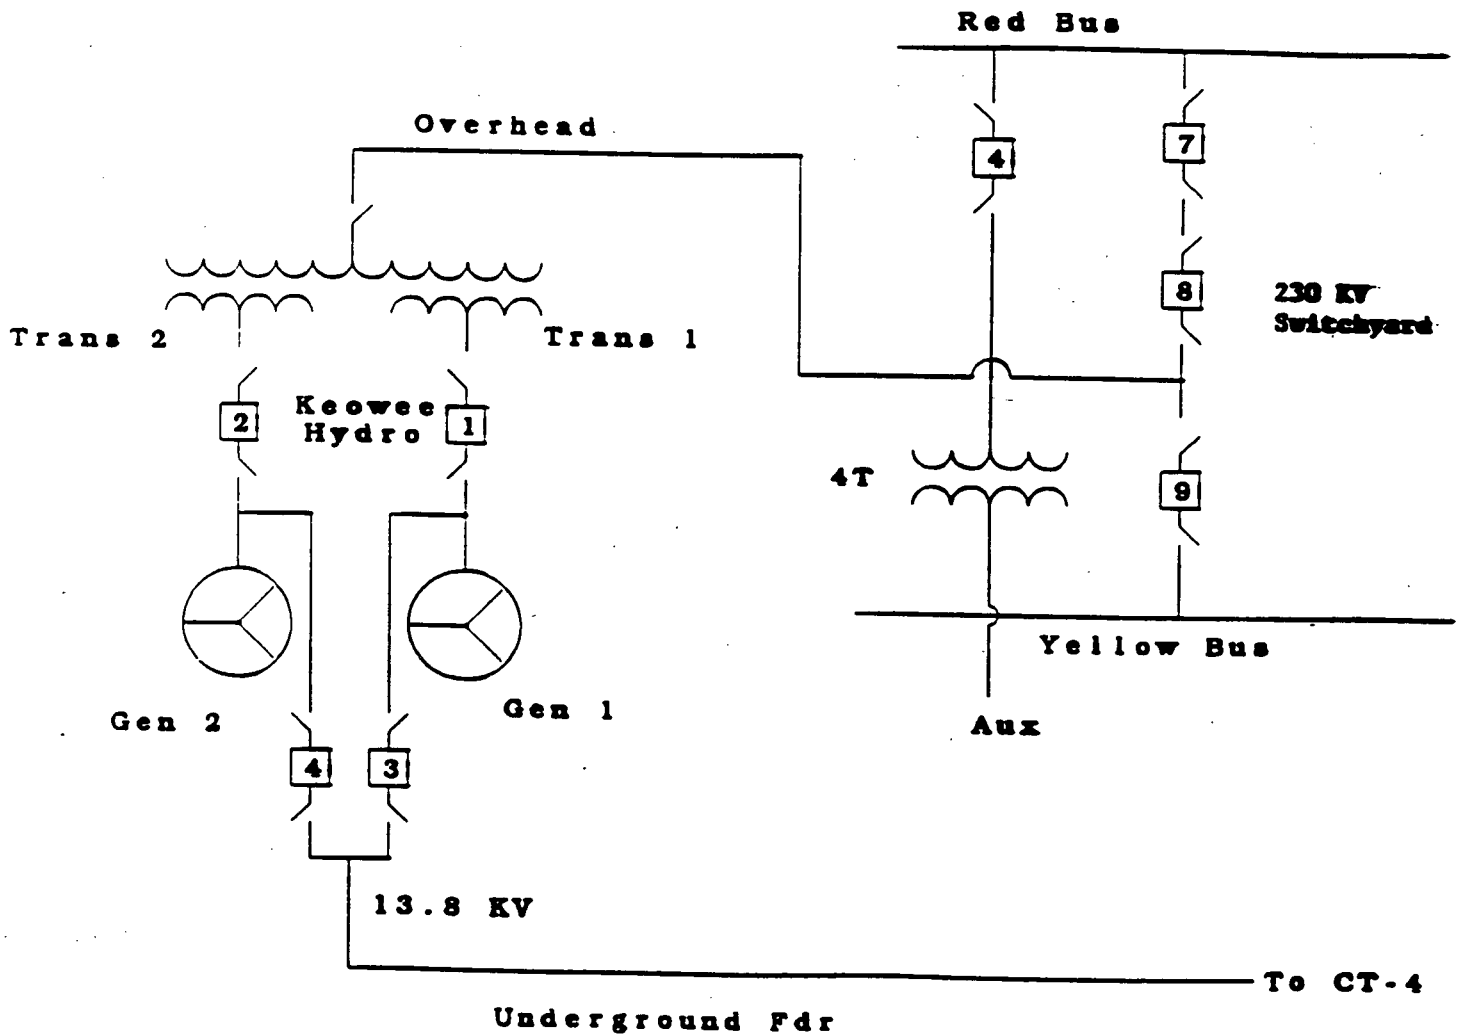
ATTACHMENT 1

The second path is an underground cable feeder to the Oconee transformer CT-4 [EIIS:XFMR] which supplies the redundant standby power buses. The underground feeder is arranged with parallel air circuit breakers (ACB-3 & ACB-4) so that it, too, can be connected to either KH unit (See Attachment 1). This underground feeder is connected, at all times, to one KH generator [EIIS:GEN] on a predetermined basis and is energized along with CT-4 whenever the associated KH unit is in service. The underground feeder and associated transformer (CT-4) are sized to carry full engineered safeguards loads of one Oconee unit plus the auxiliary loads required for safe shutdown of the other two Oconee units.
