SUBJECT: Limitorque Corporation 10 CFR Part 21, Evaluation #52'
Worm Shaft Clutch Gears Assembly, #0901-161

Duke Power Company, Oconee Nuclear Station returned (2) worm shaft clutch gear assemblies from (2) Limitorque SB-2 Valve Actuators, serial nos. L366900 & L366901. The clutch sleeves, #60-573-0007-2 which constitute part of the worm shaft gear assemblies was the failed component.

Subject: Failure of Worm Shaft Clutch Gears
SB-2/40, S/O #3J3096C, S/N's 366900 & 366901
Duke tag no. 3-LP-21 & 3-LP-22

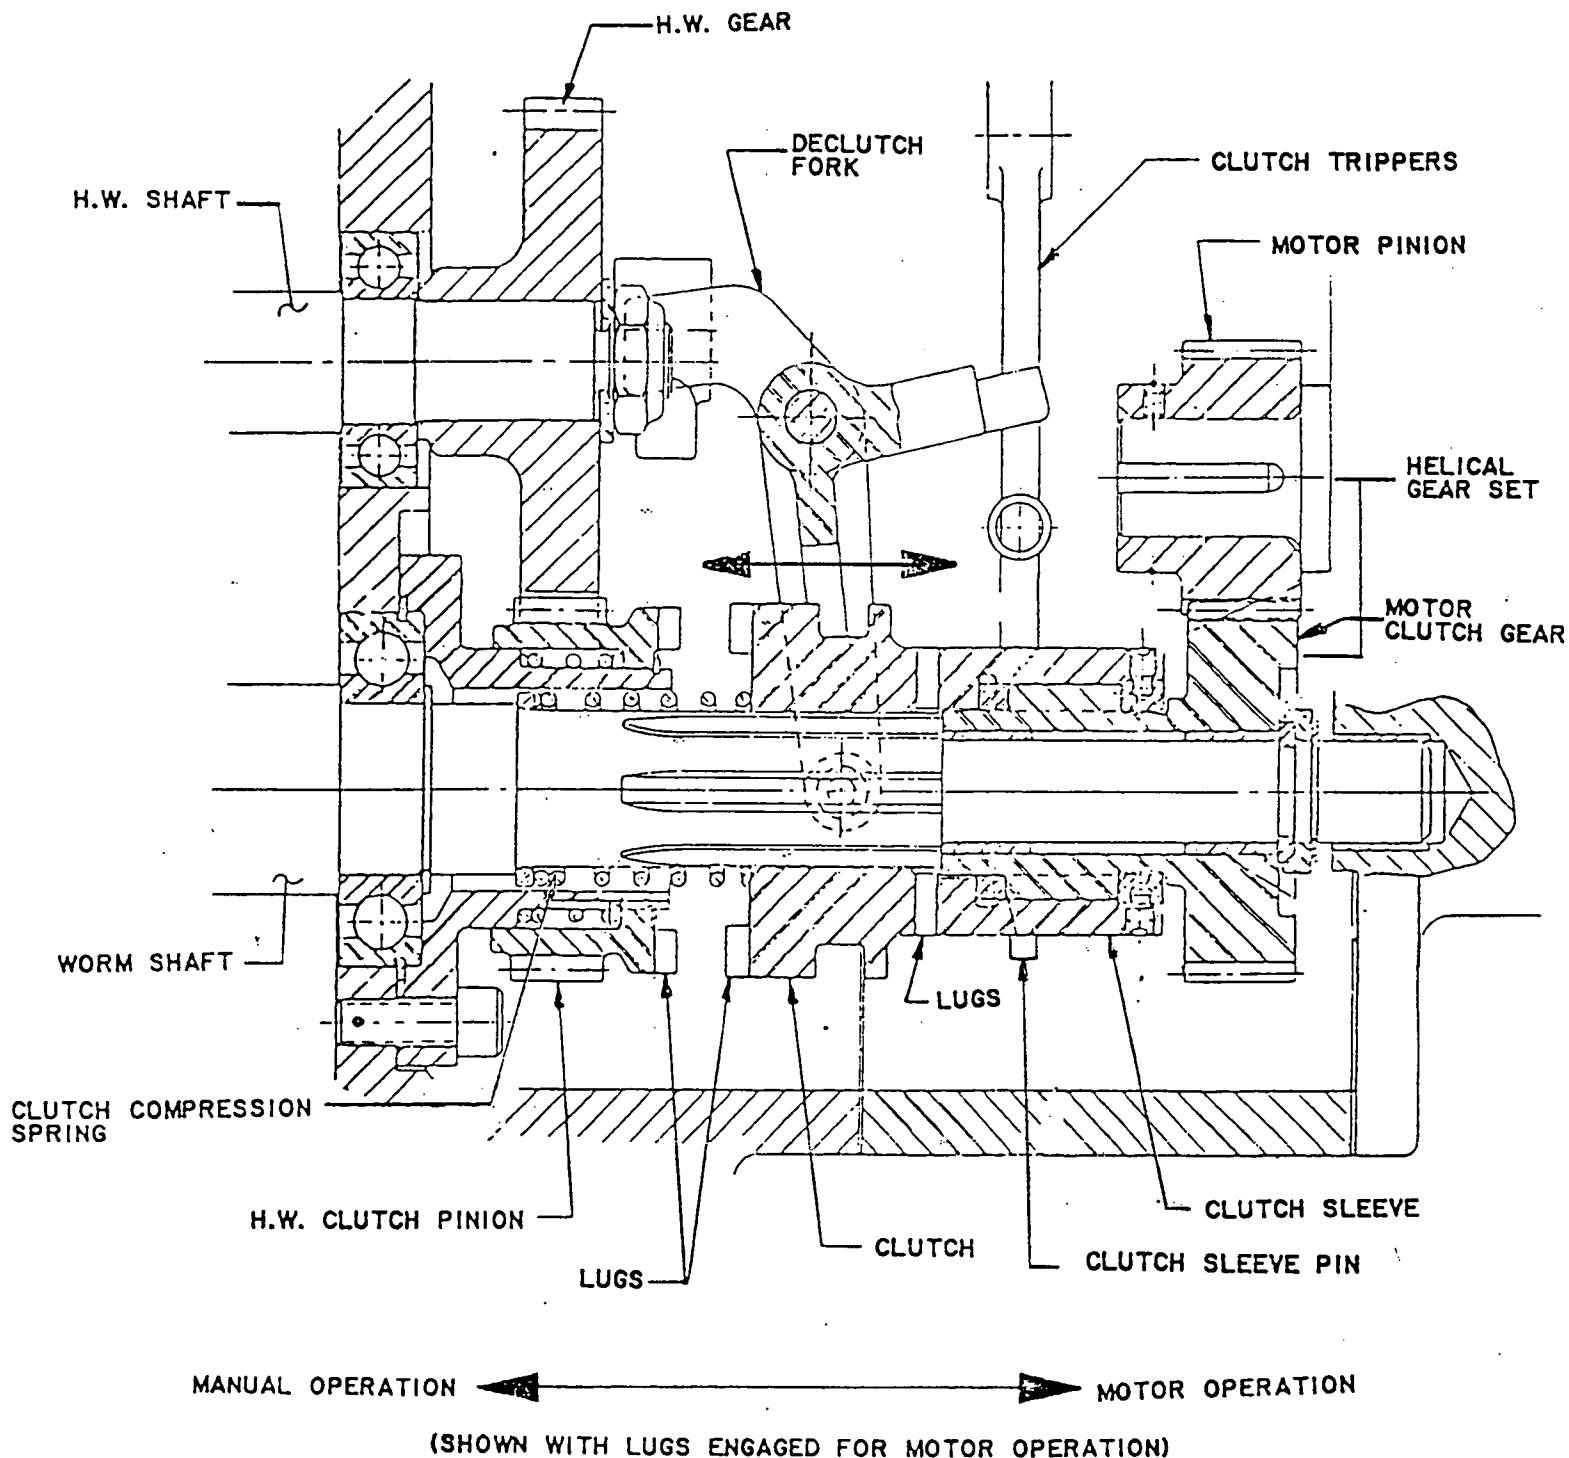
FIGURE 1, SB-2 CLUTCHING MECHANISM

The SB-2 actuator is equipped with a clutching mechanism which allows the actuator to be shifted from motor to manual or manual to motor operation. In motor operation (see Figure 1) the lugs of the clutch and clutch sleeve are engaged. Torque is transmitted from the motor pinion (via the motor clutch gear, clutch sleeve and clutch lugs) to the worm shaft. Input torque from the handwheel shaft is uncoupled from the worm shaft. When the declutch fork is rotated through actuation of the external manual declutch lever, the clutch is moved along the worm shaft until the clutch/handwheel pinion clutch lugs are engaged. The declutch fork is held in the manual position by a latching interface between the declutch fork and clutch tripper. Torque can be transmitted from the handwheel gear (via the handwheel clutch pinion/clutch lugs) to the worm shaft. In this position, the motor pinion torque interface is decoupled from the worm shaft. When the motor pinion is energized with the declutch fork in the manual position, rotation of the clutch sleeve causes the clutch sleeve pin to strike the clutch trippers which release the declutch fork from its manual position. When the clutch trippers release the declutch fork, the clutch compression spring pushes the clutch along the worm shaft until the clutch/clutch sleeve lugs engage allowing for transmission of motor torque.
