LICENSEE EVENT REPORT (LER)

FACILITY NAME (1) Oconee Nuclear Station, Unit One	DOCKET NUMBER (2) 05000 269	PAGE (3) 1 of 8
---	--------------------------------	--------------------

TITLE (4) Non-Isolable Weld Leak On Pressurizer Surge Line Drain Pipe Causes Shutdown

Diagram of Pressurizer Surge Line Drain Pipe

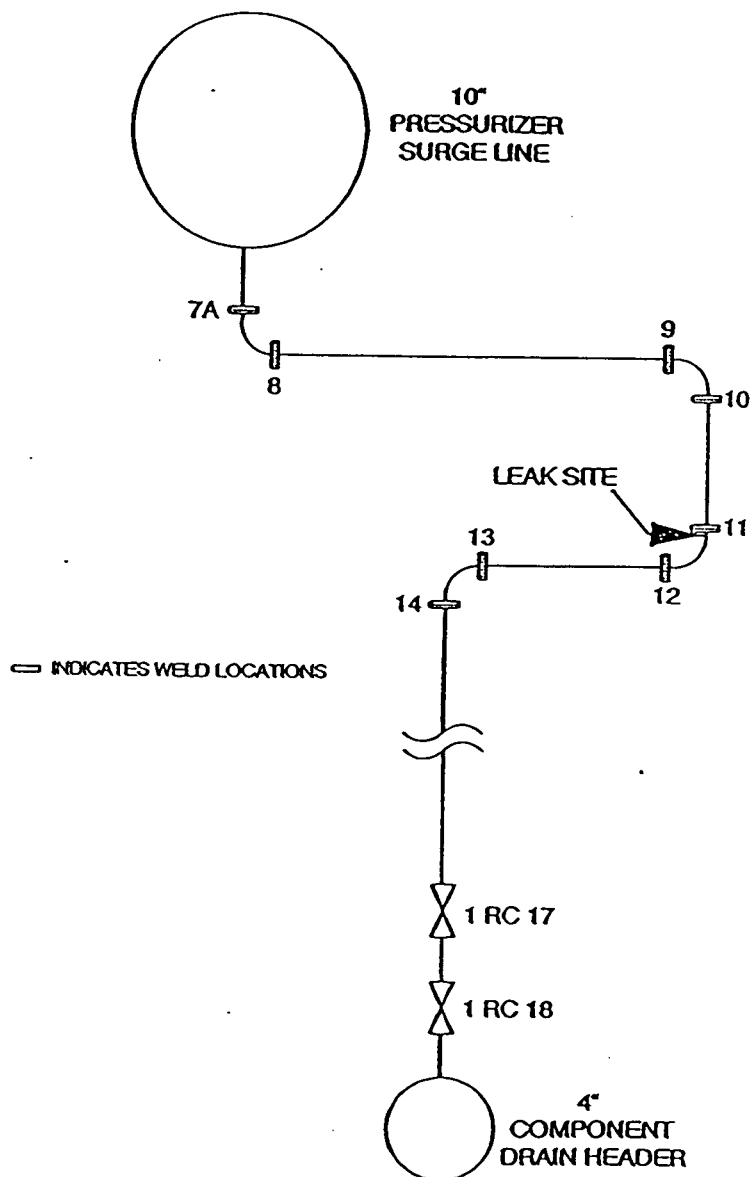
ATTACHMENT 1

The crack was located adjacent to weld 11, which joined a Schedule 160 Type 316 stainless steel vertical pipe section to a Type 316H stainless steel 90 degree elbow. It was decided to cut (at welds) and remove the line from the weld at the outlet of the PSL nozzle through the first four elbows including all straight pipe runs between the elbows. The two welds that were cut to remove the pipe were first PT'ed to determine if any surface indications existed. No indications were identified in the welds. A straight portion of the piping was also removed and retained at Oconee for additional PT work. No indications were identified in the piping. The remainder of the removed piping was packaged and shipped to the Lynchburg Research Center (LRC) of McDermott Technology, Inc. for further metallurgical examinations.

Visual inspection revealed the crack was located on the elbow side of the weld, extending approximately 170 degrees around the drain line outer diameter circumference, with the crack center located on the inner radius side of the elbow. When the fracture surfaces were exposed, it was determined that the cracking initiated on the drain line outer diameter from two distinct locations.

The piping was removed from service and replaced with all new piping.
