LICENSEE EVENT REPORT (LER)

FACILITY NAME (1)
Oconee Nuclear Station, Unit One

TITLE (4) Non-Isolable Weld Leak On Pressurizer Surge Line Drain Pipe Causes Shutdown

EVENT DATE (5)			LER NUMBER (6)				REPORT DATE (7)			OTHER FACILITIES INVOLVED (8)	
MONTH	DAY	YEAR	YEAR	SEQUENTIAL NUMBER	REVISION NUMBER	MONTH	DAY	YEAR	FACILITY NAME	DOCKET NUMBER(S)	
01	27	98	98	02	01	04	30	98		05000	
										05000

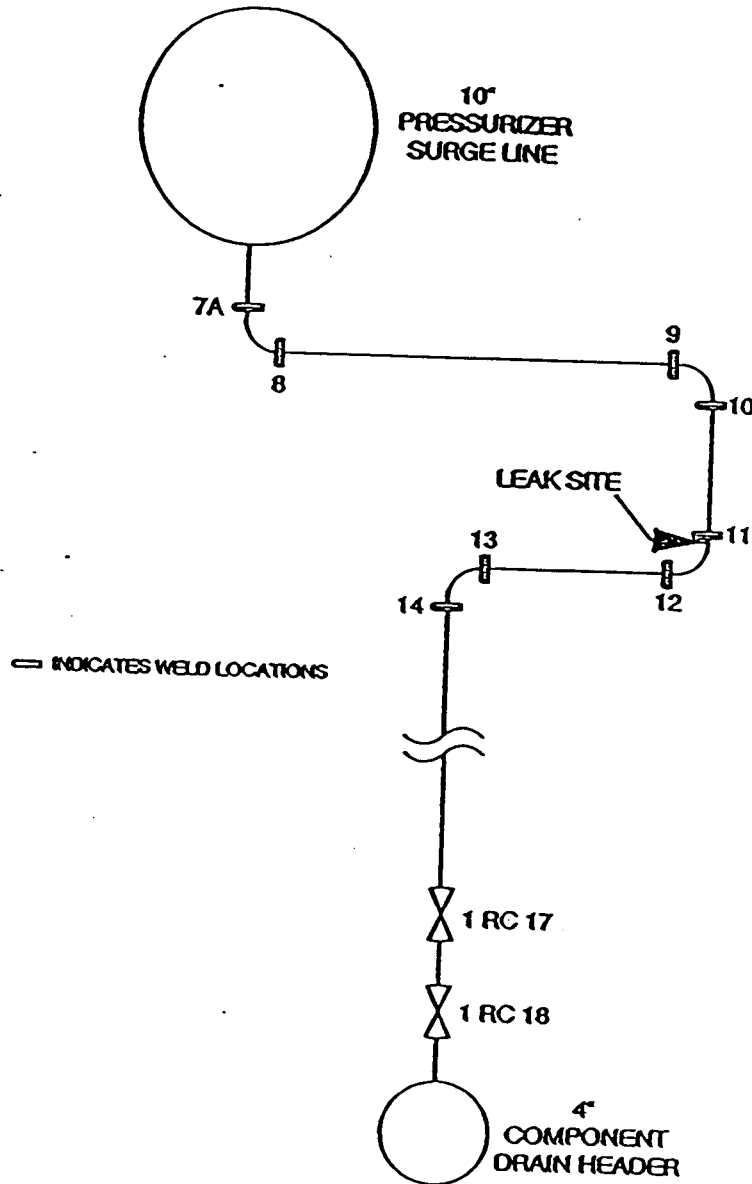
ATTACHMENT 1

The crack was located adjacent to weld 11, which joined a Schedule 160 Type 316 stainless steel vertical pipe section to a Type 316H stainless steel 90 degree elbow. It was decided to cut (at welds) and remove the line from the weld at the outlet of the PSL nozzle through the first four elbows including all straight pipe runs between the elbows. The two welds that were cut to remove the pipe were first PT'ed to determine if any surface indications existed. No indications were identified in the welds. A straight portion of the piping was also removed and retained at Oconee for additional PT work. No indications were identified in the piping. The remainder of the removed piping was packaged and shipped to the Lynchburg Research Center (LRC) of McDermott Technology, Inc. for further metallurgical examinations.

Visual inspection revealed the crack was located on the elbow side of the weld, extending approximately 170 degrees around the drain line outer diameter circumference, with the crack center located on the inner radius side of the elbow. When the fracture surfaces were exposed, it was determined that the cracking initiated on the drain line outer diameter from two distinct locations.

Diagram of Pressurizer Surge Line Drain Pipe

The piping was removed from service and replaced with all new piping.
