LICENSEE EVENT REPORT (LER)

FACILITY NAME (1) Oconee Nuclear Station, Unit 1	DOCKET NUMBER (2) 05000 269	PAGE (3) 1 of 1
---	--------------------------------	--------------------

TITLE (4) Steam Generator Tube ECT Indications Not Repaired due to Inadequate Guidance Results in Operation Prohibited by Technical Specifications

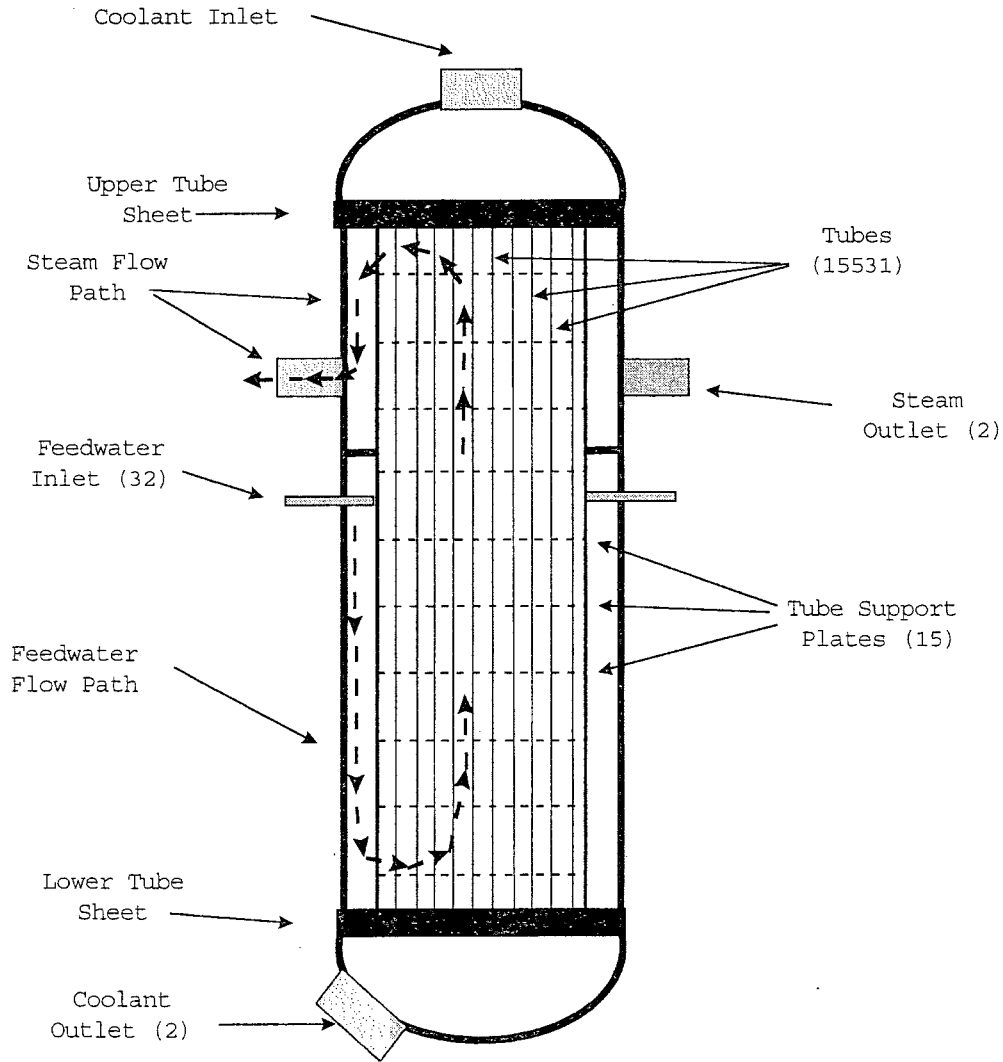
Attachment A

Oconee Nuclear Station uses the Babcock and Wilcox (B&W) Nuclear Steam Supply System [EIIS:AC], which includes two Once Through Steam Generators (OTSGs) [EIIS:SG], for primary to secondary heat transfer. The B&W OTSG is a vertical, straight tube heat exchanger. Inside the OTSG shell, there is an upper tube sheet, 15 tube support plates, a lower tube sheet, and 15531 tubes per steam generator. See Attachment A.
