FACIL: 50-269 Oconee Nuclear Station, Unit 1, Duke Power Co.      05000269

SUBJECT: ENFORCEMENT CONFERENCE SUMMARY - OCONEE  
(NRC INSPECTION REPORT NOS. 50-269/94-16, 50-270/94-16 AND  
50-287/94-16)

**FUEL HANDLING**

**ENFORCEMENT CONFERENCE**

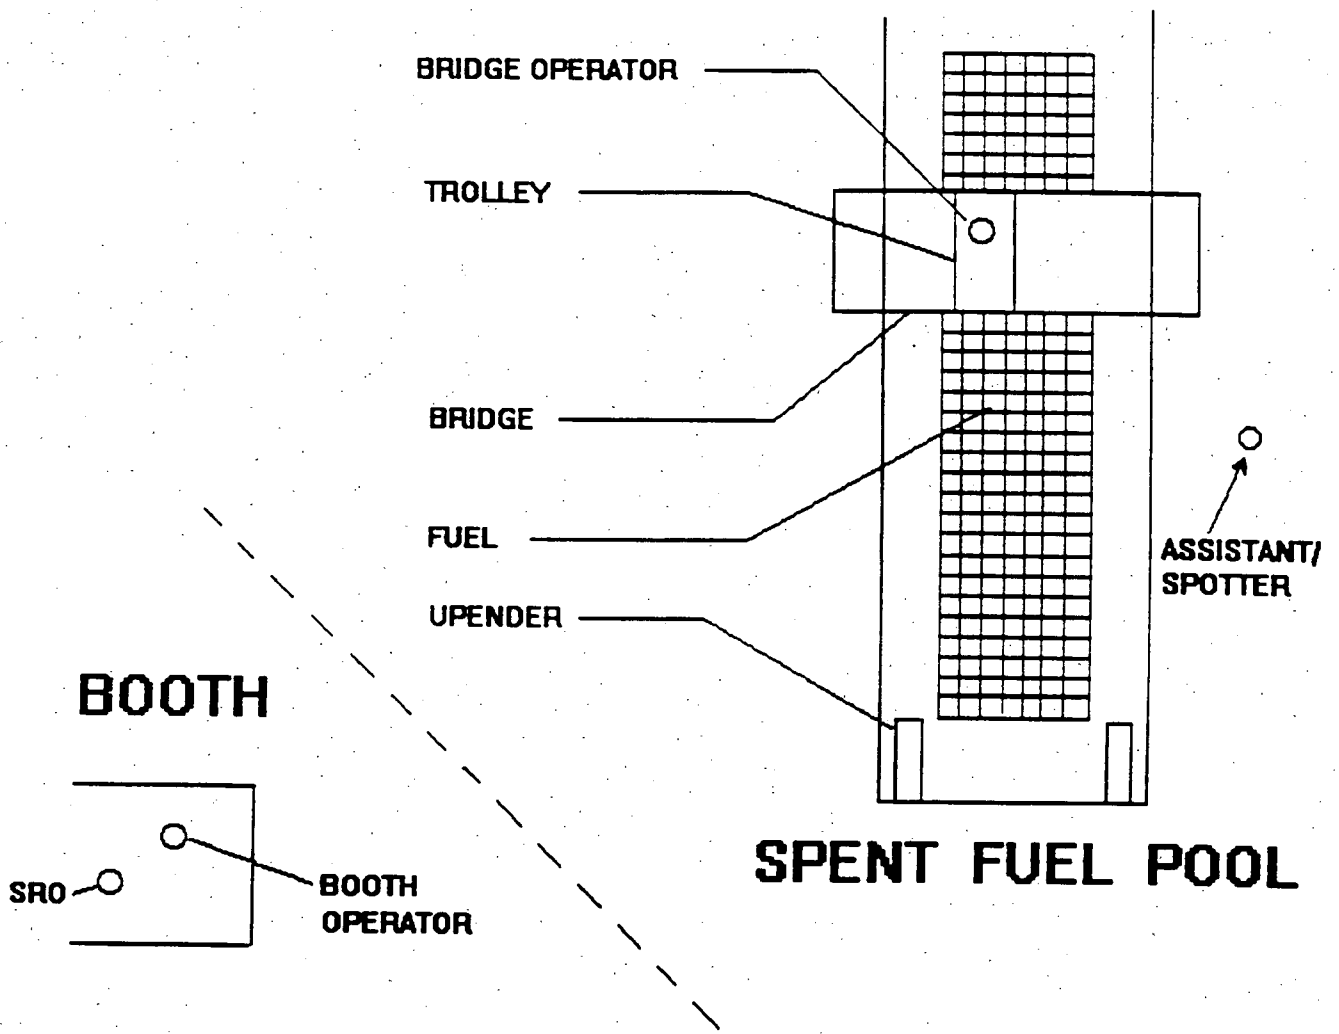
# FUEL HANDLING PLAN VIEW

- **On May 26, 1994, reloading of Oconee 1 reactor core was in progress.**
- **Refueling team in Spent Fuel Pool was directed to a location to obtain a fuel assembly and found the cell empty.**
- **Investigation revealed that a reload assembly had been erroneously selected during a previous procedure step, and placed in an incorrect core location.**

- The Unit 1 fuel assembly position was corrected.
- Maintenance Superintendent convened both shifts at next turnover to reinforce expectations.
- Station Manager reviewed fuel handling in SFP and RB with particular attention to role of spotter.
- Procedure was changed so that bridge operator is instructed to execute next step, rather than to go to next location by name. Has been tested on Unit 1 APSR swaps and worked well.
- Video camera will be added at SFP upenders as backstop to confirm fuel assembly identity.

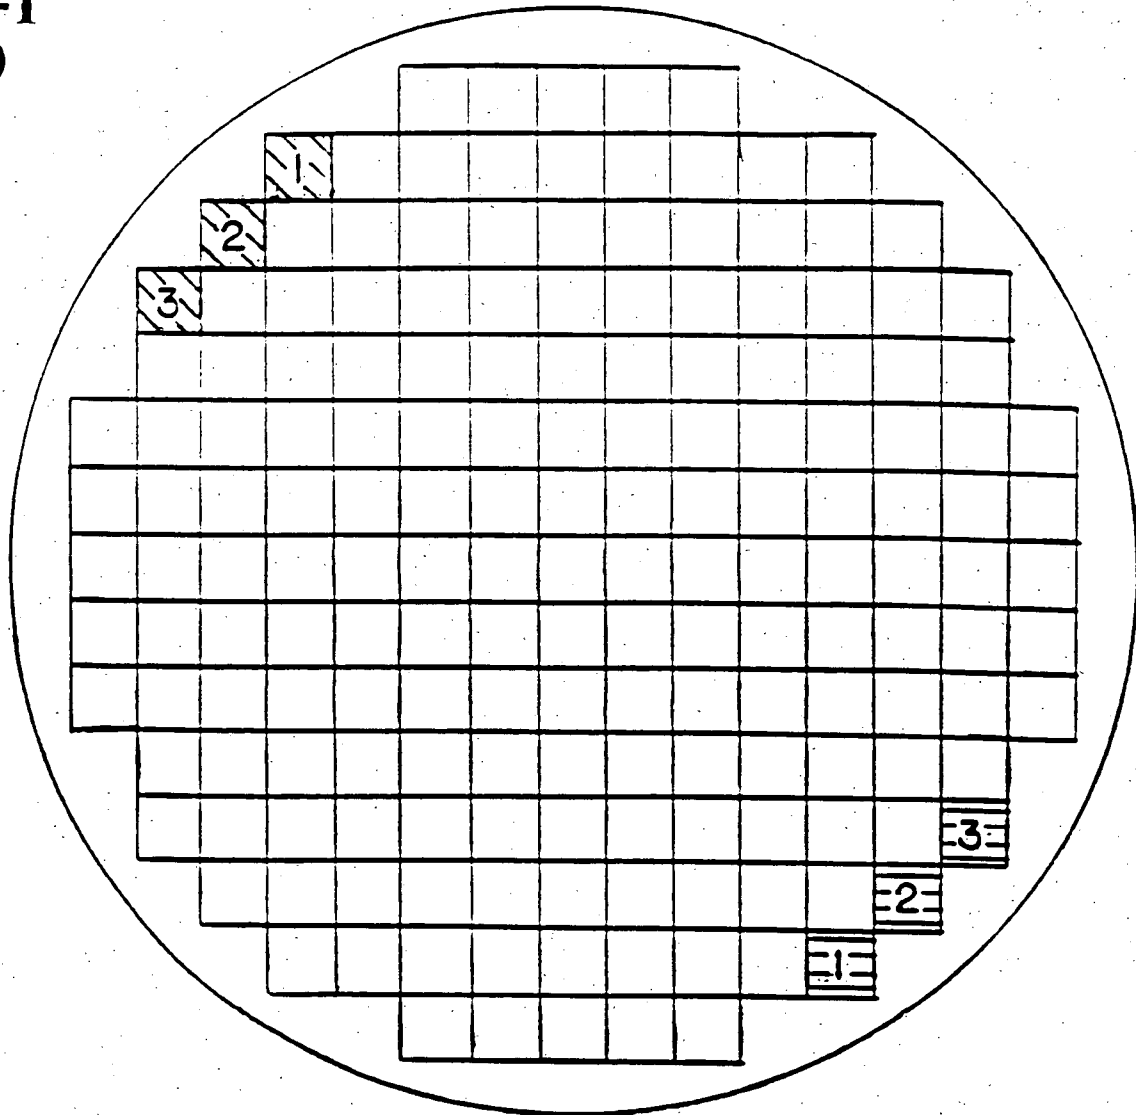
# OCONEE UNIT 1

- Fuel assemblies involved were twice-burned.
- Assemblies were not to be ungrappled. (This would have required alternate steps.)
- The first fuel assembly was loaded into the core.
- In response to questions from Resident Inspector, "alternate steps" per procedure were used for the second assembly.
- Steps for additional assemblies were not performed, due to detector maintenance in progress.

**Fuel Assembly ID No. 585**

**Fuel Assembly ID No. 587**

- "Alternate steps" per procedure were used for the second assembly.
- SROs, whose duties could include fuel handling oversight, and Reactor Engineering group will be briefed on future expectations.
