OFFICE OF INSPECTION AND ENFORCEMENT  
DIVISION OF INSPECTION PROGRAMS

Report Nos.: 50-269/86-16; 50-270/86-16; and 50-287/86-16

Facility Name: Oconee Nuclear Station

Inspection Conducted: May 5 - June 11, 1986

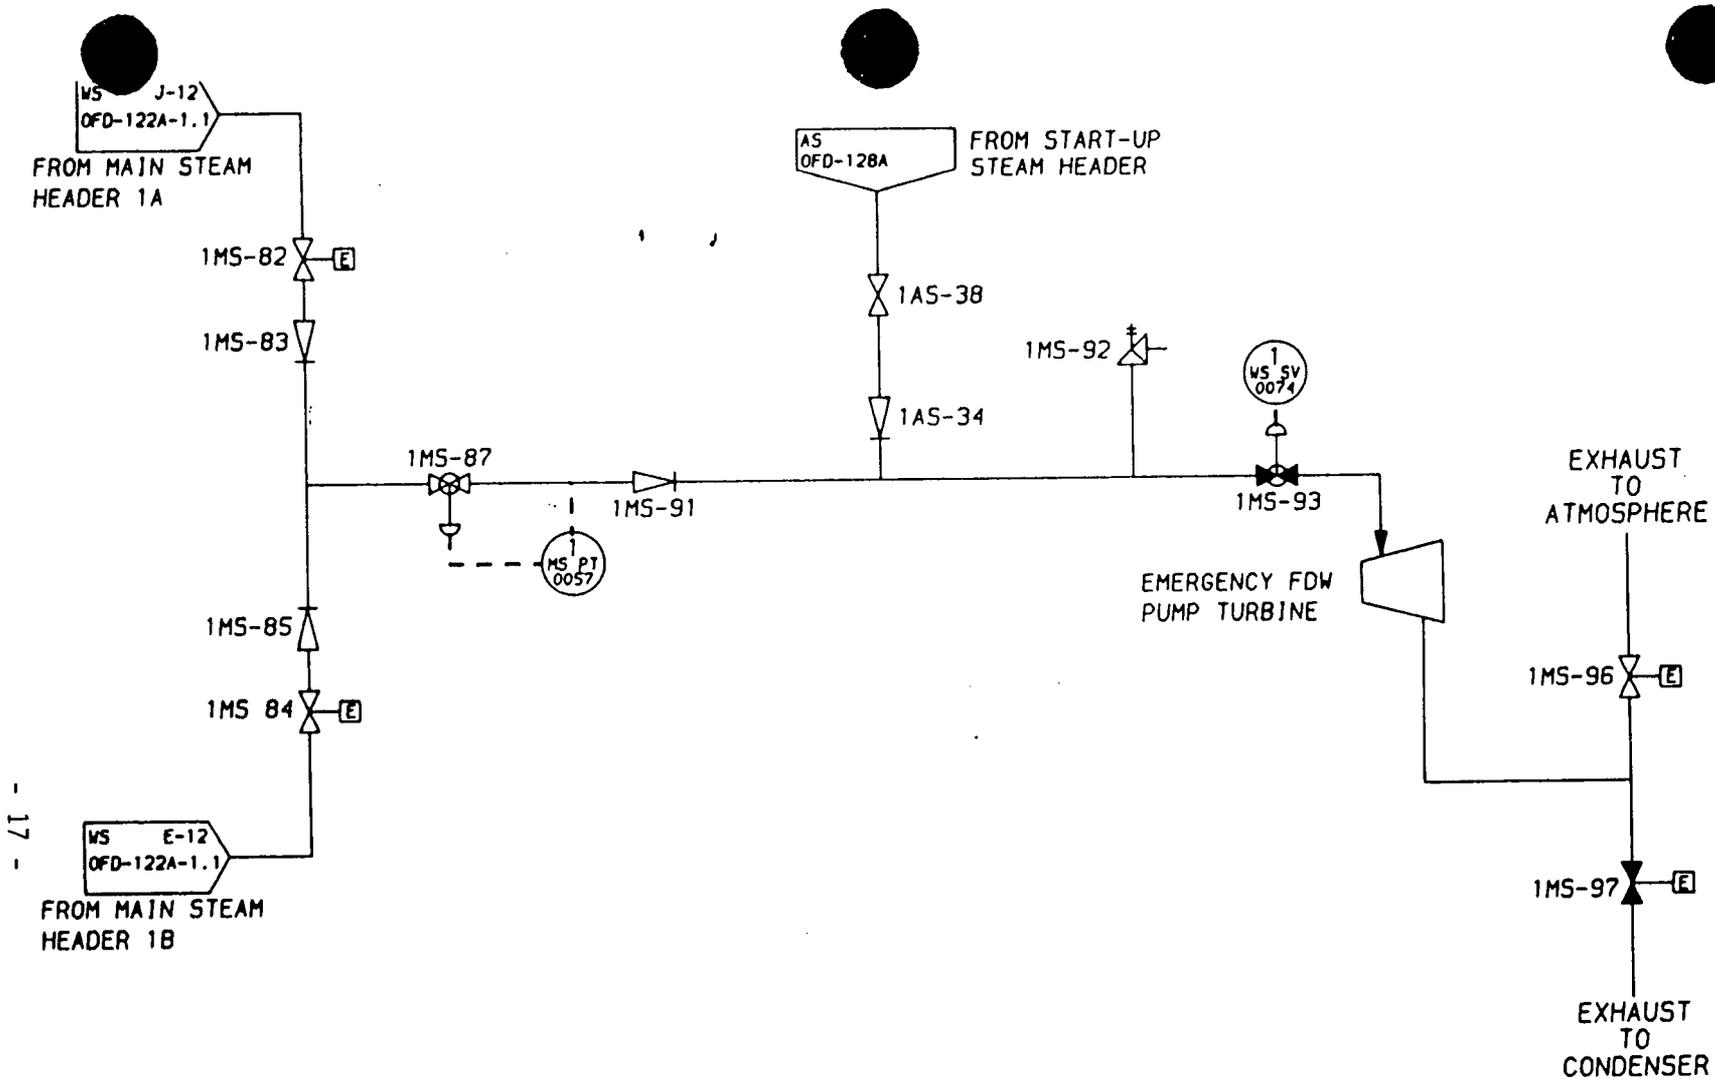
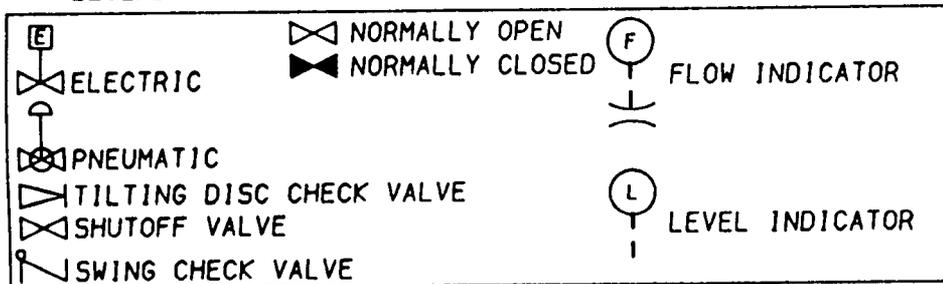
FIGURE 1.

Periodic testing of some check valves was found to be inadequate to ensure that the valves would perform their safety function during abnormal events. Valves MS-83 and MS-85 were not periodically tested in the reverse flow direction. These valves are the nonreturn check valves in the main steam branch lines that merge to supply steam to the turbine-driven EFW pump from SG A and SG B, respectively. Although these valves were periodically tested in the flow direction during turbine-driven EFW pump surveillance testing, the valves were not tested to ensure that they would perform their design function to prevent backflow through the steam line in the event of a steam line break. Figure 1 on page 17 shows the piping arrangement at the time of the inspection. Normally, motor-operated isolation valves MS-82 and MS-84 would be open so that steam could be applied to the EFW turbine pump by opening normally closed MS-93. MS-87 was a pneumatically operated pressure control valve that maintained steam turbine inlet pressure to 300 psig. Therefore, steam pressure was applied up to MS-93 during standby operation. Steam traps in the line remove any condensate that may build up, and MS-87 may open periodically to maintain downstream pressure. Although the steam flow would be expected to be small during standby operation, low steam flows have been known to cause degradation of check valves in similar applications (IE Information Notice 86-09).

Because these check valves were not tested in the backflow direction, an undetected failure could exist where, for example, the disc had broken off and become cocked in the valve, preventing full closure (thus defeating the check feature) and full opening (thus restricting steam flow). If such a failure were to occur, the plant may not be adequately protected assuming an unisolable line break in one SG and a single failure. The following example is provided to illustrate the team's concern. An unisolable high-energy line break is assumed to occur in SG B concomitant with a single failure of the overhead lines from the 230 kV switchyard. SG B depressurizes. Because it was not adequately tested, MS-85 is assumed to have an undetected failure

STEAM SUPPLY FOR TURBINE DRIVEN EFW PUMP (UNIT 1.)

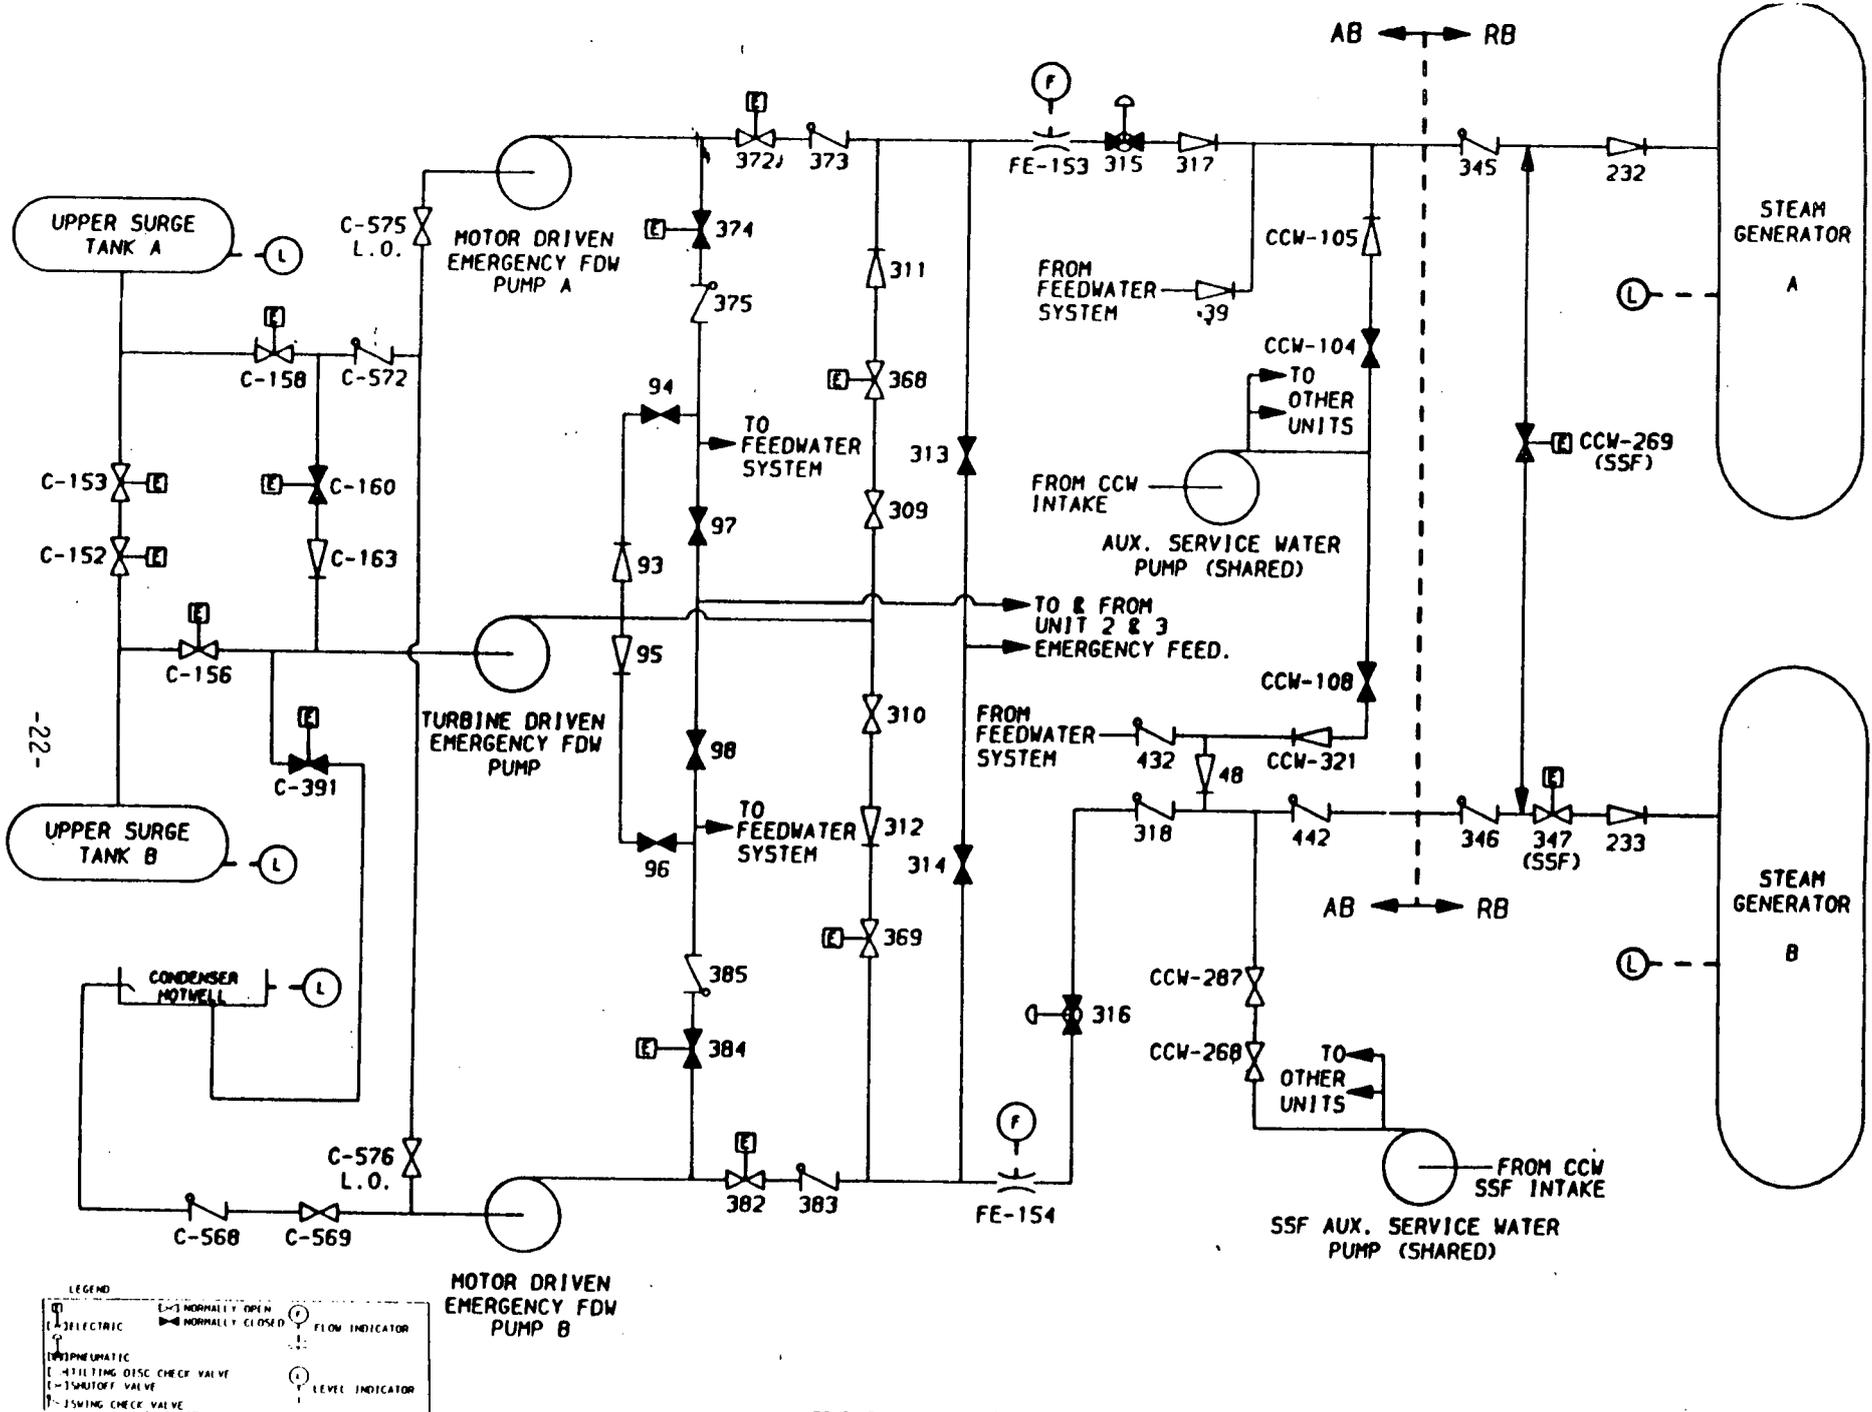
The FSAR stated that the EFW system was capable of withstanding the maximum hypothetical earthquake (equivalent to a safe shutdown earthquake) and that the failure in the nonseismic portion of attached piping would not cause the loss of function to the EFW system because automatic and remote manually operated seismic/non-seismic boundary valves are used. Contrary to this commitment in the FSAR, substantial portions of the EFW system were not designed to be capable

FIGURE 2.  
SIMPLIFIED EMERGENCY FEEDWATER SYSTEM ARRANGEMENT FOR UNIT 1.

of withstanding the maximum hypothetical earthquake. This deviation was recognized by the licensee before this NRC inspection as documented by LER 86-002, dated March 5, 1986.
