EXAMINATION OF
RADIOGRAPHIC FILMS AND
CONSIDERATIONS OF WELD INTEGRITY OF
PIPE BUTT WELDS IN
3½" OD BY 0.435" WALL
FEEDWATER PIPING
UNIT No. 1
OCONEE NUCLEAR POWER STATION
DUKE POWER COMPANY

Helmut Thielsch, PE

February 2, 1980

Report No. 1962

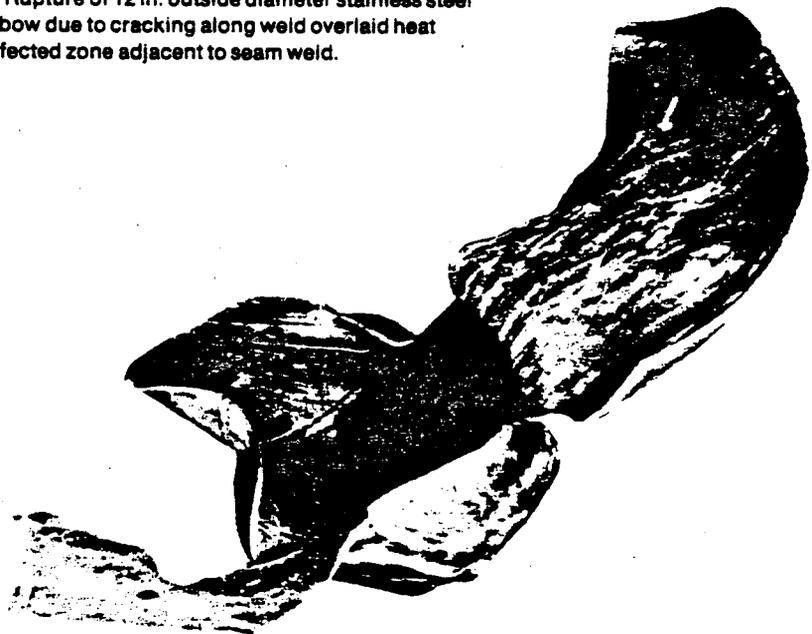
1 Rupture of 12 in. outside diameter stainless steel elbow due to cracking along weld overlaid heat affected zone adjacent to seam weld.

overgrinding, which reduced the base metal wall thickness excessively, he subsequently applied a weld overlay extending by 1 in. over the base metal beyond the original butt weld. The particular stainless steel involved is subject to severe grain growth in the heat affected zone, which exhibits lower high strength properties at elevated temperature than either base metal or the weld metal. The cracking that

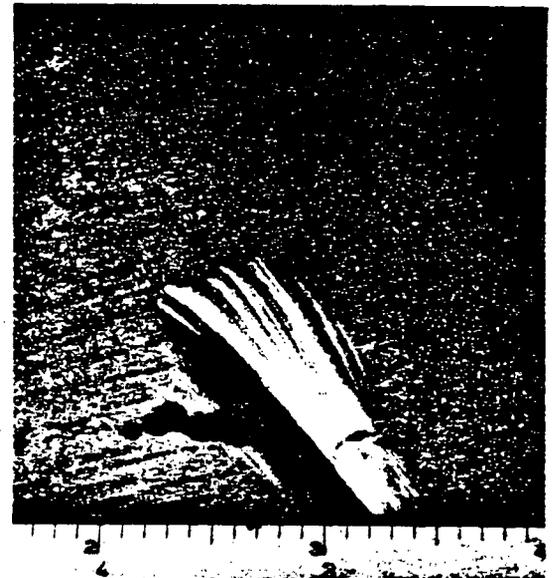
6 Photo A (left) shows surface laps on seamless 20 in. outside diameter Schedule 80 (1.031 in. wall) carbon steel pipe from 0.023 to 0.056 in. deep representing 2.2 to 4.9 percent of the pipe wall thickness. Photo B (right) shows surface lap on seamless 26 in. outside diameter by 0.975 wall carbon steel pipe 0.075 in. deep representing 8.6 percent of pipe wall thickness.

rewelding was necessary at the nuclear power plant construction site. Major schedule delays and high costs resulted. Grinding or filing across a few selected surface laps was an entirely acceptable procedure that confirmed that the laps in the particular piping were completely inconsequential (Fig. 6). The specific manufacturer's pipe products were thus proven entirely acceptable.

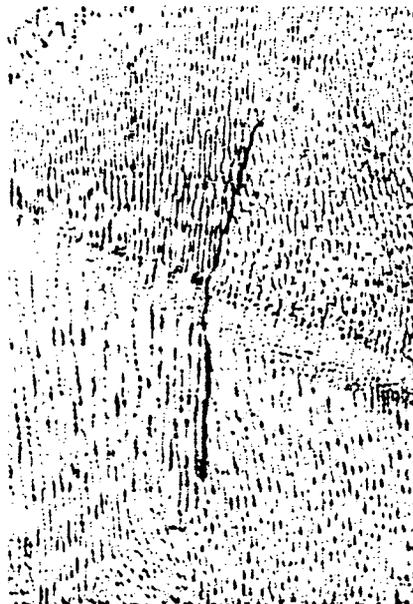
13 Examples of microfissures in Type 316 stainless steel weld joints containing 1 percent delta ferrite (Photo A, left) and 10 percent delta ferrite (Photo B, right). Both photos are reproduced at 100 X magnification.

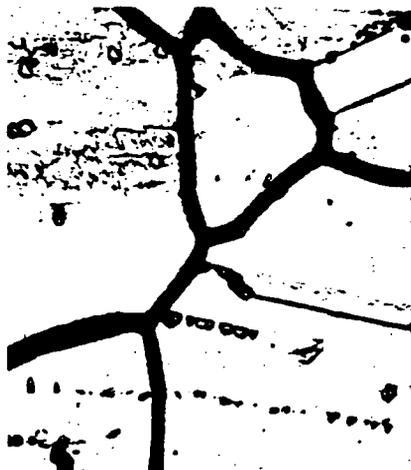
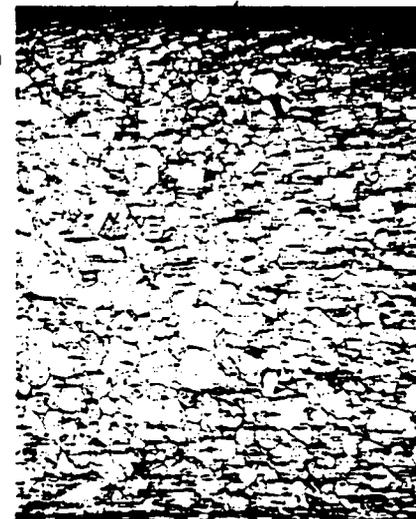
14 Views of socket weld in Type 304 stainless steel coupling with severe sensitization along inside surface of pipe as confirmed by ASTM oxalic acid sensitization etch test evidencing a ditched grain structure. Photo at left is a 1 X magnification; the bottom left, 100 X; and bottom right 500 X.

15 Example of sensitization along the inside surface of pipe sensitized by normal pipe forming. Photo at top is at 25 X magnification; bottom photo is at 500 X magnification.

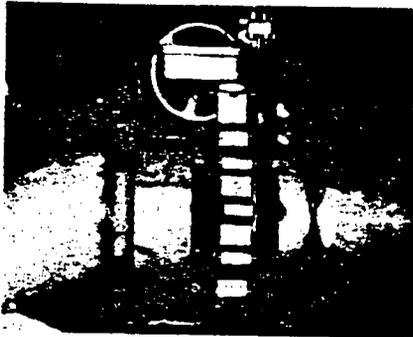
20 Carbon steel pipe clamp and carbon steel slip-on flanges on stainless steel pipe in fossil fuel power plant.
