EXAMINATION OF
RADIOGRAPHIC FILMS AND
CONSIDERATIONS OF WELD INTEGRITY OF
PIPE BUTT WELDS IN
3½" OD BY 0.435" WALL
FEEDWATER PIPING
UNIT No. 1
OCONEE NUCLEAR POWER STATION
DUKE POWER COMPANY

Helmut Thielsch, PE

February 2, 1980

Report No. 1962

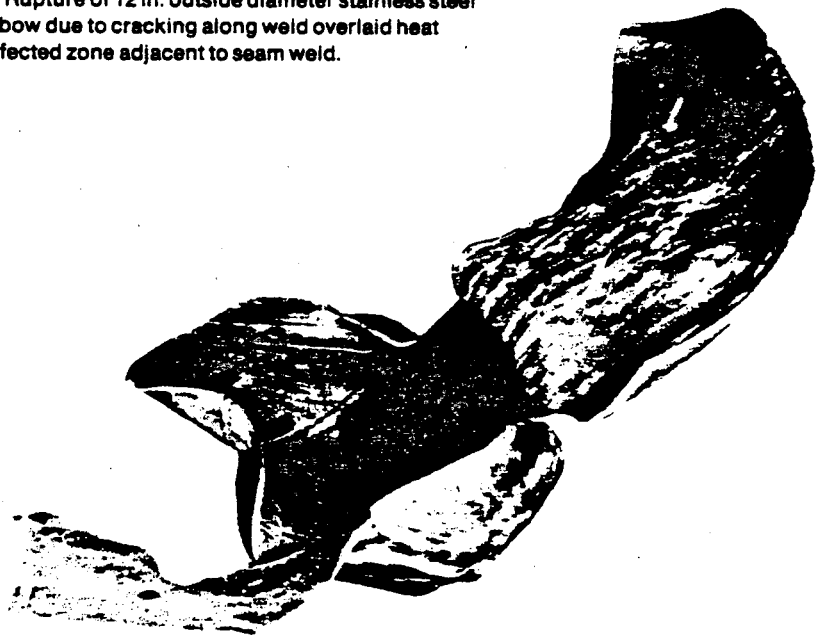
1 Rupture of 12 in. outside diameter stainless steel elbow due to cracking along weld overlaid heat affected zone adjacent to seam weld.

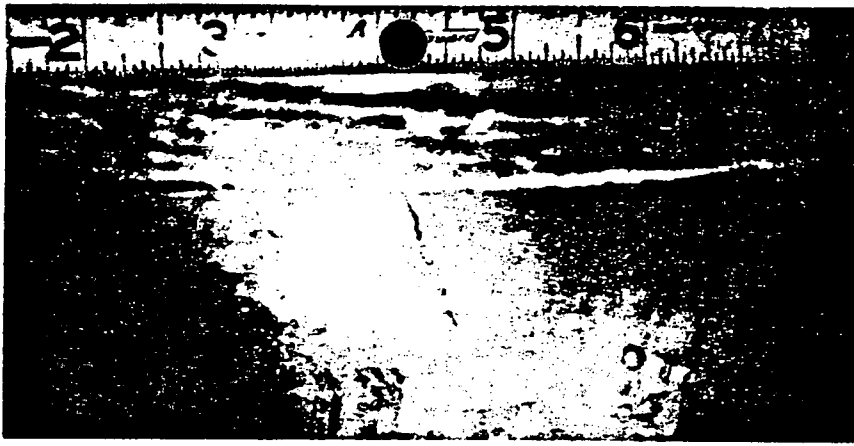
5 Illustration of typical surface lap on 14 in. seamless carbon steel pipe.

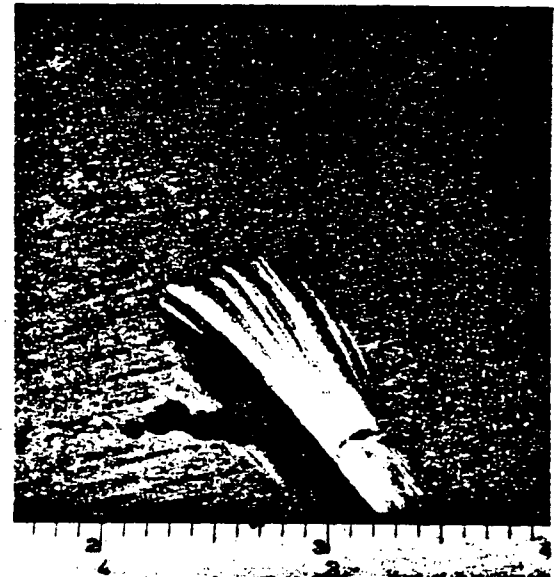
6 Photo A (left) shows surface laps on seamless 20 in. outside diameter Schedule 80 (1.031 in. wall) carbon steel pipe from 0.023 to 0.056 in. deep representing 2.2 to 4.9 percent of the pipe wall thickness. Photo B (right) shows surface lap on seamless 26 in. outside diameter by 0.975 wall carbon steel pipe 0.075 in. deep representing 8.6 percent of pipe wall thickness.

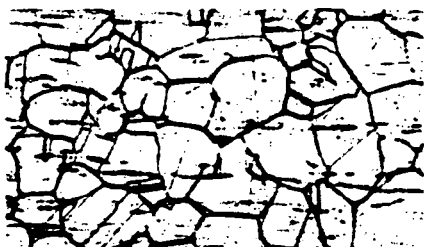
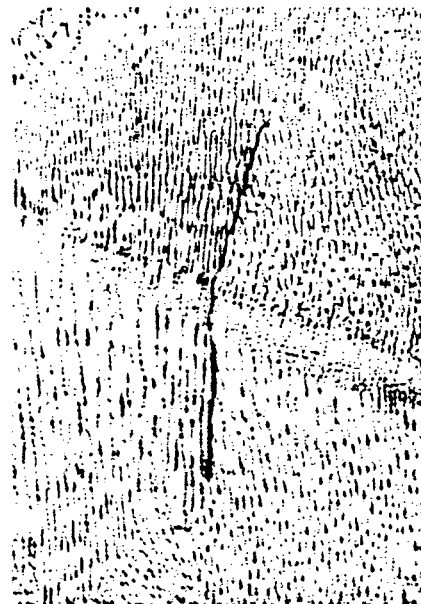
13 Examples of microfissures in Type 316 stainless steel weld joints containing 1 percent delta ferrite (Photo A, left) and 10 percent delta ferrite (Photo B, right). Both photos are reproduced at 100 X magnification.

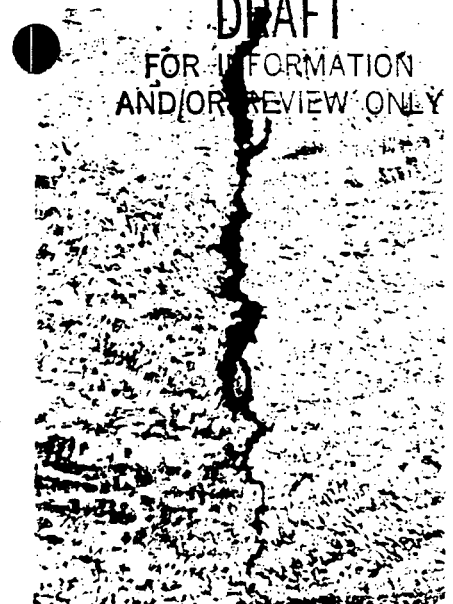
14 Views of socket weld in Type 304 stainless steel coupling with severe sensitization along inside surface of pipe as confirmed by ASTM oxalic acid sensitization etch test evidencing a ditched grain structure. Photo at left is a 1 X magnification; the bottom left, 100 X; and bottom right 500 X.

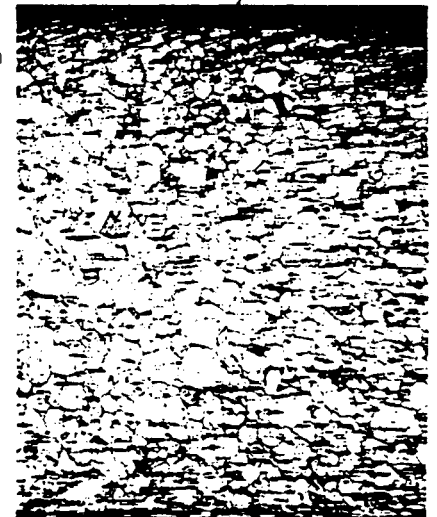
15 Example of sensitization along the inside surface of pipe sensitized by normal pipe forming. Photo at top is at 25 X magnification; bottom photo is at 500 X magnification.

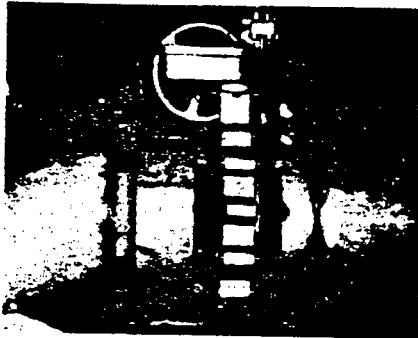
20 Carbon steel pipe clamp and carbon steel slip-on flanges on stainless steel pipe in fossil fuel power plant.
