SUBJECT: LER 80-021/03L-0: on 800612, B High pressure infection makeup  
 liner found excessively hot. Apparently caused by 1HP-153  
 check value not seating properly, allowing water to flow into  
 1B1 cold leg.

DUKE POWER COMPANY  
OCONEE UNIT 1

Report Number: RO-269/80-21

Identification of Occurrence: Overheating in the "B" Loop High Pressure Injection Lines

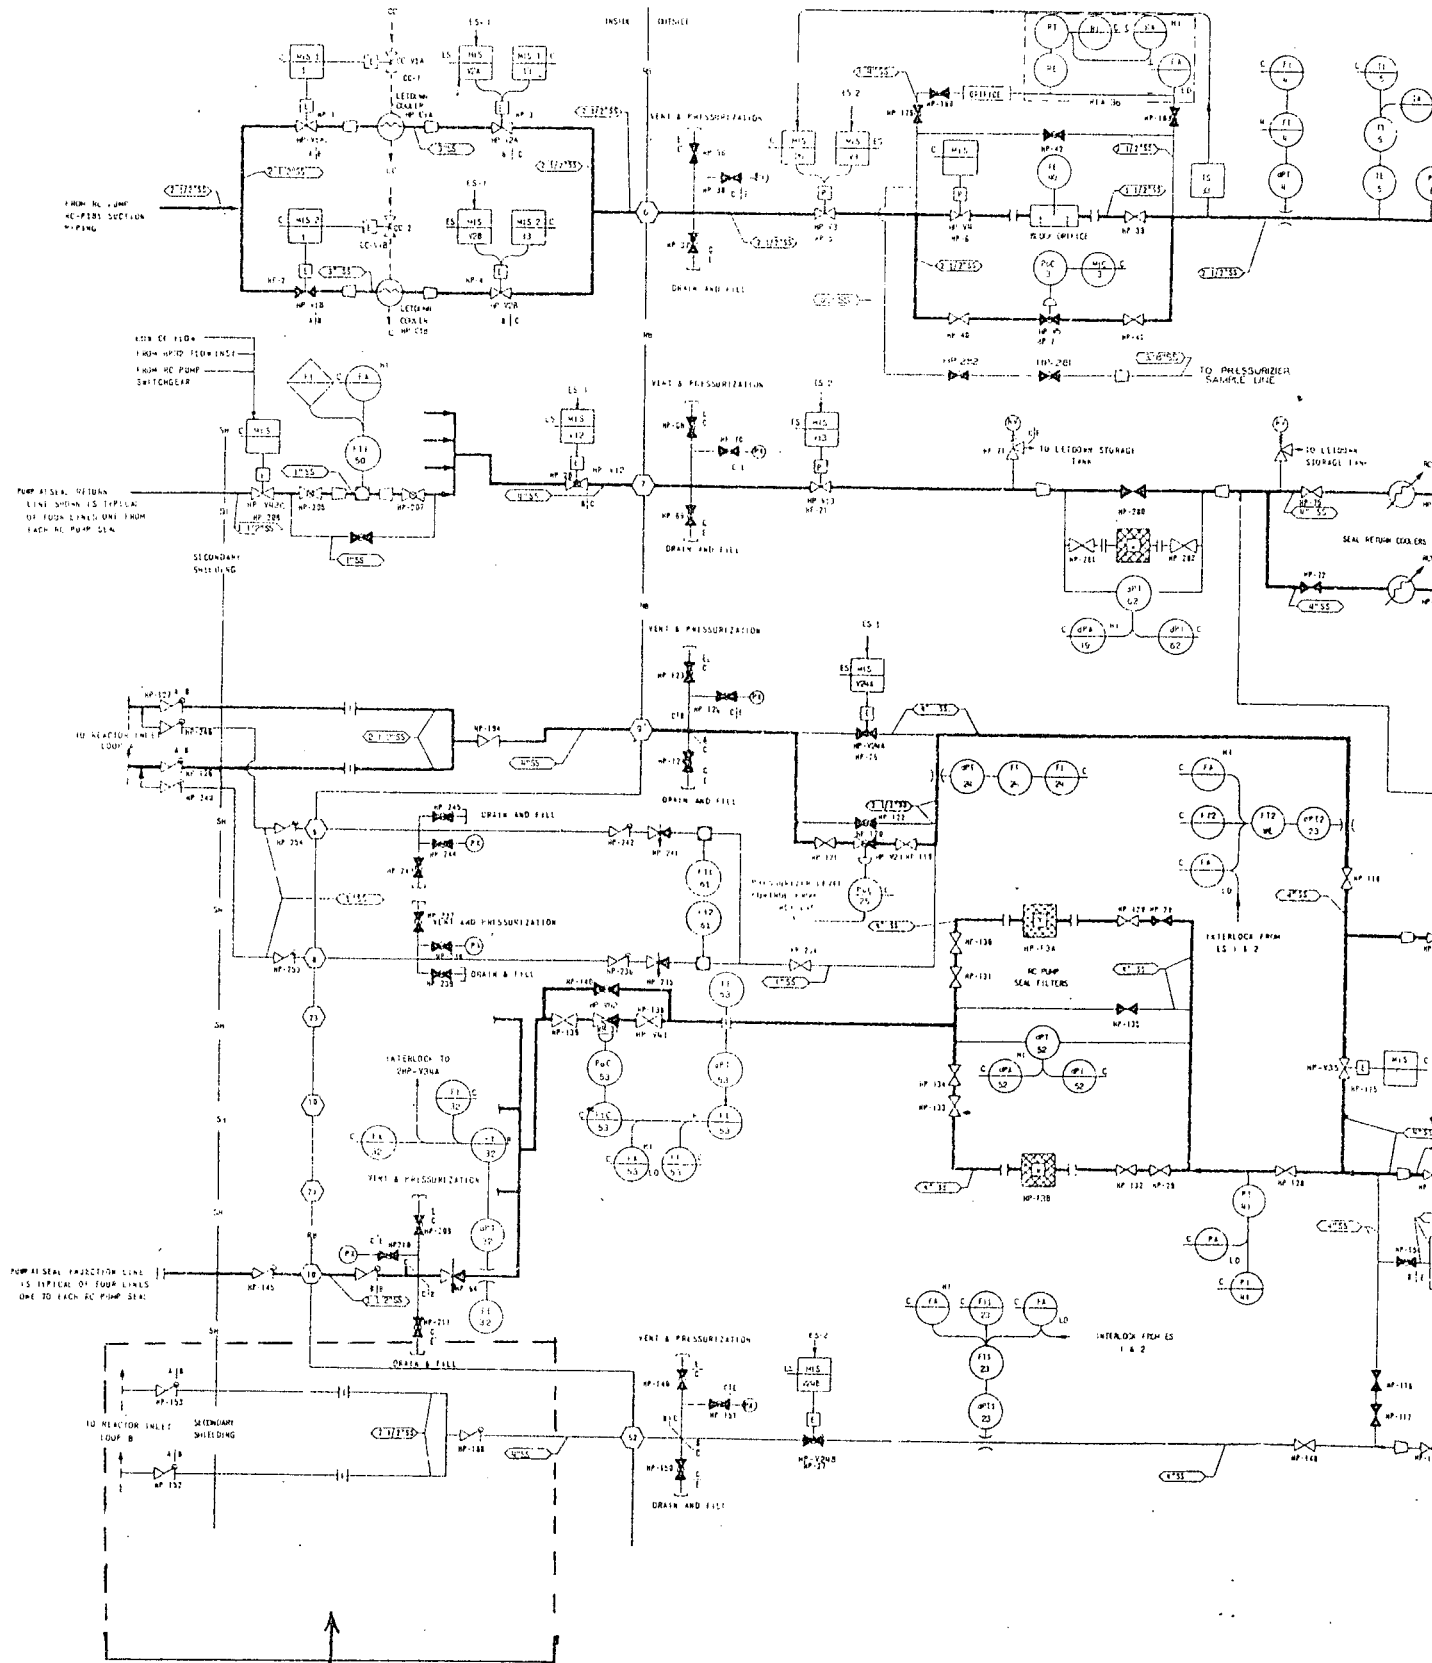
High Pressure Injection System  
(Reference Figure 4-2, Oconee Nuclear Station FSAR)

On June 12, 1980, the "B" high pressure injection (HPI) emergency makeup lines were found to be excessively hot upstream of check valves IHP-152 and IHP-153 through check valve IHP-188 (see attached figure). Due to concerns about piping and hanger integrity, the "B" HPI line was isolated from the HPI System. Just prior to this, reactor power was reduced to below 60% full power as required by Technical Specification 3.3.1. This incident constitutes operation in a degraded mode and is reportable pursuant to Technical Specification 6.6.2.1.b(2).

Valves IHP-152 and IHP-153 are located in the HPI lines feeding into the cold legs of the "B" steam generator. Reactor coolant pump 1B1 was out of service and this caused a 20 to 50 psi differential pressure across valves IHP-152 and IHP-153. Apparently the excessive heating of the piping was due to leakage past IHP-152. This valve, as well as IHP-153, is a stop check valve designed to prevent any upstream flow.

Evidently the IHP-152 check valve disk was not seating properly, and the pressure drop across it allowed reactor coolant water to flow past it and through IHP-153 into the 1B1 cold leg. Intermittent temperature measurements were taken upstream of valve IHP-188 in the penetration room and were found to stabilize at about 225°F. This heating was apparently due to convective and conductive heat transfer from the 556°F Reactor Coolant Water (RCW) within the injection loop between valves IHP-153, IHP-152 and IHP-188. There was no reason to suspect leakage past IHP-188.

Region of High Temperatures

Upon discovery of the abnormally hot piping in the "B" HPI line, this piping was isolated from the HPI System. An evaluation by Duke Power Company was performed and concluded that safe operation of the system could continue despite the temperature increase. Thus, the "B" HPI line was restored to operability.

Valves 1HP-152 and 1HP-153 were inspected during the last Unit 1 outage (late June to early July 1980) and were successfully tested by a local leak rate test on July 2, 1980.
