SUBJECT: LER 80-031/01T-0: on 800902, as result of dropped control rod & power tilt, reactor protection sys flux/flow/imbalance trip set points were set contrary to Tech Specs. Caused by personnel & station misinterpretation of required specs.

DUKE POWER COMPANY
OCONEE NUCLEAR STATION, UNIT 1

Report Number: RO-269/80-31

Identification of Occurrence: RPS Flux/Flow/Imbalance Trip Setpoint
Incorrectly Reset

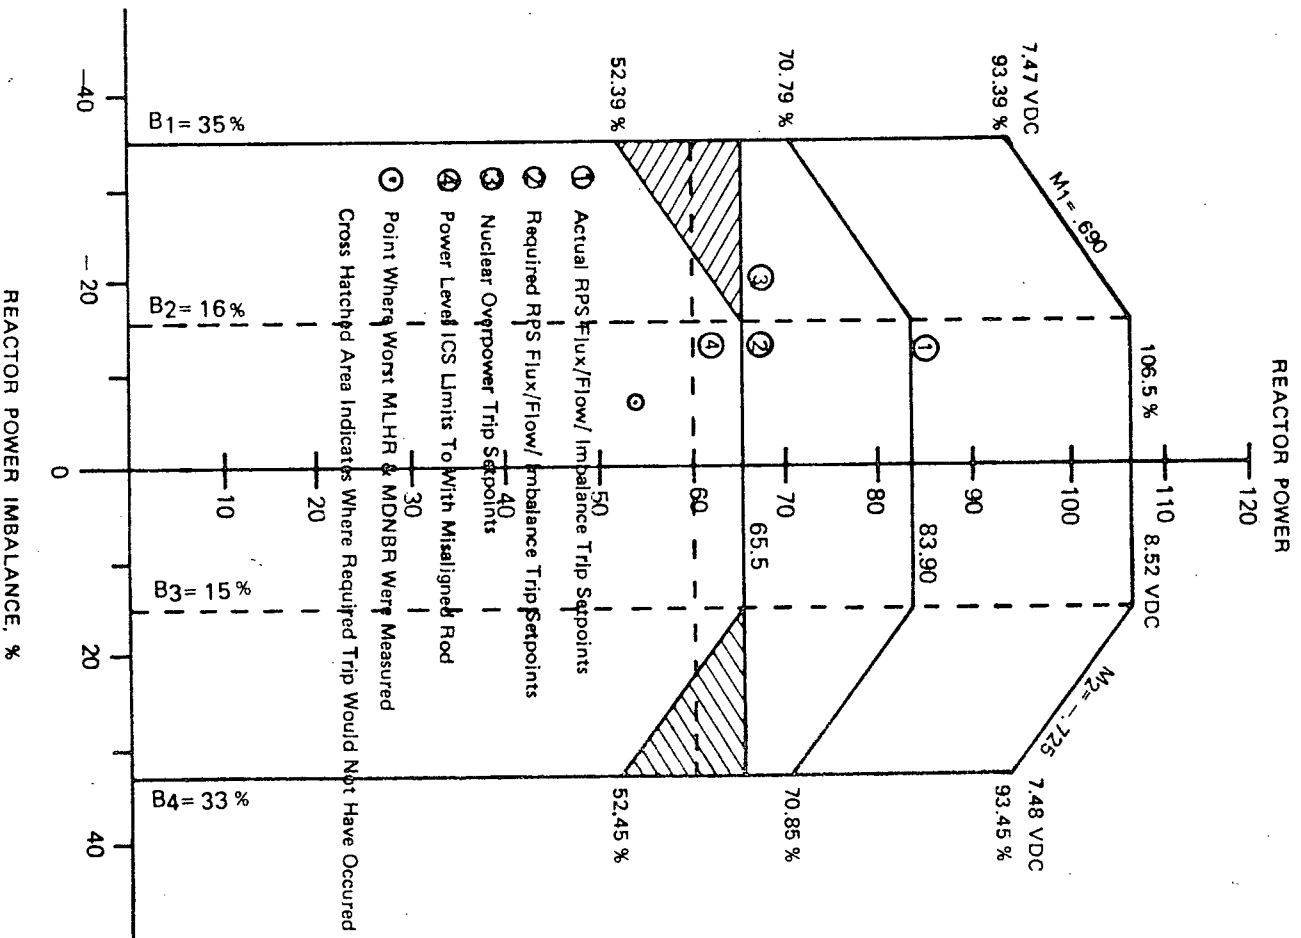
Unit 1, Cycle 6 RPS Flux/Flow/Imbalance
Trip Setpoints

The actual and required flux/flow/imbalance trip envelopes per Technical Specification 3.5.2.2.d are shown on the attached graph. The actual trip envelope was about 18.4% FP above the required envelope for continued operation with a misaligned rod. As discussed below, several mitigating circumstances would have prevented core thermal limits (i.e., 20.05 kw/ft maximum linear heat rate (MLHR) and 1.30 departure from nucleate boiling ratio (MDRBR)) from being approached for any achievable core power distribution or loss of RCS flow.

The nuclear overpower trip was set at 65.5% FP, so that for full flow conditions a trip would have occurred before reaching the required flux/flow/imbalance trip envelope except for the cross-hatched region on the attached graph. Since the unit was operating with an asymmetric rod, the ICS would have run the unit back to 55% FP if reactor power had increased to 60% FP. This further reduces the extent to which the required flux/flow/imbalance trip envelope could have been exceeded. It should also be recognized that the cross-hatched region to the right side of the graph represents positive reactor power imbalance which are not physically achievable. (Based on BOC Power Imbalance Detector Correlation Test Results)

To summarize the above, core conditions which could have been attained and for which an intended reactor trip would not have occurred are:

- operation at full flow with power between ~ 52 and 60% and imbalance between ~ 23% and 35%.
- loss of one RCP while operating above ~ 49% FP.
- loss of two RCP's while operating between ~ 42 and ~ 32% FP.
- flux/flow/imbalance trips due to loss of two RCP's when operating between ~ 54 and ~ 42% FP would have been delayed relative to the intended trip.

All of the above represent situations in which the core conditions are only marginally outside the intended trip curve.
