Part 21 (PAR)

Event # 51976

PART 21 - NOTIFICATION OF DEVIATION OF K-LINE CIRCUIT BREAKER SECONDARY TRIP LATCH

Subject: 10CFR Part 21 Notification of Deviation re. K-Line Circuit Breaker Secondary Trip Latch

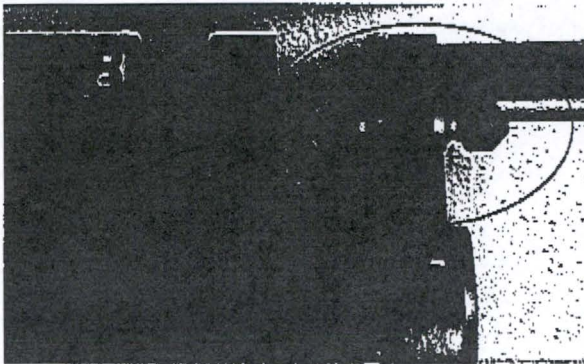
Correct – pin is centered

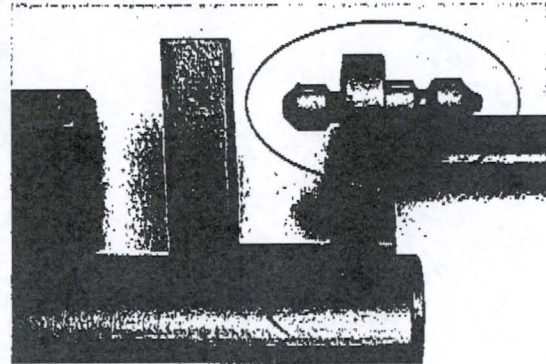
The pin that holds the return spring in place was not properly installed. The defect is believed to have occurred during the assembly process of the latch bar. The latch used in the Prairie Island Nuclear Plant circuit breaker was fabricated in 2013. Please see the photos below for an illustration of the correct, and incorrect, configuration of the pin installed in the secondary trip latch.

Incorrect – pin is not centered

- a. Quarantined and inspected P/N: 716789E00 and 167710T01/167710T03 assemblies in inventory. (Action complete)
- b. Notified vendor of the issue via the ABB Supplier Corrective Action Request process. (Action complete)
- c. Revised Critical Characteristic card for P/N: 716789E00 to incorporate measurement of the pin in question. (Action complete)
- d. Conducted training with QA and Operations personnel for awareness (Action complete)

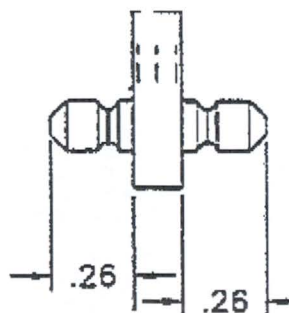
The pin should protrude 0.26 (+/- 0.02) inches out of both sides of the section of the latch bar assembly. Please see the diagram below for a visual representation.

Because of the large potential variety of usages of the potentially affected circuit breakers, ABB (Medium Voltage Service) cannot determine if the potential for a substantial safety hazard exists at any licensee's facility if the circuit breaker fails to operate. It is recommended the Licensees inspect the in-service components at the next convenient maintenance opportunity and components in stock prior to installation.

If the latch is installed on a K-Line circuit breaker, the latch can be inspected from the bottom side of the mechanism without disassembly.
