102-07272-MLL/JR
June 9, 2016

Subject: **Palo Verde Nuclear Generating Station (PVNGS) Unit 1
Docket No. STN 50-528 / License No. NPF 41
Licensee Event Report 2016-001-00**

4. TITLE
Leakage from Reactor Coolant Pump 2B Discharge Pipe Instrument Nozzle

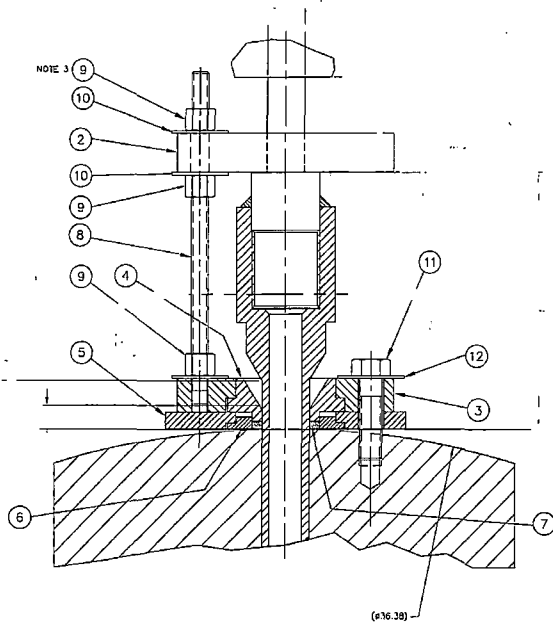
Figure 1 – Mechanical Nozzle Seal Assembly

An investigation was initiated to evaluate the condition and to establish necessary corrective actions. Scheduled refueling outage activities were continued and Unit 1 transitioned from Mode 6 to a Defueled condition on April 18, 2016, when all fuel was removed from the reactor vessel. The RCS piping was drained as necessary to allow repairs to the nozzle. To characterize the problem, engineering personnel conducted additional inspections of the nozzle and piping penetration. This included visual (VT) and dye-penetrant exams as well as eddy-current testing. The VT exam of the nozzle interior and seal weld revealed an axial crack in the nozzle in the region of the seal weld. The eddy-current testing results aligned with the VT exam. Repairs to the nozzle were performed per application of Code Case N-733 (no exceptions) with the utilization of a Mechanical Nozzle Seal Assembly (MNSA). Figure 1 illustrates the MNSA.

Repairs to the nozzle were performed per application of Code Case N-733 (no exceptions) with the utilization of a MNSA. A final repair of the nozzle will be evaluated and addressed in the Corrective Action Program.
