Part 21 Report No: P21-04302015, Rev. 2

Subject: **Update** - Report of potential 10CFR Part 21, Allen Bradley Timing Relay Model 700RTC – NRC Event Number 51030, Accession Number ML15134A016

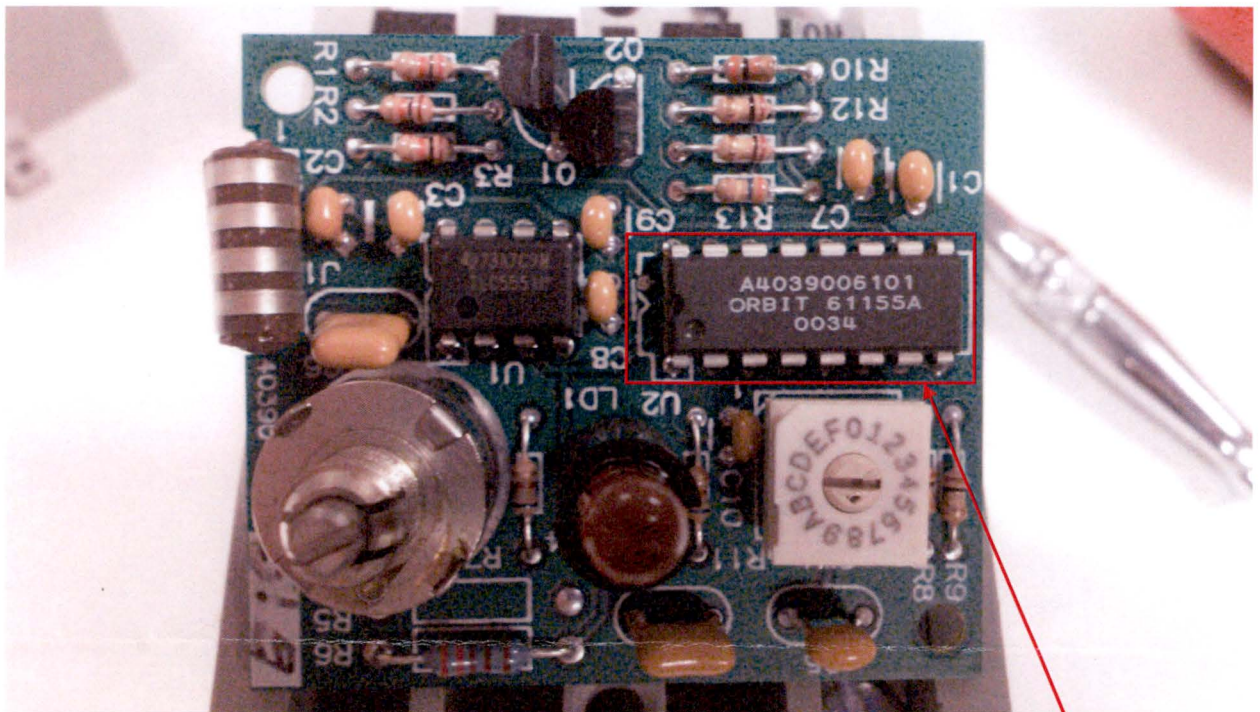
Between 2009-2010, Allen Bradley made a design change without changing the part number of the commercial relay or providing any documented evidence of a design change. The manufacturer specification data sheets maintain the classification that the relays are “solid state”, which would imply that there are no digital devices installed in the relay. However, after inspection of the internals of the timing relay (Figure 2), it has been identified that the unit does contain a CPLD which meets the definition of a digital device under the guidance of NEI 01-01. See Figures 1 and 2 below:

Figure 1- Original qualified design (prior to 2009).
Relays supplied prior to 2009 are not affected by this issue.

Original component

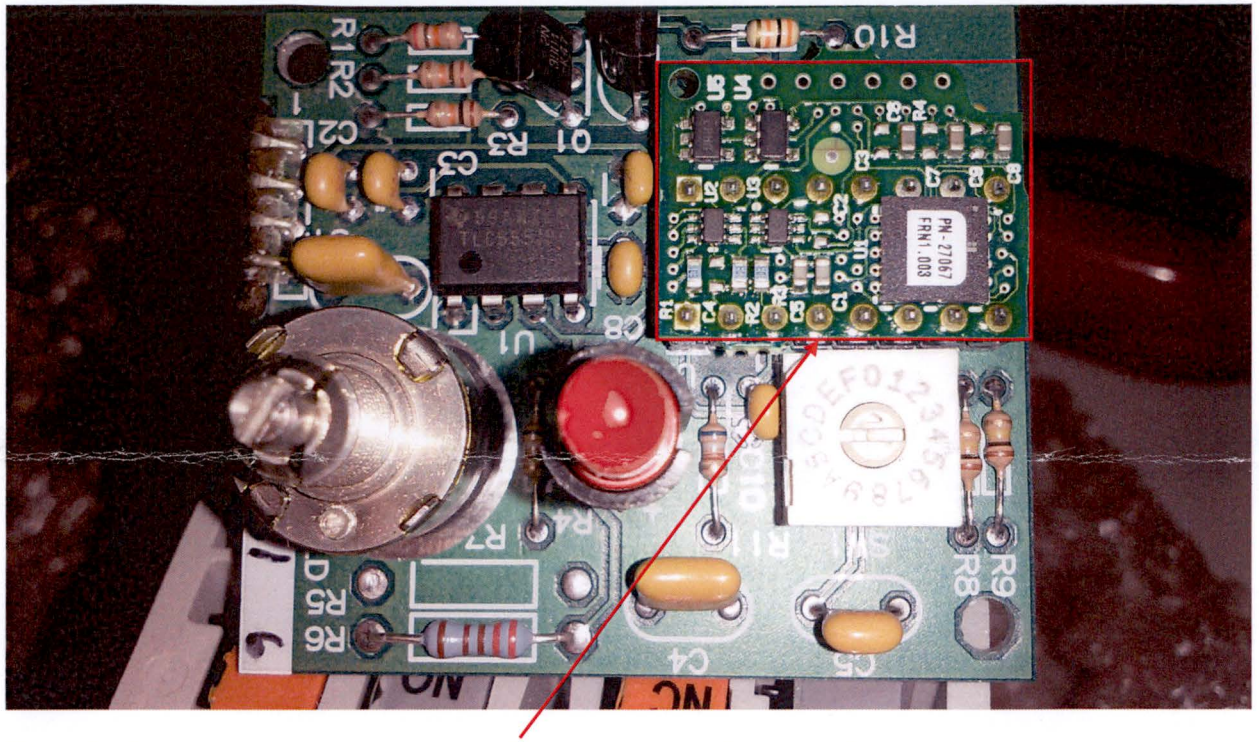
Figure 2 - New design circuit board and CPLD that replaced the original component.

The relays that are currently in stock at NLI have been placed on hold until after the units have been determined to be qualified for the specific application. NLI has completed the EMC qualification testing per the requirements of EPRI TR-102323 Rev. 4 for the following tests, as applicable: CE101, CE102, RE101, RE102, RS101, RS103, CS101, CS114, CS115 and CS116.

The results were satisfactory with exception of the following condition: During Conducted Susceptibility CS114 onto the power lines, with the timing circuit in operation, the instantaneous contacts exhibited chatter in the range of 2.6 MHz to 20.3 MHz. The unit requires a ferrite to be installed onto the input power lines of the relay with 3 turns through the ferrite core. In this modified configuration, the relay was not susceptible to Conducted Susceptibility and successfully passed the required test per CS114.

The relays are dedicated for generic application usage in timing applications. The specific plant application(s) is unknown by NLI. The EMC qualification of the relay is dependent on the installed configuration and location in the plant. The plant should evaluate whether the installed relays are subjected to the specific EMI/RFI condition Conducted Susceptibility CS114 between the frequencies of 2.6 MHz to 20.3 MHz identified above.
