## **Baffle-to-Former Bolt**

### **Bulletin No. 16-02**

S. Fyfitch, AREVA Inc.

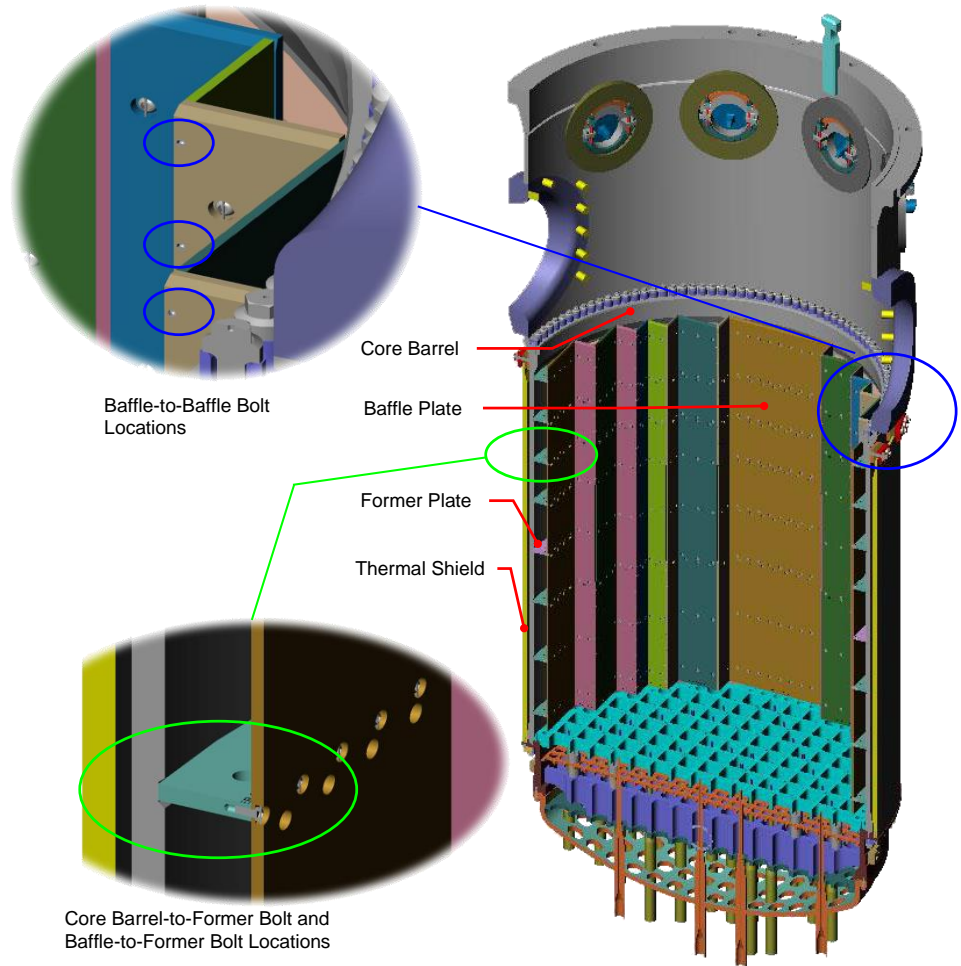
**Baffle-to-Former Bolt Locations (1/8<sup>th</sup> core)**

- ▶ **Four baffle-to-former bolt (BFB) UT examinations completed at B&W-designed units to date**
  - ◆ One BFB out of 3,450 BFBs UT examined identified with crack-like indications
  - ◆ VT examinations of all 3,456 BFBs identified no relevant indications
- ▶ **Concluded there is very high probability this was a random failure and not an indication of active degradation mechanism having initiated**
