Baffle Former Bolt Overview of Industry Experience

PWROG Materials Committee

July 19, 2016

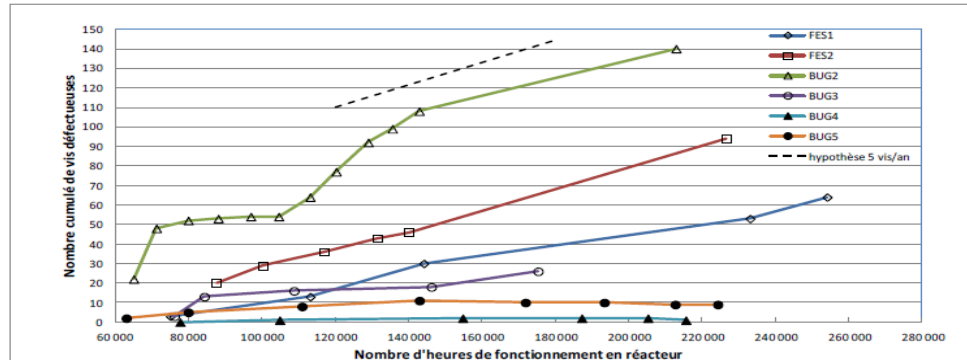
Overall BFB Timeline – CP0 Units

- X-axis: number of operating hours
- Y-axis: cumulative number of bolts found 'failed'/unconclusive'
- ----- : evolution trend, assuming 5 failed bolts per year

BUG2-FES2-FES1-BUG3: 4/6 CP0 units are 'affected'
BUG5-BUG4: 2/6 CP0 units are 'unaffected'
