UNITED STATES
NUCLEAR REGULATORY COMMISSION
REGION I
631 PARK AVENUE
KING OF PRUSSIA, PENNSYLVANIA 19406

Subject: Special Inspection No. 50-443/86-52

This refers to the special team inspection conducted by Mr. Jacques P. Durr of this office on November 3-14 and 19-21, 1986 and to the discussions of our findings held by Mr. Durr with Messrs. W. B. Derrickson and W. P. Johnson at the conclusion of the inspection. The inspection was of activities authorized by NRC License No. NPF-56 at the Seabrook Station, Unit No. 1, Seabrook, New Hampshire.

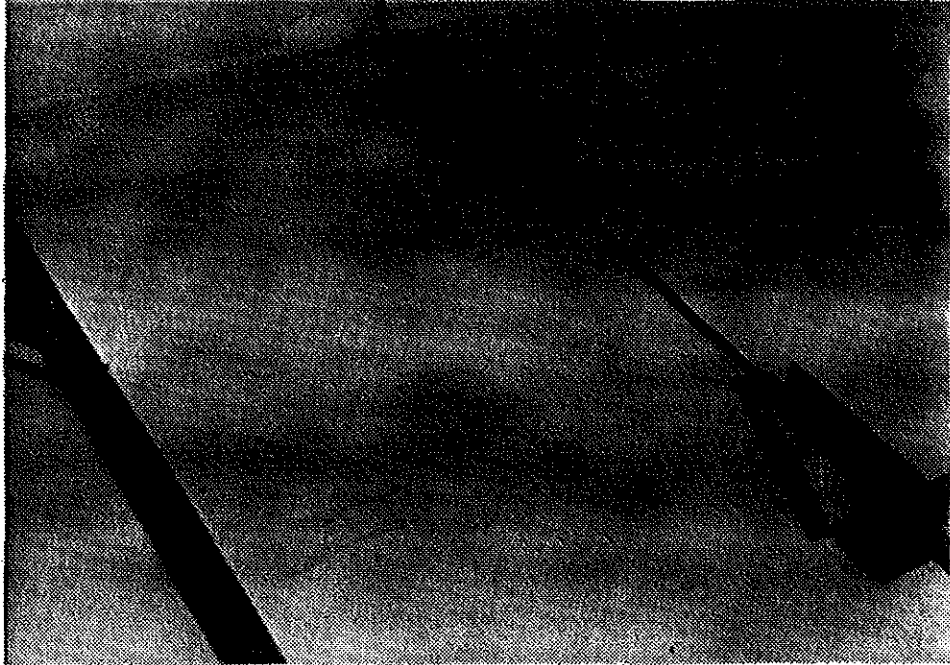
During this inspection, the inspector visually examined some concrete repairs performed to repair cracks in the containment wall and equipment vault for evidence of unacceptable workmanship or any degradation, i.e. excessive surface moisture, mineral deposits, joint cracks/shrinkage, and/or a hollow sound indicating separation of patches from sound concrete. The examined repairs did not indicate any of these conditions. The inspector, therefore, concluded that the concrete repair procedure and repairs were acceptable. (Photo nos. 1 & 2)

The allegation regarding cracks and water leakage was substantiated. Cracks in concrete are expected to occur and are permissible if they do not affect the integrity of the structure. The inspector concluded that the wall had hairline cracks, and some of them leaked groundwater through them. However, the repairs effected were in accordance with applicable codes, accepted industry practice, and approved construction techniques.

The allegation that repairs to cracks were "superficial" was not substantiated. The effected repairs were technically adequate, and met the requirements of national codes and standards.

**PHOTO NO. 1, CONCRETE REPAIRS IN THE EQUIPMENT
VAULT ELEVATION (-25') (REF. ALLEGATION NO. 4)**

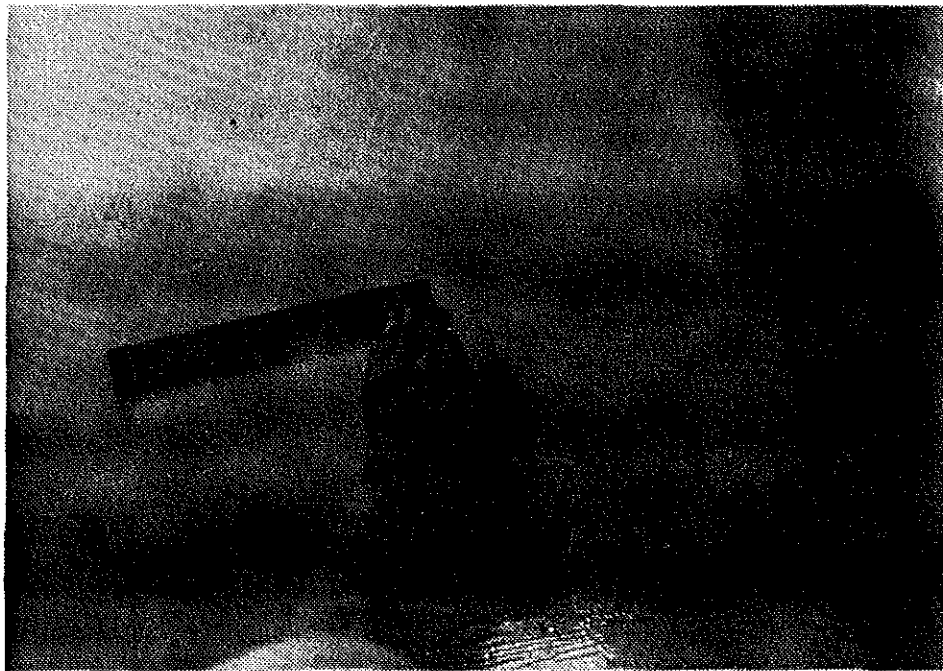
**PHOTO NO. 2, CONCRETE REPAIRS IN CONTAINMENT
ELEVATION 0' (REF. ALLEGATION NO. 4)**

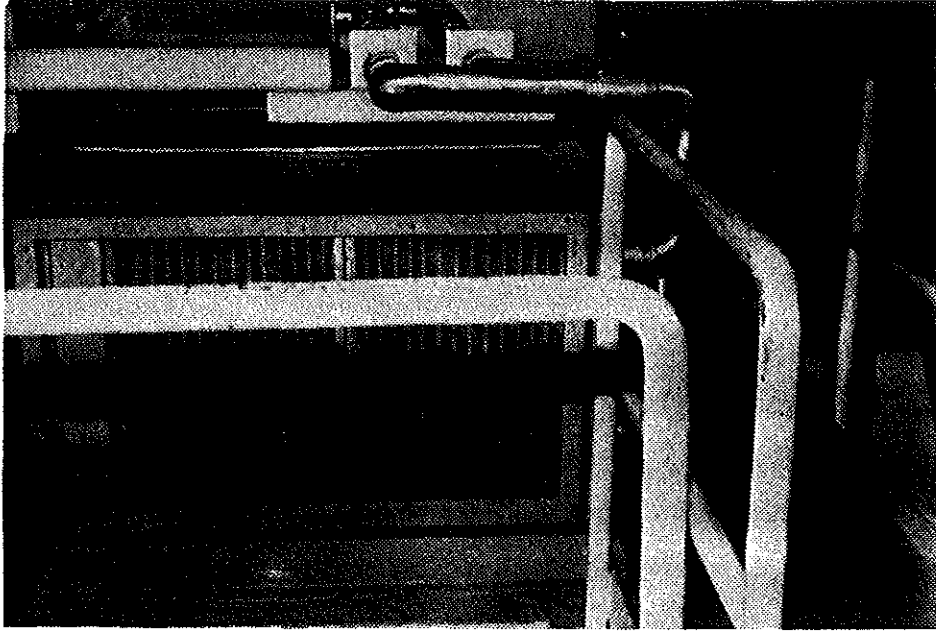
There is no evidence or presence of dirt or debris in the equipment vault area or equipment, the allegation was not substantiated.

PHOTO NO. 5, AIR HANDLING UNIT (REF. ALLEGATION NO. 18)

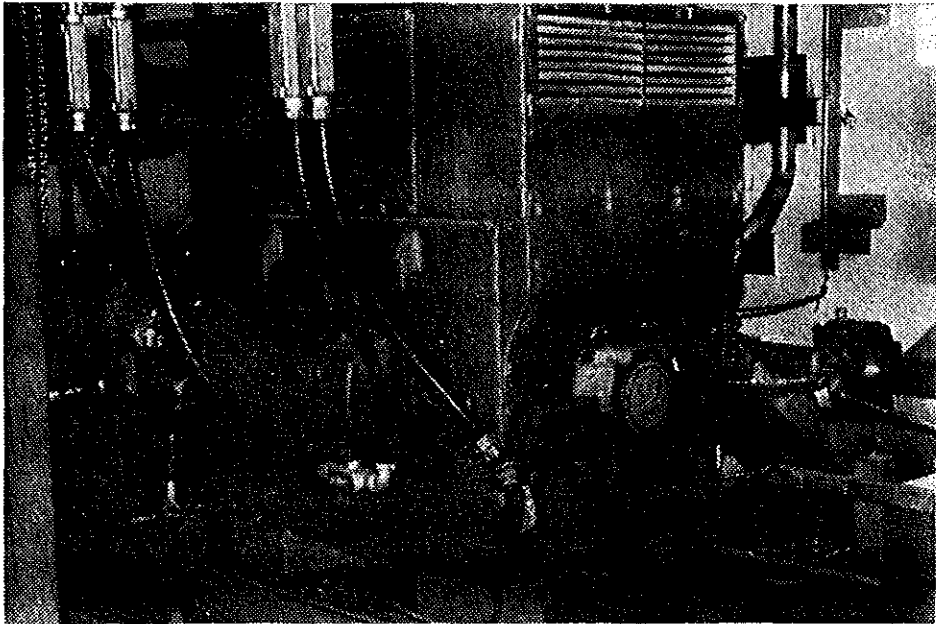
PHOTO NO. 6, SAFETY INJECTION PUMP MOTOR HOUSING (REF. ALLEGATION NO. 18)

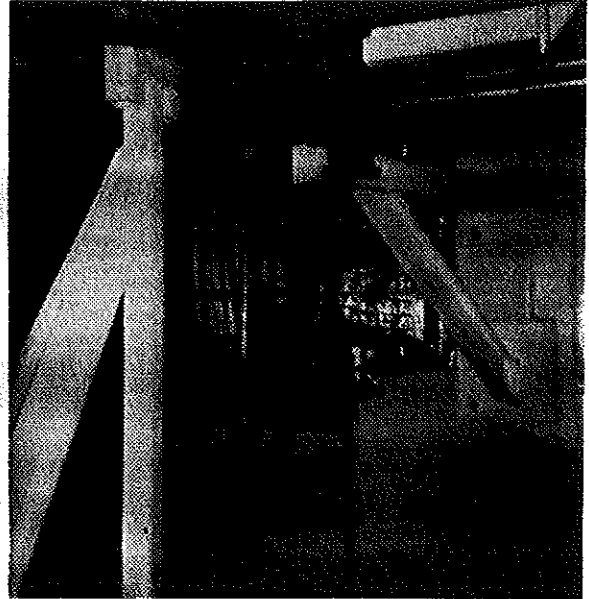
PHOTO NO. 7, CONDUITS AND J-BOX AT ELEVATION 7'-0" IN THE PRIMARY AUXILIARY BUILDING (REF. ALLEGATION 19)

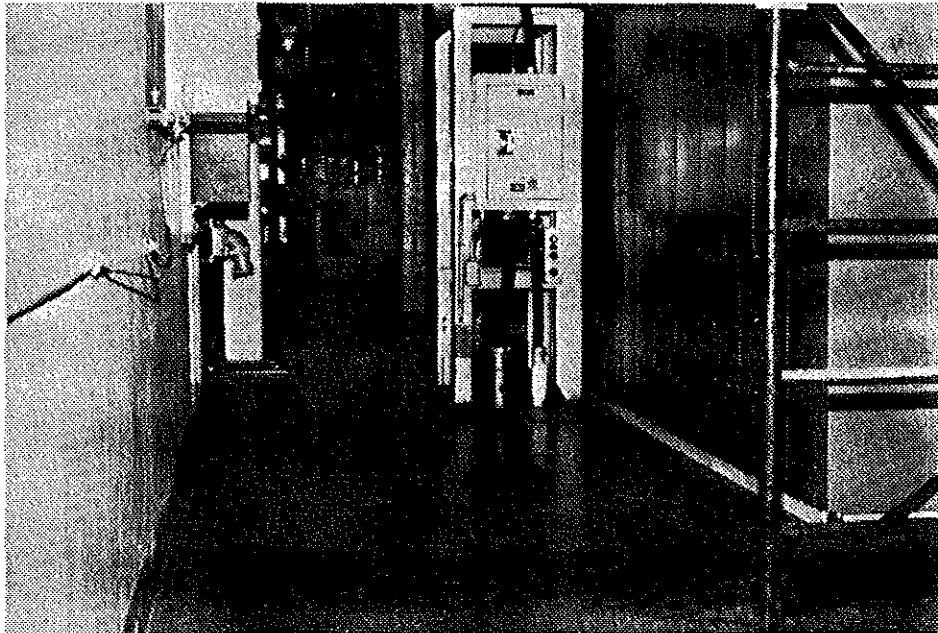
PHOTO NO. 8, PRIMARY AUXILIARY BUILDING ELEVATION 25' - 0' (REF. ALLEGATION NO. 19)

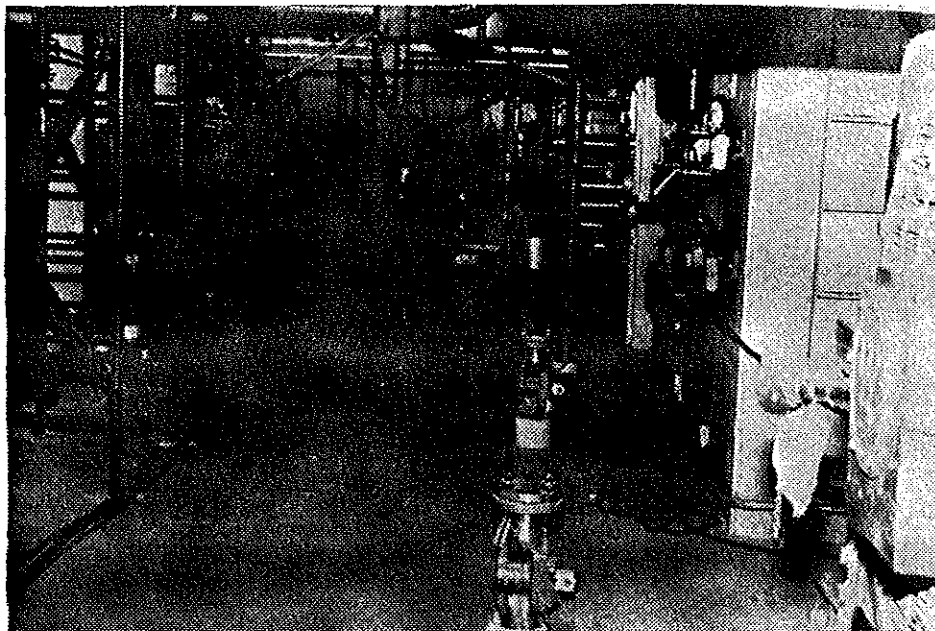
The allegation is substantiated for temporary cable; however, there is no evidence to indicate that these instances involved safety related cables.

PHOTO NO. 10, TEMPORARY WELDING AND POWER CABLES ON THE FLOOR (REF. ALLEGATION NO. 39)

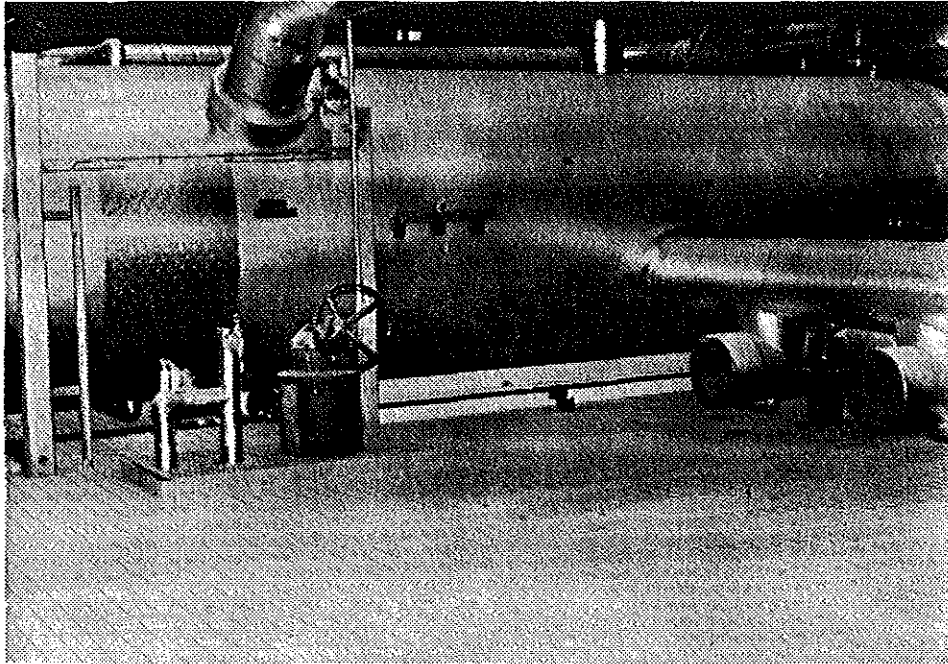
This allegation was not substantiated. During investigation of the allegation, all items inspected by the NRC were found to be installed in accordance with design drawings and equipment manuals. While it is true that the B31.1 as-built program was cancelled, the B31.1 code conformance was met by installation practices and procedures. No safety-related equipment deficiencies could be identified as a result of these allegations.

PHOTO NO. 11, FEEDWATER HEATER BEING CHECKED FOR LEVEL INSTALLATION (REF. ALLEGATION NO. 55)
