UNITED STATES
NUCLEAR REGULATORY COMMISSION
REGION I
631 PARK AVENUE
KING OF PRUSSIA, PENNSYLVANIA 19406

Subject: Special Inspection No. 50-443/86-52

This refers to the special team inspection conducted by Mr. Jacques P. Durr of this office on November 3-14 and 19-21, 1986 and to the discussions of our findings held by Mr. Durr with Messrs. W. B. Derrickson and W. P. Johnson at the conclusion of the inspection. The inspection was of activities authorized by NRC License No. NPF-56 at the Seabrook Station, Unit No. 1, Seabrook, New Hampshire.

The inspection independently examined allegations related to construction activities and management controls at Seabrook Site that were provided to the NRC from several sources. The inspection consisted of interviews with personnel, reviews of quality records, examinations of equipment and independent tests. The conclusions of the inspection team are presented in the Executive Summary at the beginning of this report.

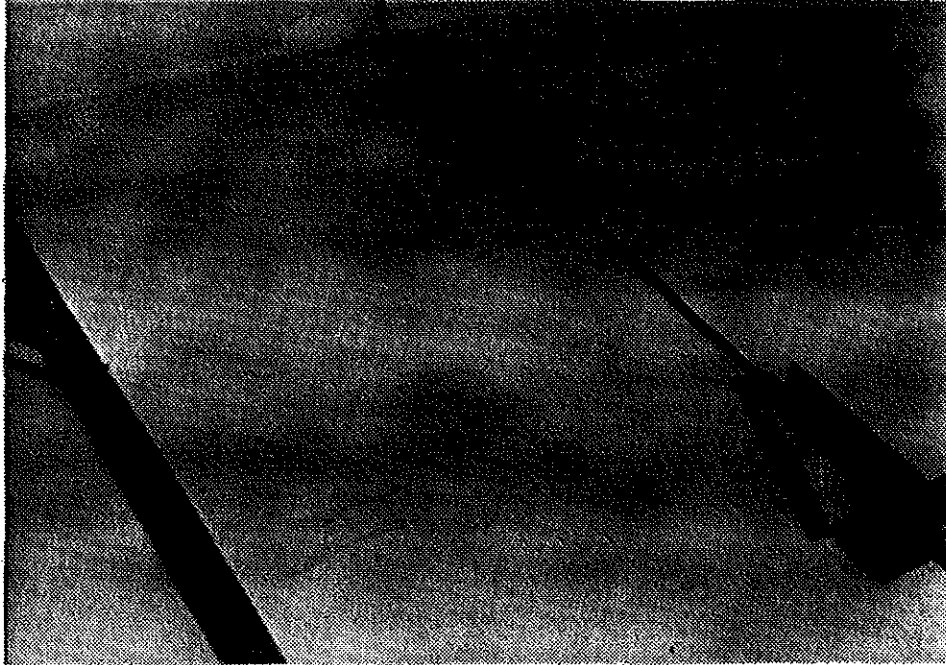
17. This allegation refers to two related conditions: 1) there are cracks in concrete in the equipment vault and containment dome; and 2) water seeps through the cracks in the equipment vault.

During this inspection, the inspector visually examined some concrete repairs performed to repair cracks in the containment wall and equipment vault for evidence of unacceptable workmanship or any degradation, i.e. excessive surface moisture, mineral deposits, joint cracks/shrinkage, and/or a hollow sound indicating separation of patches from sound concrete. The examined repairs did not indicate any of these conditions. The inspector, therefore, concluded that the concrete repair procedure and repairs were acceptable. (Photo nos. 1 & 2)

The allegation regarding cracks and water leakage was substantiated. Cracks in concrete are expected to occur and are permissible if they do not affect the integrity of the structure. The inspector concluded that the wall had hairline cracks, and some of them leaked groundwater through them. However, the repairs effected were in accordance with applicable codes, accepted industry practice, and approved construction techniques.

**PHOTO NO. 1, CONCRETE REPAIRS IN THE EQUIPMENT
VAULT ELEVATION (-25') (REF. ALLEGATION NO. 4)**

The repair of concrete is described in the American Concrete Institute's specification ACI 301-72, "Specification for Structural Concrete for Buildings", Section 9.0. The inspector reviewed pertinent documents and determined that the repairs to concrete were acceptable. It met the requirements of the Architect-Engineer's (AE's) specification and the governing design and construction codes, i.e. ACI, and ASME, Section III, Division 2.

The allegation that repairs to cracks were "superficial" was not substantiated. The effected repairs were technically adequate, and met the requirements of national codes and standards.

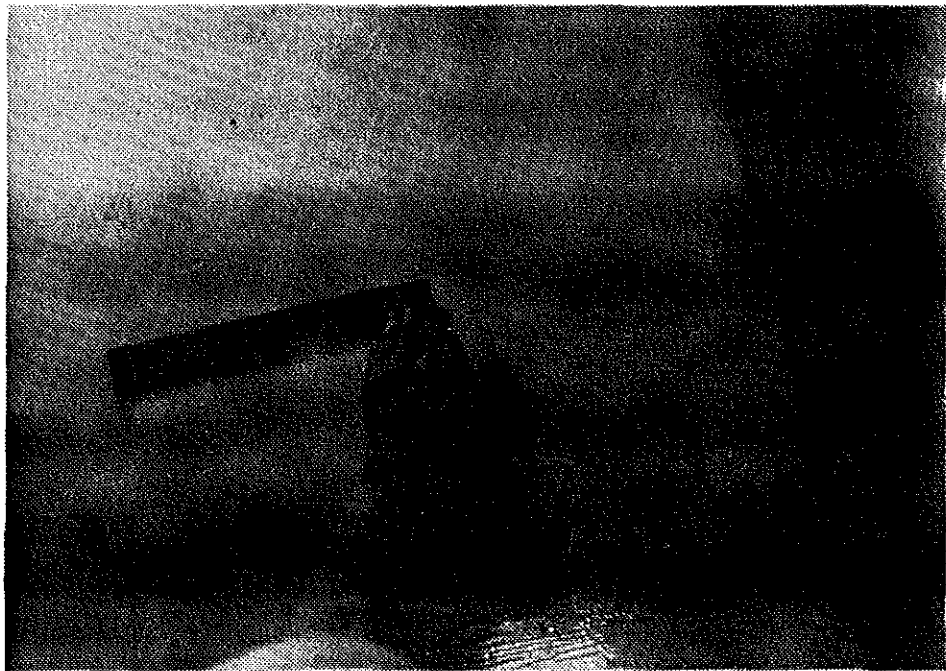
**PHOTO NO. 2, CONCRETE REPAIRS IN CONTAINMENT
ELEVATION 0' (REF. ALLEGATION NO. 4)**

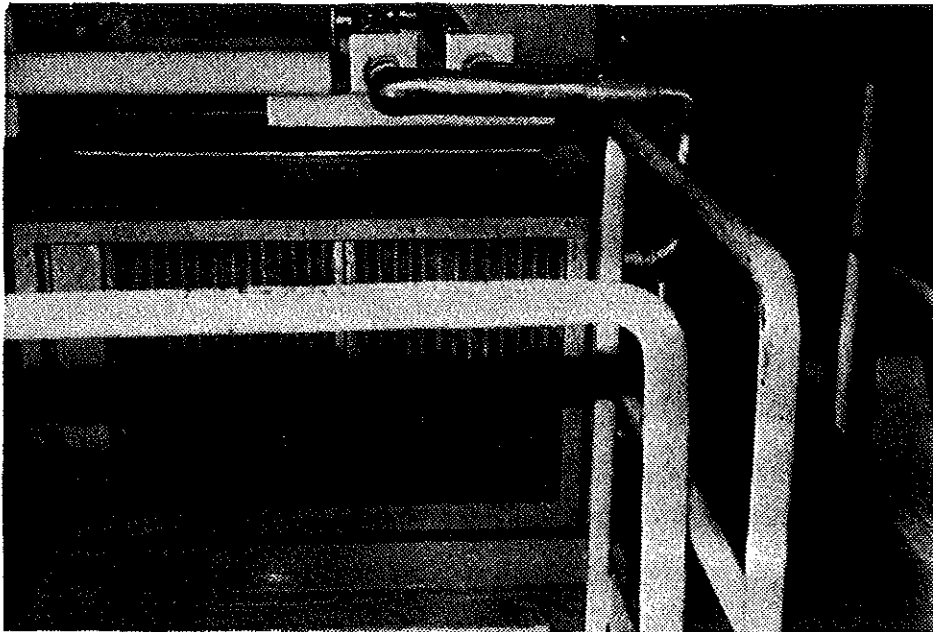
There is no evidence or presence of dirt or debris in the equipment vault area or equipment, the allegation was not substantiated.

PHOTO NO. 5, AIR HANDLING UNIT (REF. ALLEGATION NO. 18)

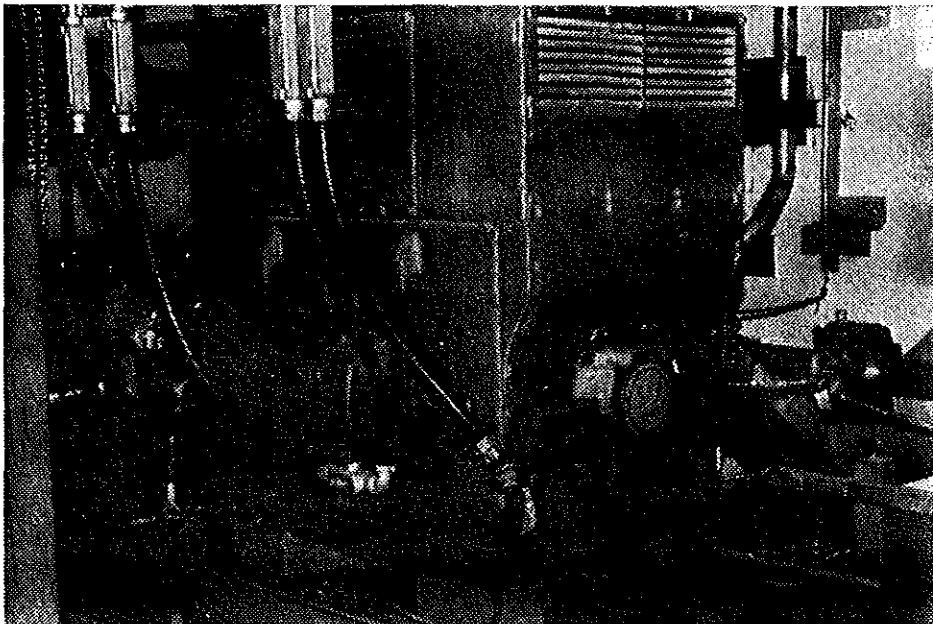
PHOTO NO. 6, SAFETY INJECTION PUMP MOTOR HOUSING (REF. ALLEGATION NO. 18)

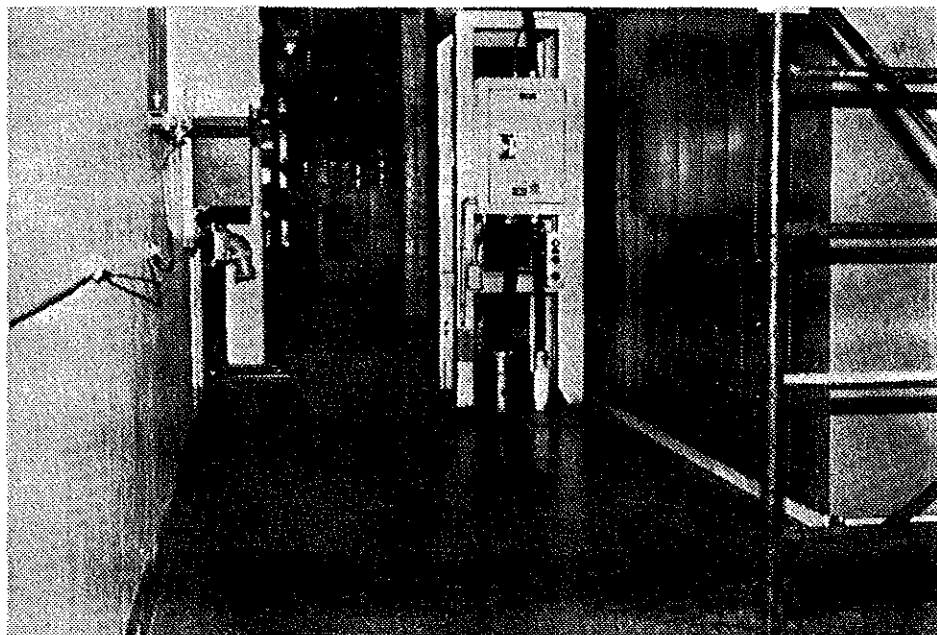
Since the cigarette requires ventilation to achieve the higher temperatures required to ignite the cable, a cigarette discarded into a conduit is not hot enough to ignite the cable or to sustain a fire and:

PHOTO NO. 8, PRIMARY AUXILIARY BUILDING ELEVATION 25' - 0' (REF. ALLEGATION NO. 19)

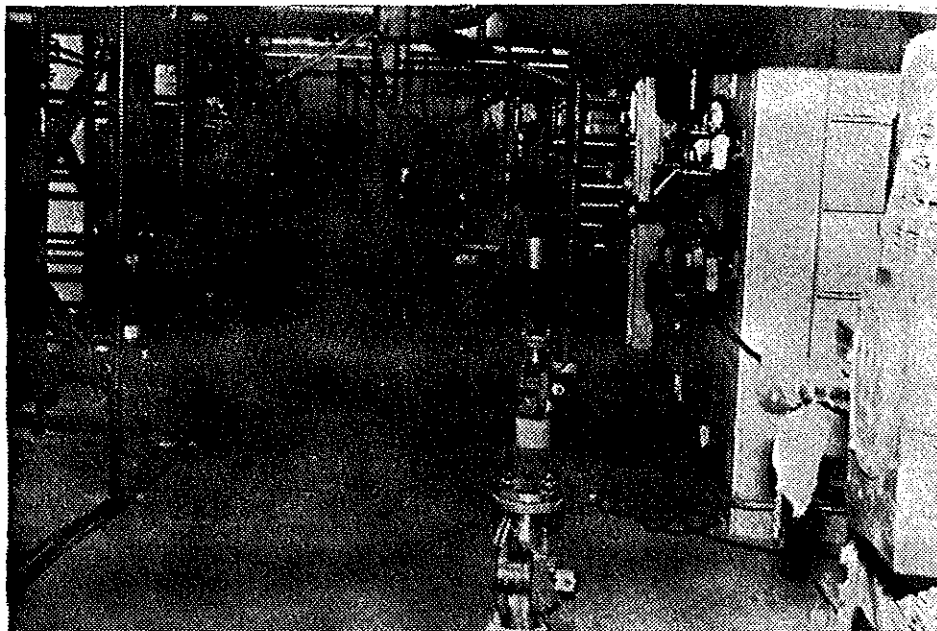
The allegation is substantiated for temporary cable; however, there is no evidence to indicate that these instances involved safety related cables.

**PHOTO NO. 10, TEMPORARY WELDING AND POWER
CABLES ON THE FLOOR (REF. ALLEGATION NO. 39)**

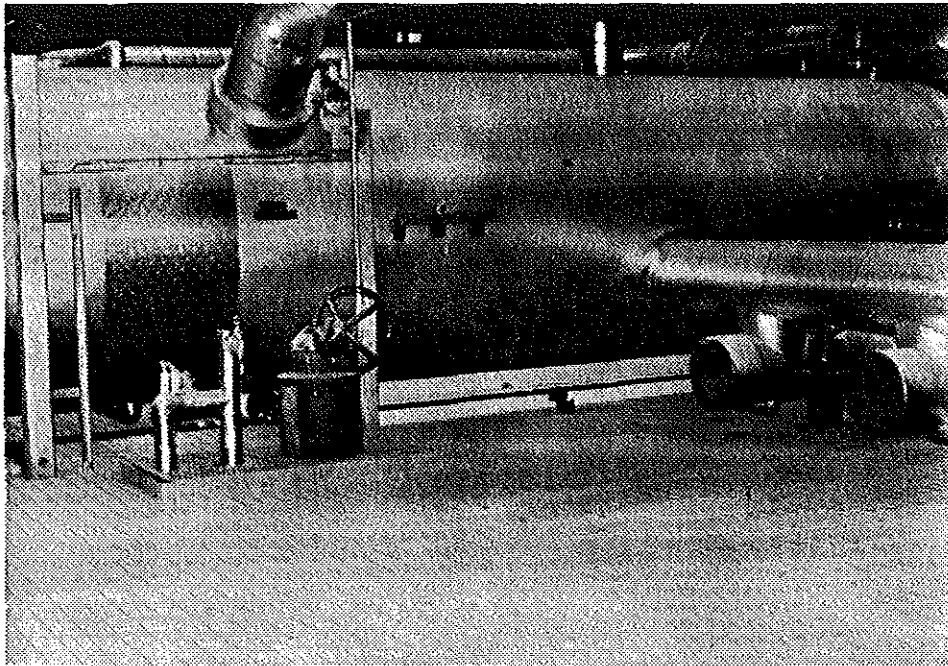
This allegation was not substantiated. During investigation of the allegation, all items inspected by the NRC were found to be installed in accordance with design drawings and equipment manuals. While it is true that the B31.1 as-built program was cancelled, the B31.1 code conformance was met by installation practices and procedures. No safety-related equipment deficiencies could be identified as a result of these allegations.

**PHOTO NO. 11, FEEDWATER HEATER BEING CHECKED
FOR LEVEL INSTALLATION (REF. ALLEGATION NO. 55)**

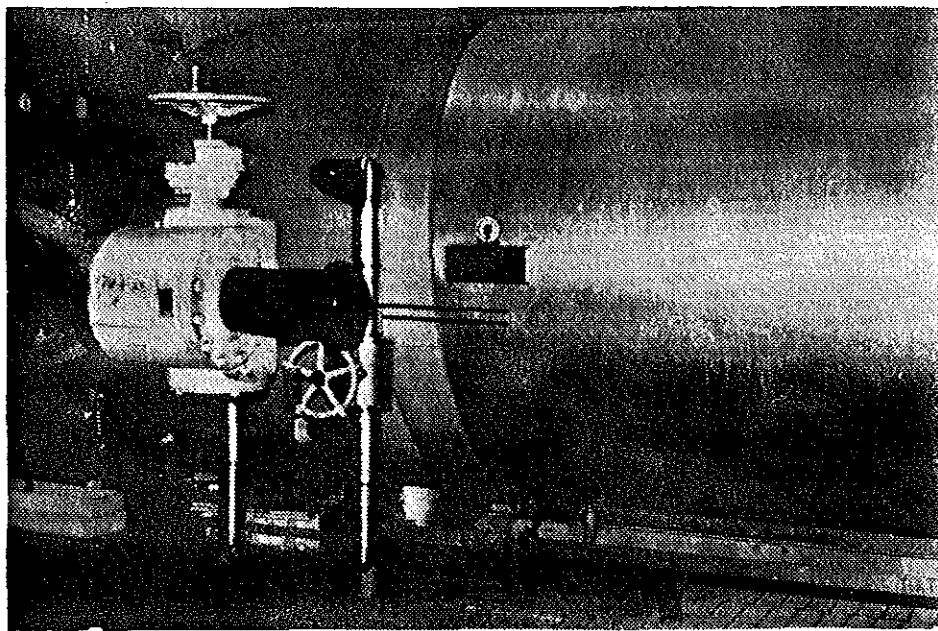
**PHOTO NO. 12, FEEDWATER HEATER BEING CHECKED
FOR LEVEL INSTALLATION (REF. ALLEGATION NO. 55)**
