#### **Briefing on Indian Point Baffle Bolt Inspections**

April 19, 2016

**Enclosure 1**

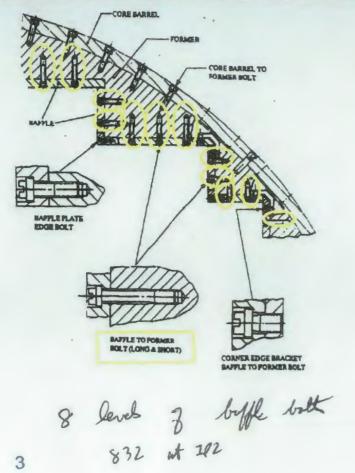
Stainless steel bolts are 5/8" dia. x ~2" long and attach the baffle plates to the former plates to form the baffle assembly Baffle-former bolt head 10-18-10 Tack weld Locking tab
