**UNITED STATES
NUCLEAR REGULATORY COMMISSION**

August 8, 2016

**SUBJECT: HOPE CREEK GENERATING STATION UNIT 1 – INTEGRATED INSPECTION
REPORT 05000354/2016002**

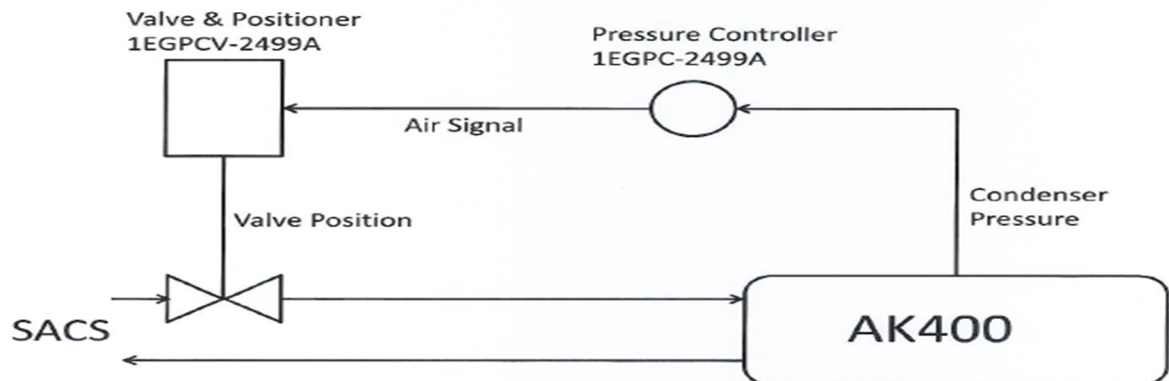
Pressure Control Valve (PCV) Failures:

1. June 15, 2016 – ‘B’ MCR chiller became inoperable due to the SACS pressure control valve (PCV), EG-PCV-2499B, failing in the fully closed position (NOTF 20732364). PSEG isolated control air to the PCV which failed the PCV open, allowing operators to deem the chiller operable but in degraded status.
[Controller issue]

2. May 6, 2016 – ‘A’ MCR chiller tripped due to the SACS PCV, EG-PCV-2499A, opening late. PSEG replaced the failed PCV positioner and completed WGE 70186738 which determined that the failed positioner was only 2 years old, was previously replaced in April 2014, and that the only maintenance that involved the PCV was an actuator overhaul in February 2016. PSEG’s FFCDE and failure analysis are still pending.
[Positioner issue]
