***Budney Overhaul & Repair, LTD.***  
***Budney Aerospace, Inc.***  
***131 New Park Drive***  
***P.O. Box 8158***  
***Berlin, CT 06037-8158***  
***Tel (860) 828-0585 Fax (860) 828-9506 / 2975***

August 5, 2016

RE: License Termination Request  
Radioactive Materials License No. STB-1530  
Docket No. 04008974

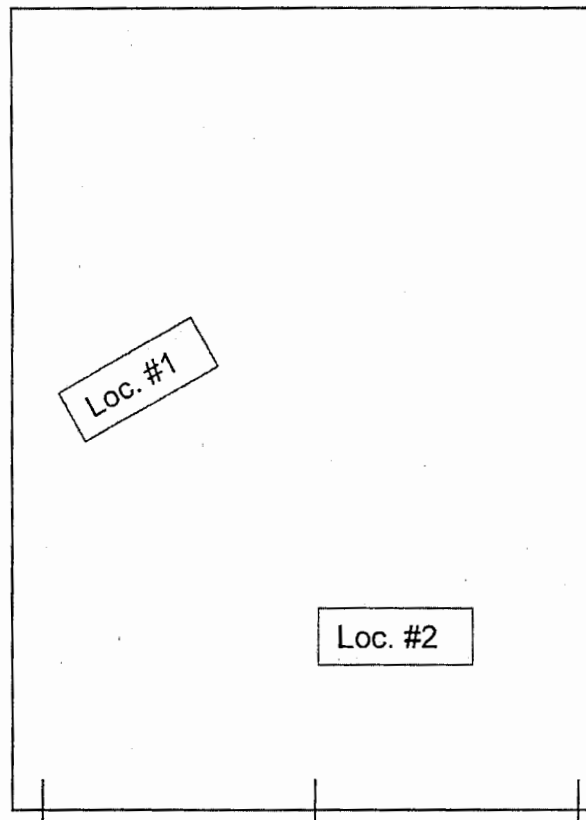
Fixed-measurement locations

2. As requested, two (2) random fixed-point surveys were performed in the waste storage container on July 27, 2016. A map identifying the storage locations is included with this letter. A 15-minute count was performed in contact with the floor at each location. The readings obtained were as follows:
  - a) Location 1: 3,069 counts = 205 cpm

- b) Location 2: 3,193 counts = 213 cpm
3. Upon review of the 1997 drawing, it was determined that random direct readings had not be obtained from the previous radioactive waste storage location. Therefore, two (2) random fixed-point surveys were performed in the old waste storage location on July 27, 2016. A map identifying the storage locations is included with this letter. A 15-minute count was performed in contact with the floor at each location. The readings obtained were as follows:

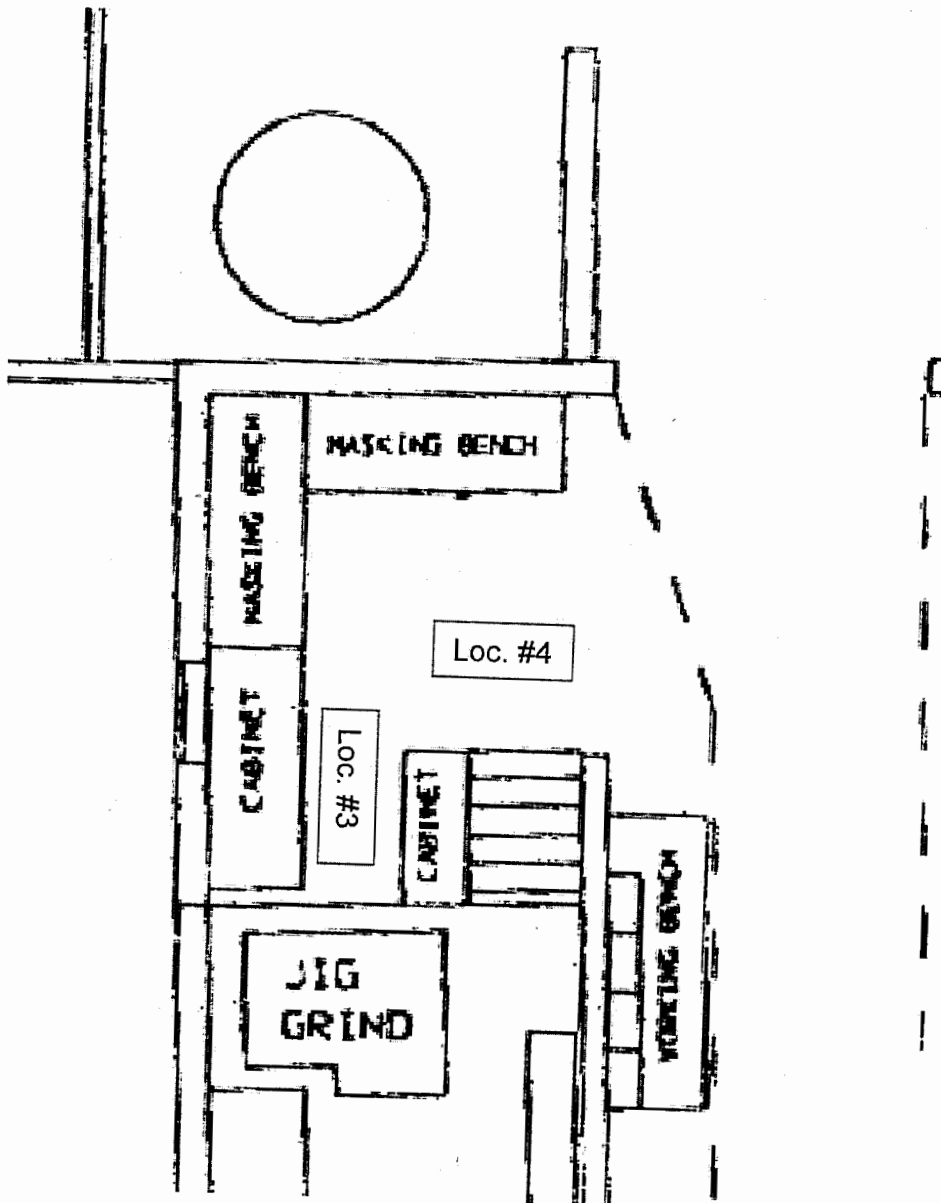
Budney Overhaul & Repair, Ltd.  
Old Rad Waste Storage Area  
Fixed-measurement locations

- a) Location 3: 4,589 counts = 306 cpm
- b) Location 4: 4,176 counts = 279 cpm
4. Scanning surveys were not initially performed of the facility. The radioactive material possessed under this license was in the form of natural thorium incorporated into a magnesium alloy at a maximum percentage of 3.9% by weight. Due to the low percentage of thorium in the metal, you would typically have to have a visual amount of metal present in order to obtain a reading with a portable survey meter.
