DUKE POWER COMPANY

OCONEE NUCLEAR STATION

REACTOR BUILDING

END ANCHORAGE SURVEILLANCE

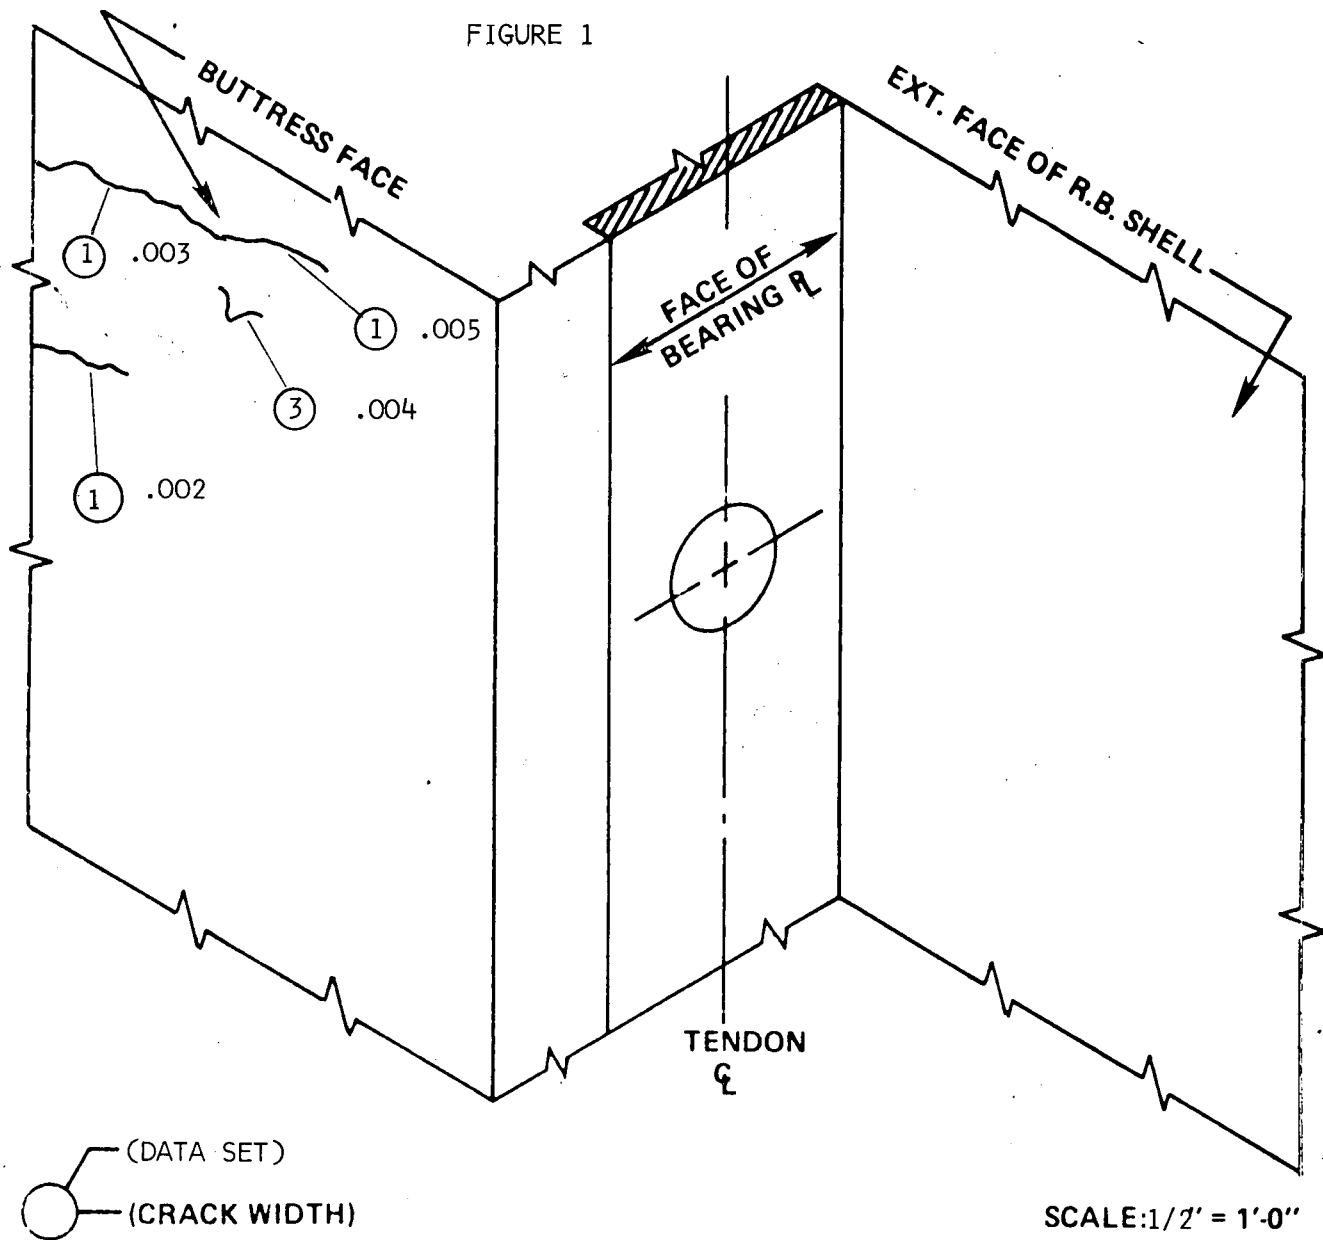
FIGURE 1

TENDON 26H37
 ELEVATION 841'

<u>DATA SET</u>	<u>DATE</u>	<u>TEMP INSIDE °F</u>	<u>TEMP OUTSIDE °F</u>	<u>REMARKS</u>
1	6-12-73	81	85	
2	1-22-74	76	67	NO NEW CRACKS
3	7-31-74	130	78	ONE NEW CRACK FOUND

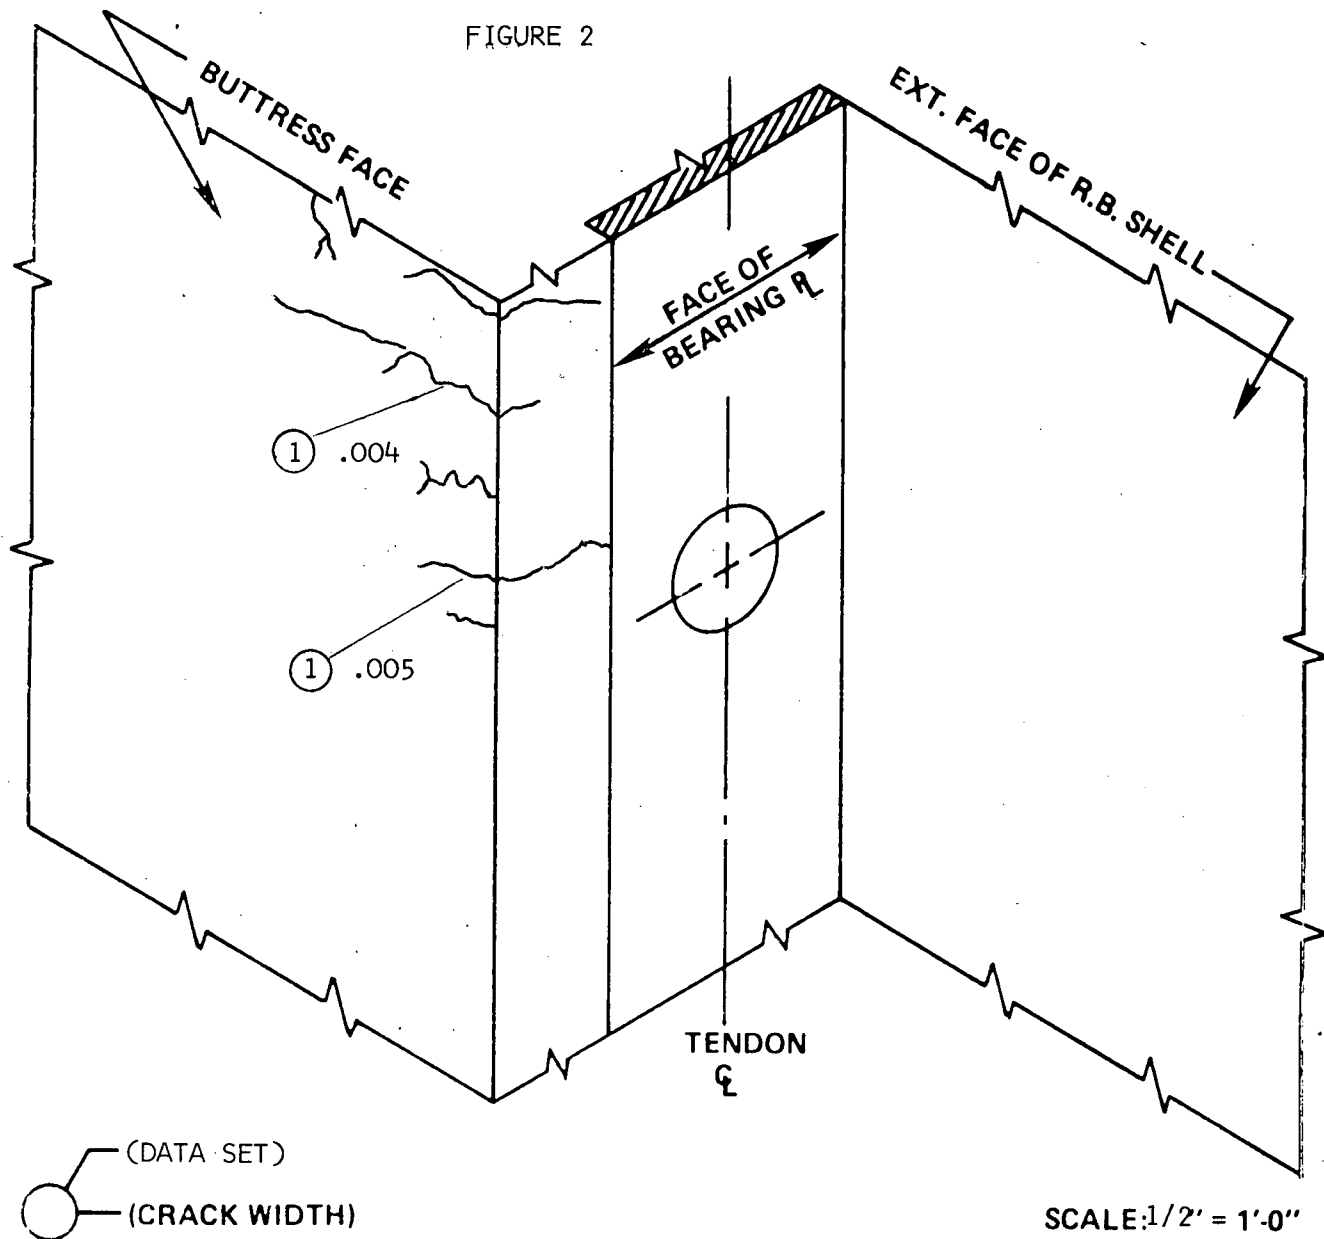
FIGURE 2

TENDON 26H37

ELEVATION 841'

<u>DATA SET</u>	<u>DATE</u>	<u>TEMP INSIDE °F</u>	<u>TEMP OUTSIDE °F</u>	<u>REMARKS</u>
1	6-12-73	81	85	
2	1-22-74	76	67	NO NEW CRACKS
3	7-31-74	130	78	NO NEW CRACKS

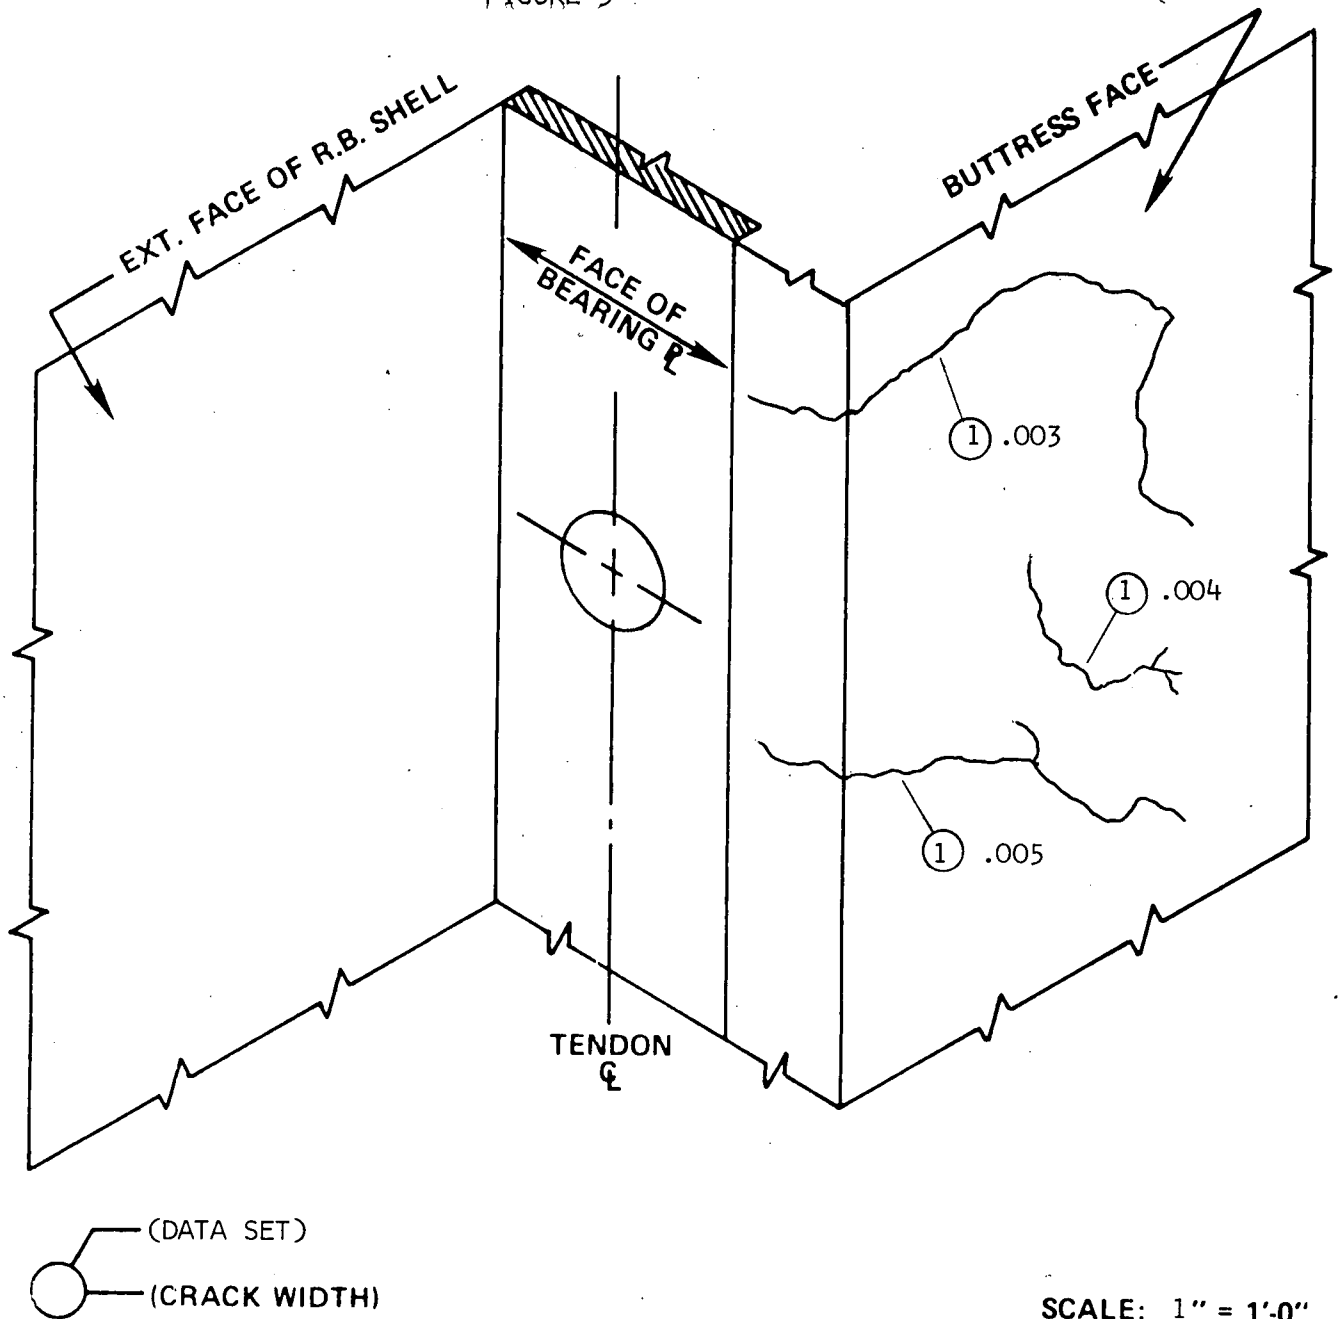
FIGURE 3

TENDON 24H70

ELEVATION 896'

<u>DATA SET</u>	<u>DATE</u>	<u>TEMP INSIDE °F</u>	<u>TEMP OUTSIDE °F</u>	<u>REMARKS</u>
1	6-12-73	81	85	
2	1-22-74	76	67	NO NEW CRACKS
3	7-31-74	130	78	NO NEW CRACKS

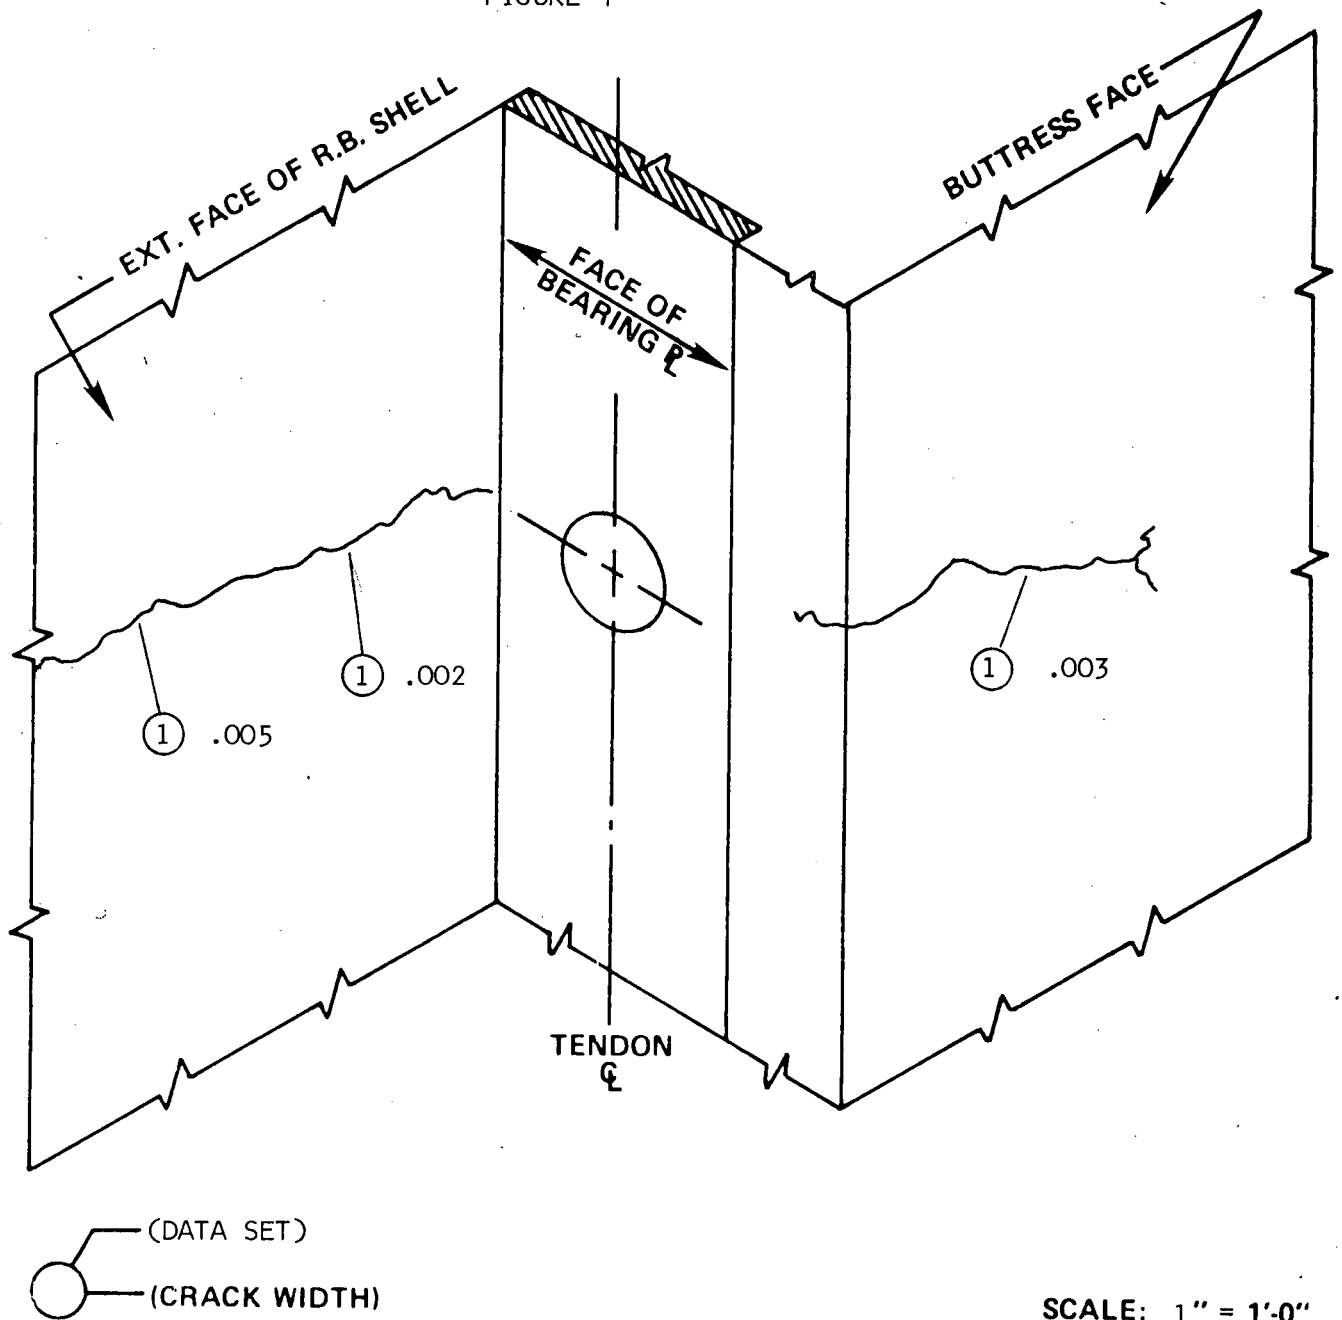
FIGURE 4

TENDON 24H76

ELEVATION 906'

<u>DATA SET</u>	<u>DATE</u>	<u>TEMP INSIDE °F</u>	<u>TEMP OUTSIDE °F</u>	<u>REMARKS</u>
1	6-12-73	81	85	
2	1-22-74	76	65	NO NEW CRACKS
3	7-31-74	130	78	NO NEW CRACKS

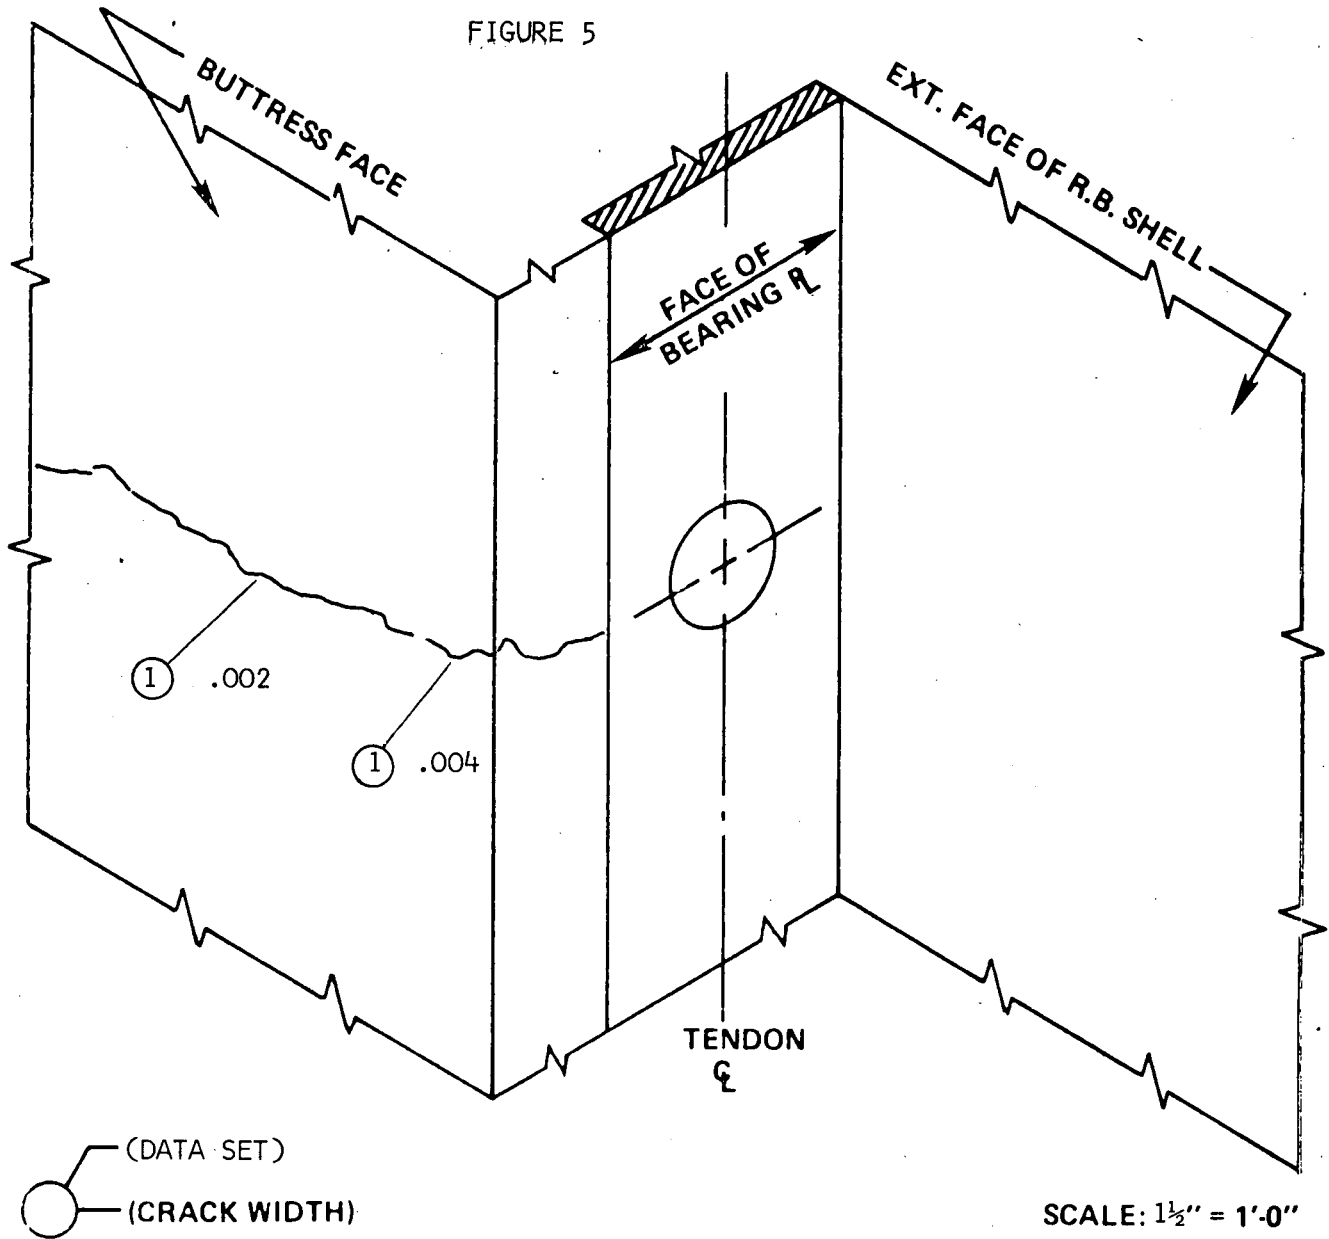
FIGURE 5

TENDON 24H86

ELEVATION 920'

<u>DATA SET</u>	<u>DATE</u>	<u>TEMP INSIDE °F</u>	<u>TEMP OUTSIDE °F</u>	<u>REMARKS</u>
1	6-12-73	81	85	
2	1-22-74	76	67	NO NEW CRACKS
3	7-31-74	130	78	NO NEW CRACKS

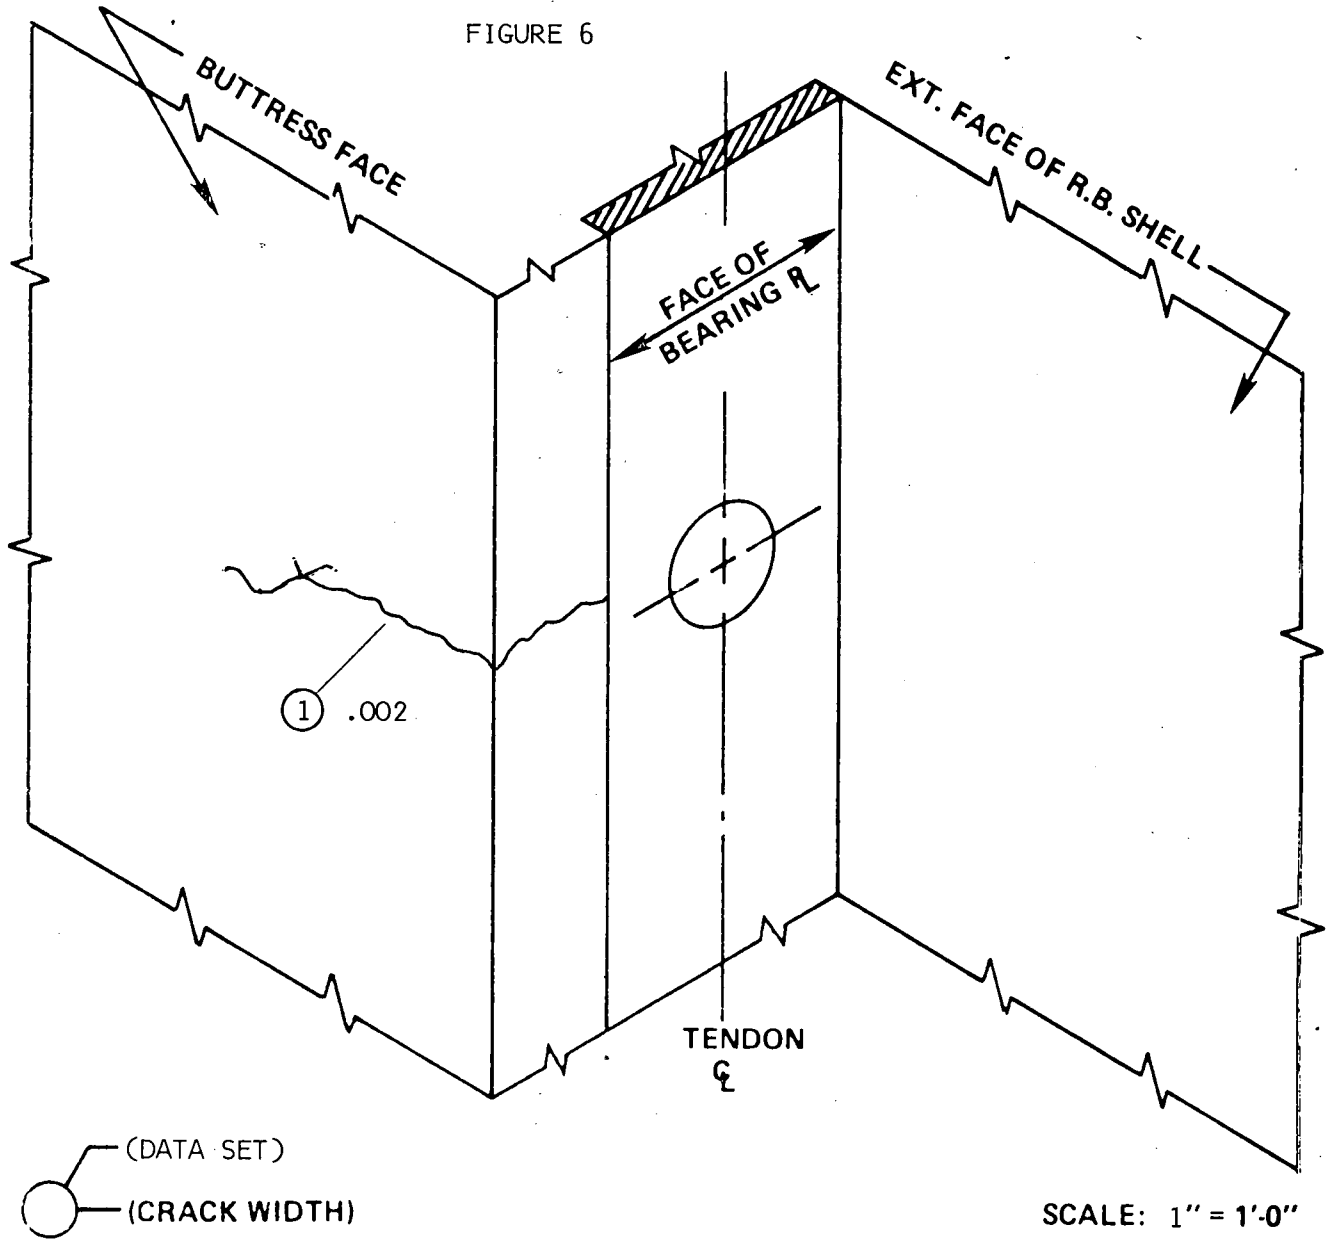
FIGURE 6

TENDON 26H89

ELEVATION 927'

<u>DATA SET</u>	<u>DATE</u>	<u>TEMP INSIDE °F</u>	<u>TEMP OUTSIDE °F</u>	<u>REMARKS</u>
1	6-12-73	81	85	
2	1-22-74	76	67	NO NEW CRACKS
3	7-31-74	130	78	NO NEW CRACKS

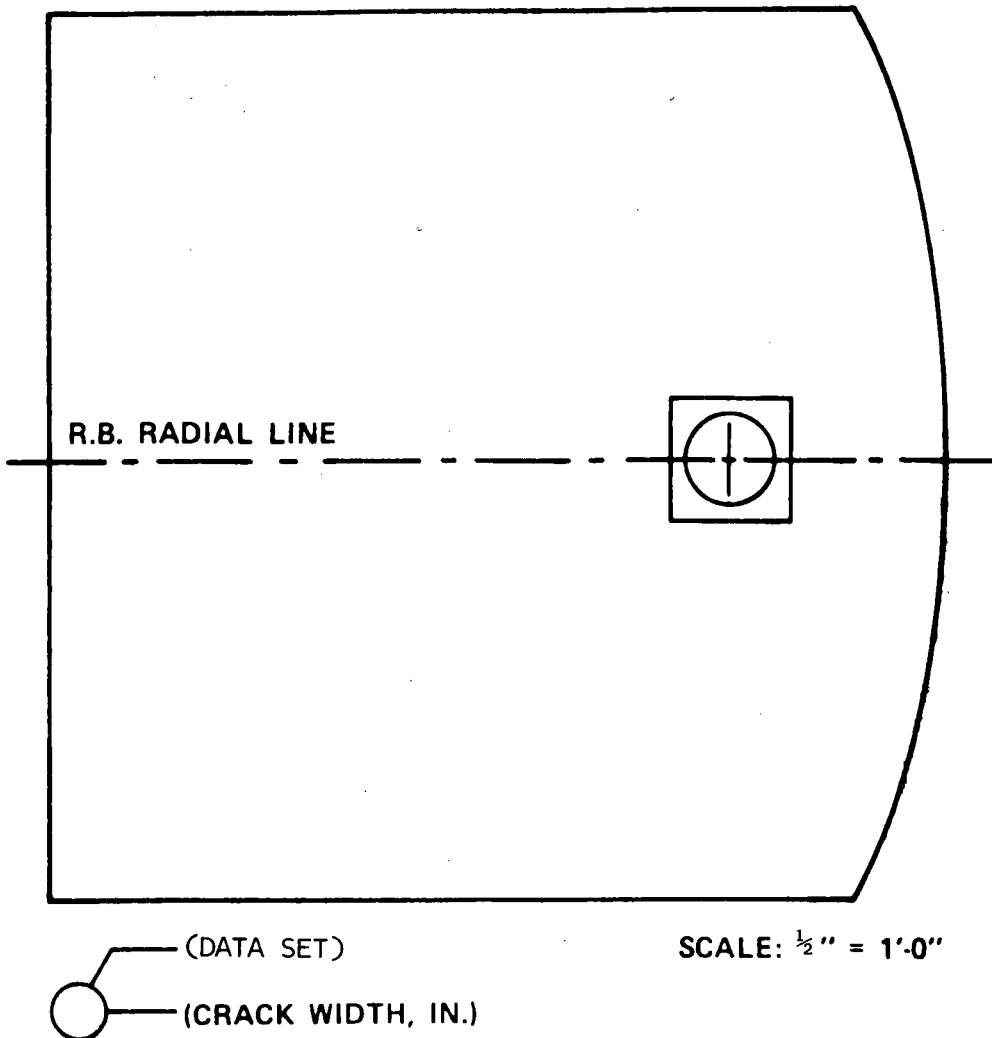
FIGURE 7

TENDON 12V28

ELEVATION 970'

<u>DATA SET</u>	<u>DATE</u>	<u>TEMP INSIDE °F</u>	<u>TEMP OUTSIDE °F</u>	<u>REMARKS</u>
1	6-12-73	81	85	NO CRACKS FOUND
2	1-22-74	76	65	NO NEW CRACKS
3	7-31-74	130	78	NO NEW CRACKS
