#### POTENTIALLY UNQUALIFIED COMPONENT IN CERTAIN ALLEN BRADLEY TIMING RELAYS

"Report of potential 10 CFR Part 21, Allen Bradley Timing Relay Model 700RTC

**UPDATE** - Report of potential 10CFR Part 21, Allen Bradley Timing  
Relay Model 700RTC  
Report No: P21-04302015, Rev. 3

Part 21 Report No: P21-04302015, Rev. 3

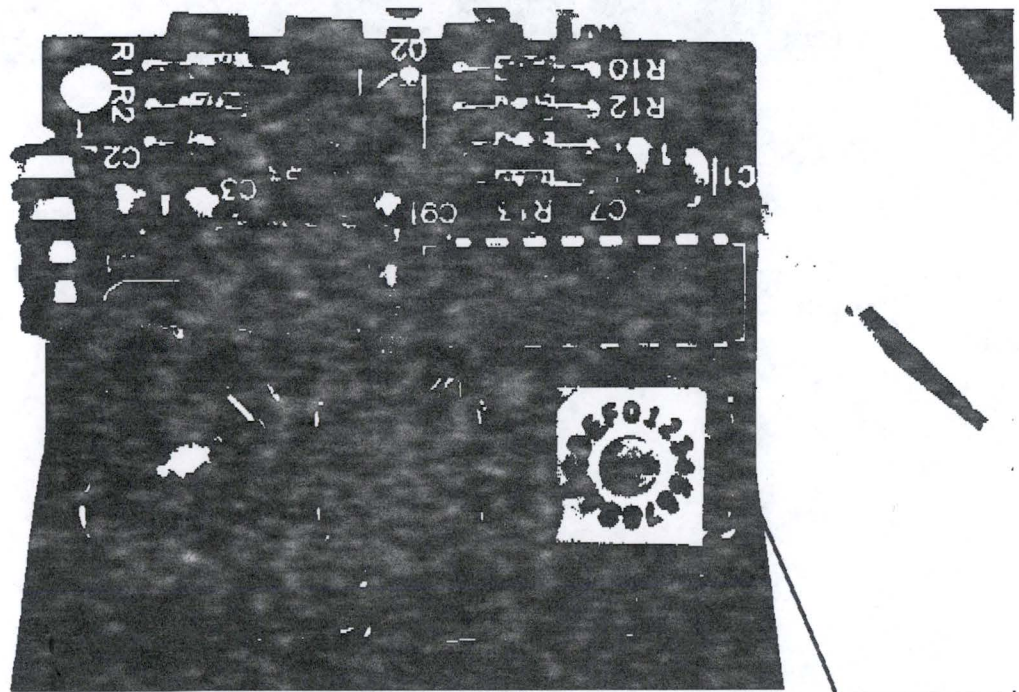
Figure 1- Original qualified design (prior to October 2008).  
Relays supplied prior to October 2008 are not affected by this issue.

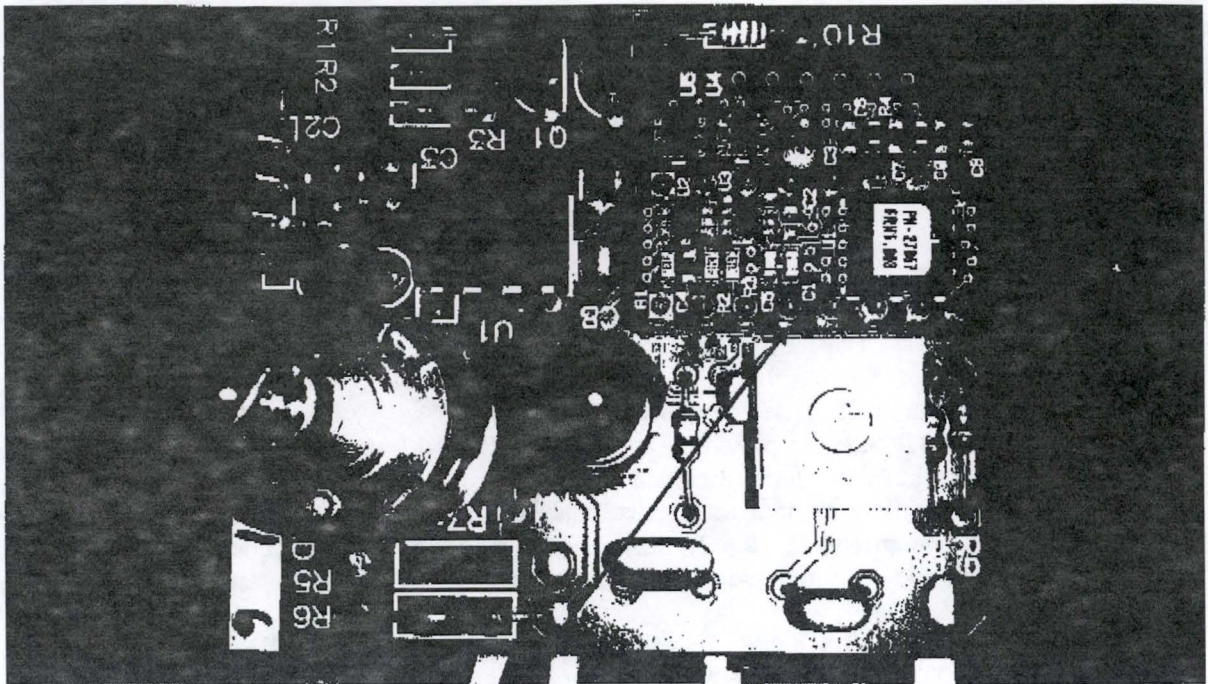
In October 2008, Allen Bradley made a design change without changing the part number of the commercial relay or providing any documented evidence of a design change. The manufacturer specification data sheets maintain the classification that the relays are "solid state", which would imply that there are no digital devices installed in the relay. However, after inspection of the internals of the timing relay (Figure 2), it has been identified that the unit does contain a CPLD which meets the definition of a digital device under the guidance of NEI 01-01. See Figures 1 and 2 below:

Figure 2 - New design circuit board and CPLD that replaced the original component.

The results were satisfactory with exception of the following condition: During Conducted Susceptibility CS114 onto the power lines, with the timing circuit in operation, the instantaneous contacts exhibited chatter in the range of 2.6 MHz to 20.3 MHz. The unit requires a ferrite to be installed onto the input power lines of the relay with 3 turns through the ferrite core. In this modified configuration, the relay was not susceptible to Conducted Susceptibility and successfully passed the required test per CS114.

The relays that are currently in stock at NLI have been placed on hold until after the units have been determined to be qualified for the specific application. NLI has completed the EMC qualification testing per the requirements of EPRI TR-102323 Rev. 4 for the following tests, as applicable: CE101, CE102, RE101, RE102, RS101, RS103, CS101, CS114, CS115 and CS116.

The relays are dedicated for generic application usage in timing applications. The specific plant application(s) is unknown by NLI. The EMC qualification of the relay is dependent on the installed configuration and location in the plant. The plant should evaluate whether the installed relays are subjected to the specific EMI/RFI condition Conducted Susceptibility CS114 between the frequencies of 2.6 MHz to 20.3 MHz identified above.
