**SUBJECT: THREE MILE ISLAND, UNIT 2, INDEPENDENT SPENT FUEL STORAGE  
INSTALLATION INSPECTION REPORT 072-00020/2016-001**

Dockets No.: 072-00020  
Licenses No.: SNM-2508  
Report No.: 072-00020/2016-001  
Licensee: United States Department of Energy – Idaho Operations  
Facility: Three Mile Island, Unit 2  
Independent Spent Fuel Storage Installation  
Location: Idaho Operations Office  
1955 Fremont Avenue  
Idaho Falls, ID 83415  
Dates: July 20-21, 2016  
Inspector: Eric J. Simpson, ISFSI Inspector  
Fuel Cycle and Decommissioning Branch  
Approved By: Jack E. Whitten, Chief  
Fuel Cycle and Decommissioning Branch  
Division of Nuclear Materials Safety

United States Department of Energy  
NRC Inspection Report 072-00020/2016-001

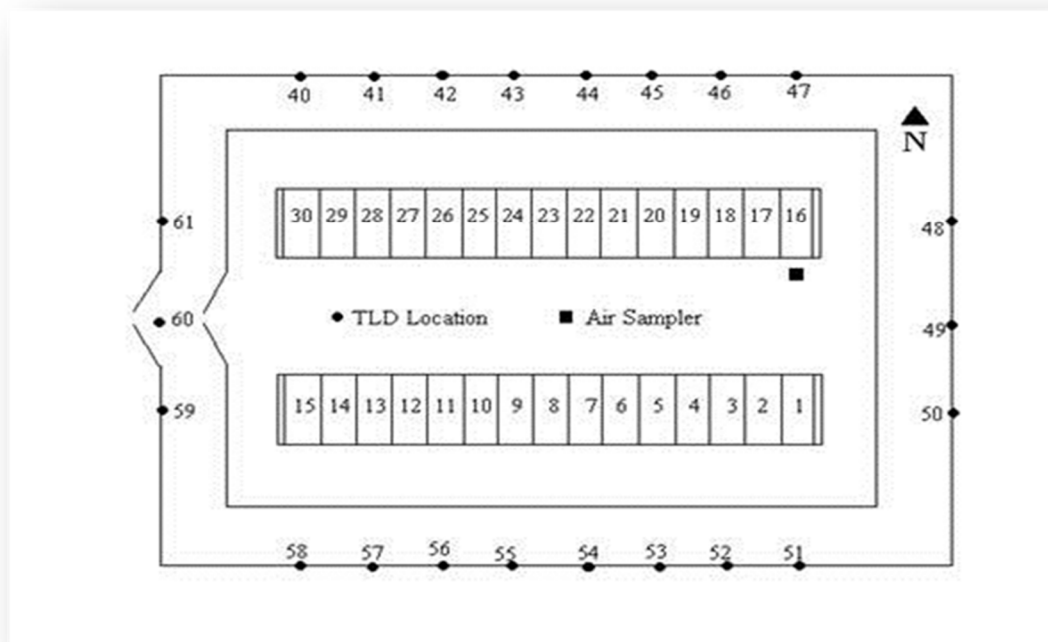
Figure 1, TMI-2 ISFSI

Thirty HSMs were situated on the TMI-2 ISFSI pad, with all but one containing spent fuel from the damaged TMI-2 reactor. The additional HSM situated on the pad was to serve as a backup storage location if problems arose with existing HSMs or DSCs. The 30 storage casks were arranged in two east-west rows of 15 with the door openings facing inward. The HSM casks 1–15 were situated in the southern row and casks 16–30 on the northern row (see Figure 1, above).

The inspection of the physical condition of the ISFSI found the concrete to be in good condition. The NRC inspector did not observe any vegetative growth in or around the concrete pad or any flammable or combustible materials stored on the ISFSI pad. A low volume air sampler was situated on the ISFSI pad in close proximity to HSM #16. The purpose of the air sampler is to determine radiological effluent releases from the TMI-2 ISFSI.

The physical condition of the concrete HSMs was observed to be very good. Signs of past concrete repairs were evident on many of the storage modules; however, all concrete repairs to the ISFSI were intact and appeared to be free from further degradation. All hardware, doors, latches, and ports installed in the TMI-2 HSMs inspected were in good condition. The NRC inspector utilized a Ludlum Model 19 sodium-iodide gamma survey meter (NRC #033906, calibration due 3/8/2017) to measure gamma exposure rates in microRoentgens per hour ( $\mu\text{R}^1/\text{h}$ ). Radiological conditions were observed and recorded by the NRC inspector on approach to the TMI-2 ISFSI, at the outer boundary locations of the pad, and at the HSM front and rear door locations. Ambient radiation levels at the INL site were elevated due to the influence of radioactive materials stored onsite that were unrelated to materials stored in the TMI-2 ISFSI. Ambient levels were approximately 150  $\mu\text{R}/\text{h}$  on approach to the ISFSI pad front gate. Measurements taken by the NRC inspector at various locations around the pad ranged from 70 – 190  $\mu\text{R}/\text{h}$ . Contact measurements were taken at various HSM front door locations and ranged from 190 – 1100  $\mu\text{R}/\text{h}$  (1.1 milliRoentgens/h). The HSM rear door panel contact measurements ranged for the HSMs from 40 – 500  $\mu\text{R}/\text{h}$ . All measurements were determined by the NRC inspector to be well below Technical Specification 3.2.1 and 3.2.2 dose rate limit requirements of no more than 100 millirem/hour for the front and rear access doors.
