POTENTIALLY UNQUALIFIED COMPONENT IN CERTAIN ALLEN BRADLEY TIMING RELAYS

UPDATE - Report of potential 10CFR Part 21, Allen Bradley Timing
Relay Model 700RTC
Report No: P21-04302015, Rev. 4

Part 21 Report No: P21-04302015, Rev. 4

Subject: Update - Report of potential 10CFR Part 21, Allen Bradley Timing Relay Model 700RTC – NRC Event Number 51030, Accession Number ML15134A016

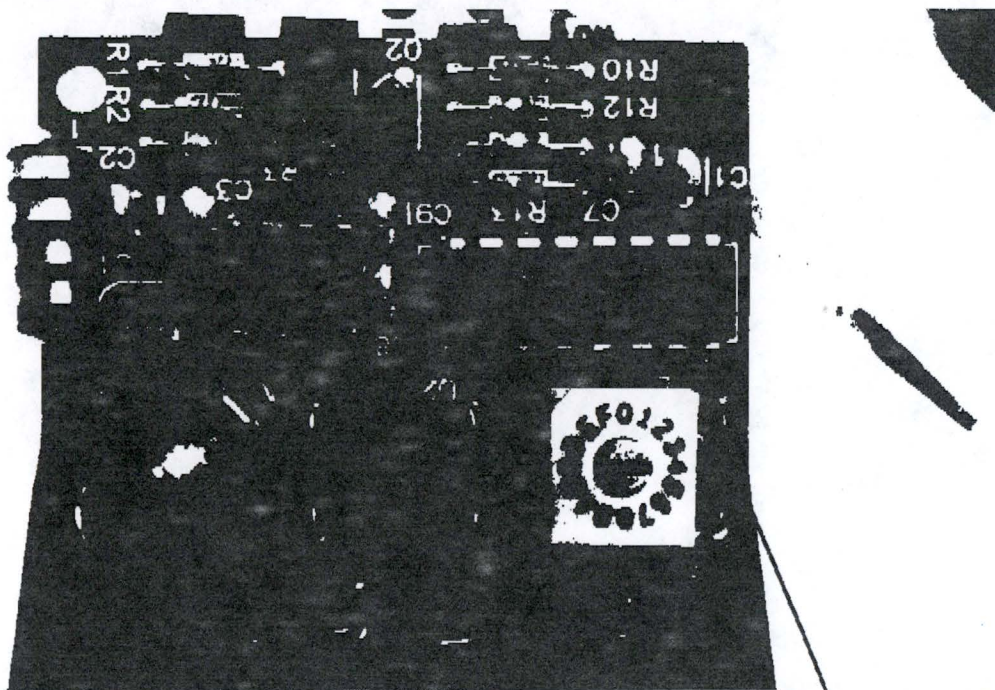
Figure 1- Original qualified design (prior to October 2008).
Relays supplied prior to October 2008 are not affected by this issue.
