## POTENTIALLY UNQUALIFIED COMPONENT IN CERTAIN ALLEN BRADLEY TIMING RELAYS

"Report of potential 10 CFR Part 21, Allen Bradley Timing Relay Model 700RTC

**UPDATE** - Report of potential 10CFR Part 21, Allen Bradley Timing  
Relay Model 700RTC  
Report No: P21-04302015, Rev. 4

Part 21 Report No: P21-04302015, Rev. 4

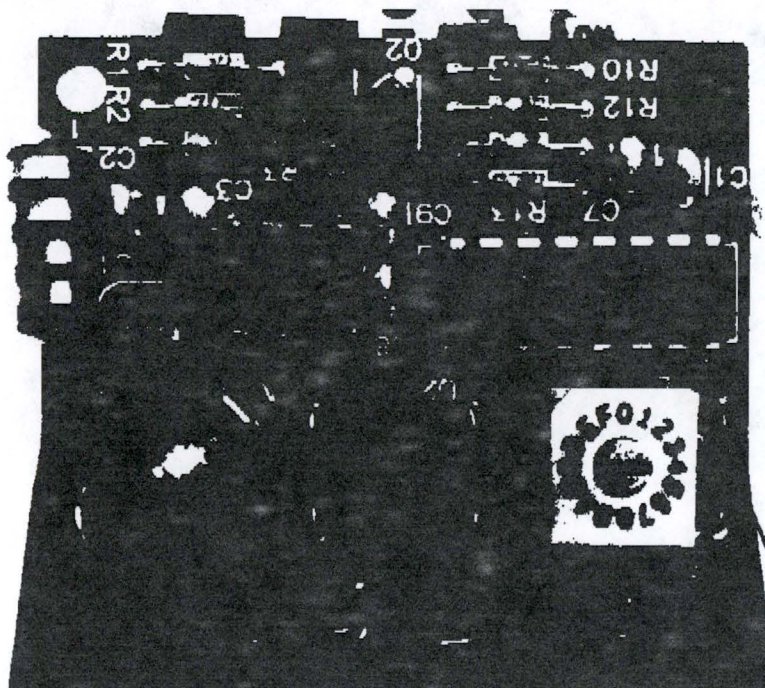
In October 2008, Allen Bradley made a design change without changing the part number of the commercial relay or providing any documented evidence of a design change. The manufacturer specification data sheets maintain the classification that the relays are "solid state", which would imply that there are no digital devices installed in the relay. However, after inspection of the internals of the timing relay (Figure 2), it has been identified that the unit does contain a CPLD which meets the definition of a digital device under the guidance of NEI 01-01. See Figures 1 and 2 below:

Figure 1- Original qualified design (prior to October 2008).  
Relays supplied prior to October 2008 are not affected by this issue.

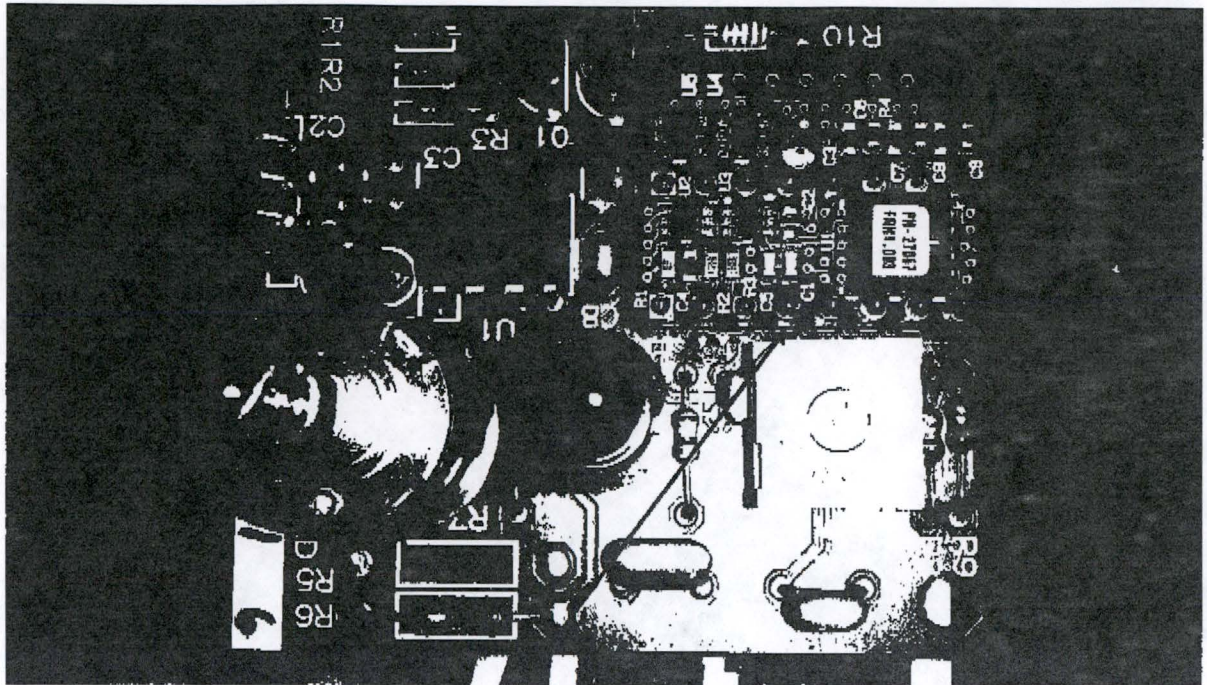
As of October 2008, Allen Bradley relays base model 700RTC, contain a CPLD (Complex Programmable Logic Device). This was an unpublished design change that was implemented to replace an obsolete integrated circuit chip. The undocumented design change did not result in a part number change from Allen-Bradley. There was no change to the appearance of the relay that would

Figure 2 - New design circuit board and CPLD that replaced the original component.

NLI has completed the EMC qualification testing per the requirements of EPRI TR-102323 Rev. 4 for the following tests, as applicable: CE101, CE102, RE101, RE102, RS101, RS103, CS101, CS114, CS115 and CS116.

The results were satisfactory with exception of the following condition: During Conducted Susceptibility CS114 onto the power lines, with the timing circuit in operation, the **Normally Open Timing** contact exhibited chatter (changed state) in the range of 3.3 MHz to 24.0 MHz. Supplemental testing was conducted to confirm the Timing contact was susceptible to the condition. The unit requires a ferrite to be installed onto the input power lines of the relay with 3 turns through the ferrite core. In this modified configuration, the relay was not susceptible to Conducted Susceptibility and successfully passed the required test per CS114.

The relays are dedicated for generic application usage in timing applications. The specific plant application(s) is unknown by NLI. The EMC qualification of the relay is dependent on the installed configuration and location in the plant. The plant should evaluate whether the installed relays are subjected to the specific EMI/RFI condition Conducted Susceptibility CS114 between the frequencies of 3.3 to 24.0 MHz identified above.
