Entergy Nuclear Operations, Inc.  
Pilgrim Nuclear Power Station  
600 Rocky Hill Road  
Plymouth, MA 02360

SUBJECT: Licensee Event Report 2016-002-01, Online Maintenance Test Configuration  
Prohibited By Technical Specifications

Licensee Event Report 2016-002-01

Online Maintenance Test Configuration Prohibited By Technical Specifications

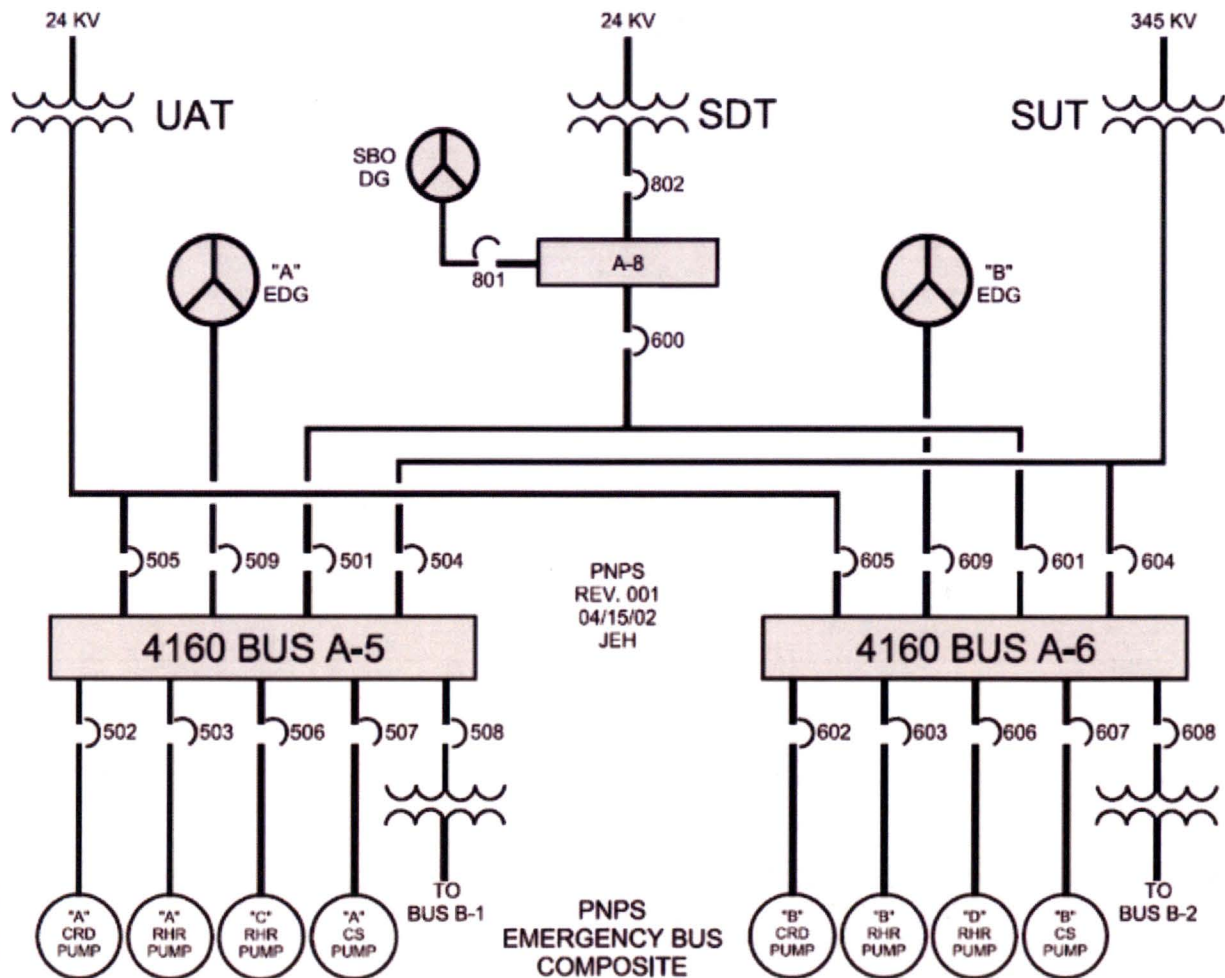
FIGURE 1

Another 4160 volt bus, Bus A8, is powered from either the shutdown transformer through Breaker A802 or the Station Blackout Diesel Generator (SBODG) through Breaker A801. Bus A8 provides power to Emergency Bus A5 through Breakers A600 and A501 and to Emergency Bus A6 through Breaker A600 and A601. Relays in the Bus A8 to Bus A5 and Bus A8 to Bus A6 control circuits are tested while the plant is online, at a two year interval, in accordance with Procedure 3.M.3-1, A5/A6 Buses 4kV Protective Relay Calibration/Functional Test and Annunciator Verification, Attachment 10, Bus A8 to A5 & A6 Relays. See Figure 1 for bus and breaker arrangement.

On April 19, 2016, at approximately 1450 hours, it was discovered, and documented in the Corrective Action Program under Condition Report CR-PNP-2016-02735, that maintenance activities performed on protective relays between 2010 hours on August 26, 2014 and 0143 hours on August 27, 2014, had rendered the Startup Transformer (X4) and the standby EDGs (X-107A&B) unable to automatically supply power to Buses A5 and A6, due to the breaker interlock that prevents Startup Transformer breakers (152-504 and 152-604) and Standby EDG breakers (152-509 and 152-609) from closing when Bus A5 breaker (152-501) and Bus A6 breaker (52-601) are in the TEST position and CLOSED. With incoming power unavailable from the shutdown transformer and power not automatically available from the startup transformer or the standby EDGs, the Limiting Conditions for Operation (LCO) 3.9.B.2 was not met. See Figure 1 for bus and breaker configuration.

During functional testing of negative sequence relays 146-600/A and B undervoltage relays 127-600A/1 and 2 and 127-600B/1 and 2, breakers 152-501 (shutdown transformer supply to Bus A5) and 152-601 (shutdown transformer supply to A6) are closed briefly and tripped on three different occasions in accordance with Procedure 3.M.3-1, Attachment 10. Based on a review of associated alarm data, operator logs, and interviews with maintenance personnel, the longest single duration when the buses were not operable was approximately 13 minutes; the combined duration is estimated to be approximately 33 minutes.
