SUBJECT: Licensee Event Report # 2015-005-01, "Automatic Reactor Trip Due to a Turbine-Generator Trip Caused by the Trip of 345kV Main Generator Output Breaker 3 due to a Failure of South Ring Bus 345kV Breaker 5"
Indian Point Unit No. 3
Docket No. 50-286
DPR-64

1. FACILITY NAME: INDIAN POINT 3

4. TITLE: Automatic Reactor Trip Due to a Turbine-Generator Trip Caused by the Trip of 345kV Main Generator Output Breaker 3 due to a Failure of South Ring Bus 345kV Breaker 5

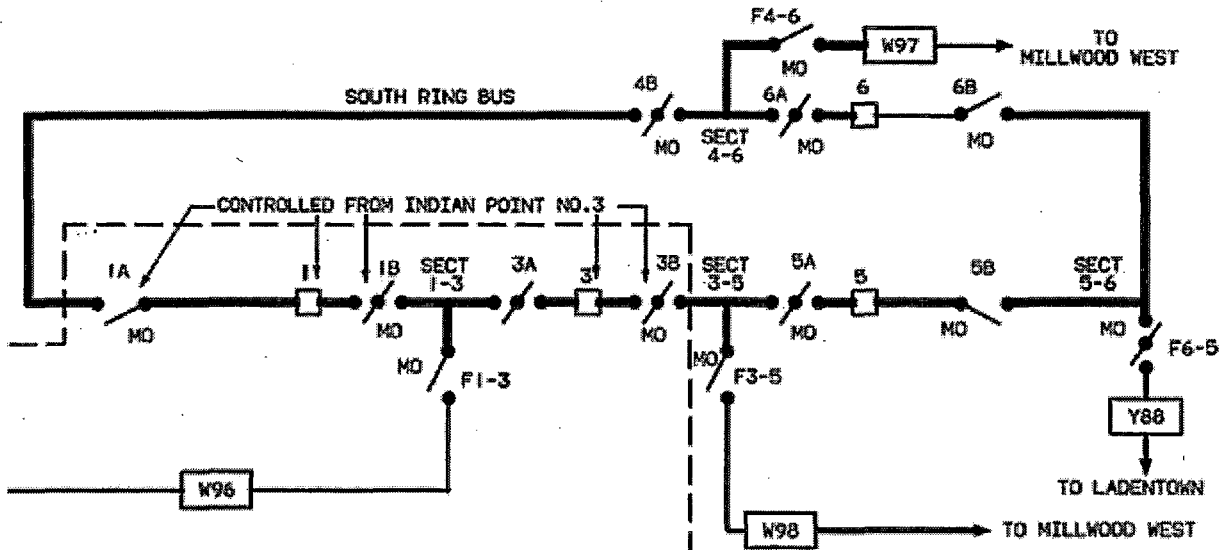
Figure of South Ring Bus at Buchanan 345kV Substation

The Unit 3 High Voltage Electrical Distribution System consists of the following subsystems: 1) 22kV system, 2) 345kV system, and 3) 138kV and 13.8kV system. The Unit 3 Main Generator supplies electrical power at 22kV through isolated phase bus to the two Main Transformers (MT). The MTs increase the voltage of the generator output to 345kV which is transmitted to the Buchanan Substation South Ring Bus via feeder W96. The Buchanan Substation contains two 345kV Ring Buses (North and South) and a 138kv bus. The South Ring Bus is normally supplied by Unit 3 and the North Ring Bus by Unit 2. The South Ring Bus is connected to the Millwood West Substation via two feeders, W97 and W98 and to the Ladentown Substation via feeder Y88. The South Ring Bus consists of four 345kV breakers, numbered 1, 3, 5 and 6. The 345kV breaker #5 was a Power Circuit Breaker, Type 345GA 25-30, SN 41-39006-2044, manufactured by ITE Imperial Corporation {I004} in 1971 and installed in 1973. This breaker is owned by Con Edison.

As a result of two successive in-service failures of breaker 3, both breaker 1 and 3 were replaced in 2003 with HVB Model SF6 circuit breakers. Con Edison had previously replaced breaker 6 in 2009. Breaker 5 was replaced due to its failure reported in this LER leaving no other ITE 345 kV Type GA breakers in the Buchanan switchyard. 138kV breakers are considered similar in that they are high power circuit breakers. 138kV breaker BT5-6 is ITE Imperial Model 230GA similar to 345 kV breaker 5. It was determined that any failures during testing or maintenance, aside from an in-service failure, would not pose the same operational risk, as the components are out of service when tested or maintained. Based on the results of Preventive Maintenance (PM)s performed on BT5-6, it was determined the probability of an in-service failure was medium. 138kV breaker BT5-6 is scheduled for replacement in the 2019 refueling outage. The PMs performed and their periodicities are consistent with ENN-EP-G-004 (Switchyard and Large Power Transformer Preventive Maintenance Guidelines). A review of the PM results did not show any negative or degrading trend. An EOC corrective action was included in the action plan to perform an internal inspection of breaker BT5-6 at the next available opportunity. The risk to continued operation is considered low due to the low number of operating cycles this breaker experiences. Low operating cycles reduces the stress on the contact support structure. Similar high voltage breakers are 345 kV GE-Hitachi HVB breakers 1, 3, 6, 7, 9 and 11. The failed breaker 5 was replaced with an GE-Hitachi HVB breaker. Currently all PMs for these breakers are complete and no PMs have been deferred and no adverse trends have been noted.

Direct cause of the RT was failure of Buchanan 345kV breaker 5 due to age-related degradation of the C phase contacts. This degradation was due to misalignment of the contacts that resulted in a hot spot due to high resistance. Con Edison who owned the breaker, determined the contact support system failed due to repeated cycling (fatigue failure). The failure of breaker 5 activated protective relays that opened the remaining Main Generator Output breaker 3 which initiated a trip sequence that resulted in an immediate Generator Trip, Turbine Trip and RT. The root cause was Indian Point Energy Center did not provide formal notification of industry operating experience (OE) to Con Edison. The specific incident pertains to the OE on ITE Type GA breakers that could impact IPEC generation. The condition was exacerbated by the OE process (EN-OE-100) that did not have a trigger for formal communication of important OE information to external groups that control and own equipment critical to IPEC generation.

- A detailed inspection and failure analysis of 345kV breaker 5 was performed by Con Edison to identify the specific failure mechanism and root cause. The Con Edison results were discussed with Entergy and a Root Cause Evaluation performed that included the results obtained from Con Edison.
- 345kV Breaker 5 was replaced by Con Edison.
- Procedure EN-OE-100 (OE Program) was revised by including a new section describing how to initiate formal notification to external groups when OE related to components they own and/or control can affect generation.
- A new IPEC site procedure was prepared (SMM-LI-126) that formalizes the process for notifying external groups of operating experience that can affect generation at IPEC.
