NL-16-102

September 14, 2016

SUBJECT: Licensee Event Report # 2015-005-01, "Automatic Reactor Trip Due to a Turbine-Generator Trip Caused by the Trip of 345kV Main Generator Output Breaker 3 due to a Failure of South Ring Bus 345kV Breaker 5"
Indian Point Unit No. 3
Docket No. 50-286
DPR-64

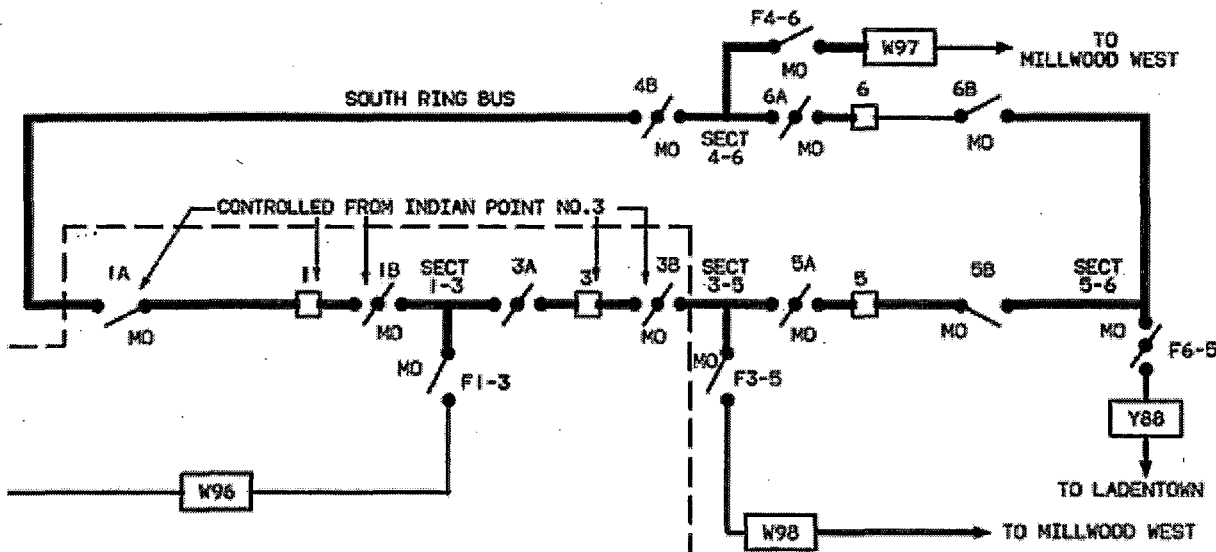
Figure of South Ring Bus at Buchanan 345kV Substation

The Unit 3 High Voltage Electrical Distribution System consists of the following subsystems: 1) 22kV system, 2) 345kV system, and 3) 138kV and 13.8kV system. The Unit 3 Main Generator supplies electrical power at 22kV through isolated phase bus to the two Main Transformers (MT). The MTs increase the voltage of the generator output to 345kV which is transmitted to the Buchanan Substation South Ring Bus via feeder W96. The Buchanan Substation contains two 345kV Ring Buses (North and South) and a 138kv bus. The South Ring Bus is normally supplied by Unit 3 and the North Ring Bus by Unit 2. The South Ring Bus is connected to the Millwood West Substation via two feeders, W97 and W98 and to the Ladentown Substation via feeder Y88. The South Ring Bus consists of four 345kV breakers, numbered 1, 3, 5 and 6. The 345kV breaker #5 was a Power Circuit Breaker, Type 345GA 25-30, SN 41-39006-2044, manufactured by ITE Imperial Corporation {I004} in 1971 and installed in 1973. This breaker is owned by Con Edison.

Direct cause of the RT was failure of Buchanan 345kV breaker 5 due to age-related degradation of the C phase contacts. This degradation was due to misalignment of the contacts that resulted in a hot spot due to high resistance. Con Edison who owned the breaker, determined the contact support system failed due to repeated cycling (fatigue failure). The failure of breaker 5 activated protective relays that opened the remaining Main Generator Output breaker 3 which initiated a trip sequence that resulted in an immediate Generator Trip, Turbine Trip and RT. The root cause was Indian Point Energy Center did not provide formal notification of industry operating experience (OE) to Con Edison. The specific incident pertains to the OE on ITE Type GA breakers that could impact IPEC generation. The condition was exacerbated by the OE process (EN-OE-100) that did not have a trigger for formal communication of important OE information to external groups that control and own equipment critical to IPEC generation.

- A detailed inspection and failure analysis of 345kV breaker 5 was performed by Con Edison to identify the specific failure mechanism and root cause. The Con Edison results were discussed with Entergy and a Root Cause Evaluation performed that included the results obtained from Con Edison.
- 345kV Breaker 5 was replaced by Con Edison.
- Procedure EN-OE-100 (OE Program) was revised by including a new section describing how to initiate formal notification to external groups when OE related to components they own and/or control can affect generation.
- A new IPEC site procedure was prepared (SMM-LI-126) that formalizes the process for notifying external groups of operating experience that can affect generation at IPEC.
