Subject: Licensee Event Report Number 52185, "Irradiator Safety Equipment Failure"

Licensee Event Report – Safety Equipment Failure

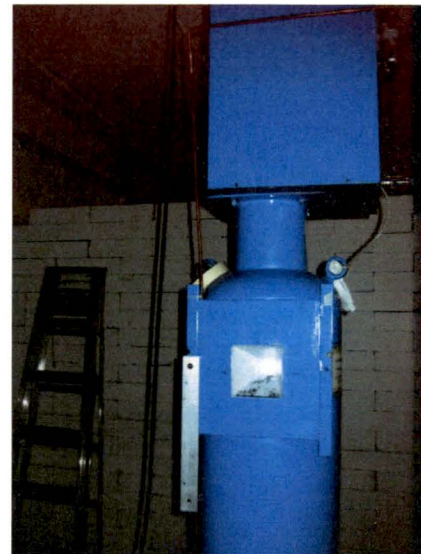
On the afternoon of August 15, 2016, a member of the radiation safety office was performing routine survey instrument calibrations using a NIST-owned J.L. Shepherd and Associates irradiator. The unit is a Model 81-12Q calibrator. At the end of an instrument calibration the technician noticed that the indicated radiation level on the survey instrument (seen via closed-circuit video camera system) was not receding after pressing the source-return button on the control panel of the irradiator. Further visual checks were made by observing the warning light still flashing and noticing the source-up indicators on the control panel. The technician immediately recognized the unusual situation and proceeded to make a phone call to the supervisor to seek assistance.

Authorized J.L. Shepherd personnel visited NIST Gaithersburg on August 17, 2016 and performed an emergency service to repair the irradiator. The field service engineer identified failure of a 1-inch negator spring as the probable cause of the event. The negator spring, upon failure, obstructed the return path for the sources into the shield. Given the position of the obstruction, the sources became stuck at the 6 Ci position.

- The field service engineer replaced the failed negator spring causing the event and performed checks to ensure proper operation of the unit prior to resuming operations with the irradiator.
- A one-time contract for a full-scope preventative maintenance service of the irradiator was scheduled for October 2016.
