UNITED STATES
NUCLEAR REGULATORY COMMISSION
WASHINGTON, D. C. 20555

TRIP REPORT - OCONEE NUCLEAR STATION

Subject: Oconee Aux. Feedwater Header
File: OS-211.04

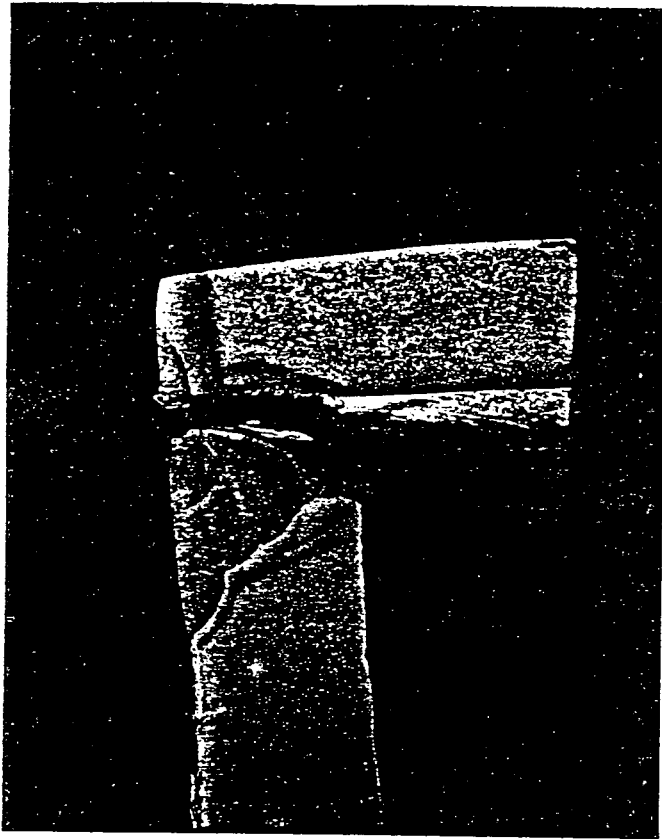
Figure 1

The weld shown in figure 1 is thought to be from generator A. It is essentially a full penetration weld of good quality at the location examined. The plate appears to be a plain low carbon steel of 3/8" nominal thickness. The hardness of the two parts shown in figure 1 is in the range HR_B 71-86. The failure propagated in the heat affected zone immediately adjacent to the weld.

Section of weld from
aux. feedwater header
Oconee Unit 3 A
generator

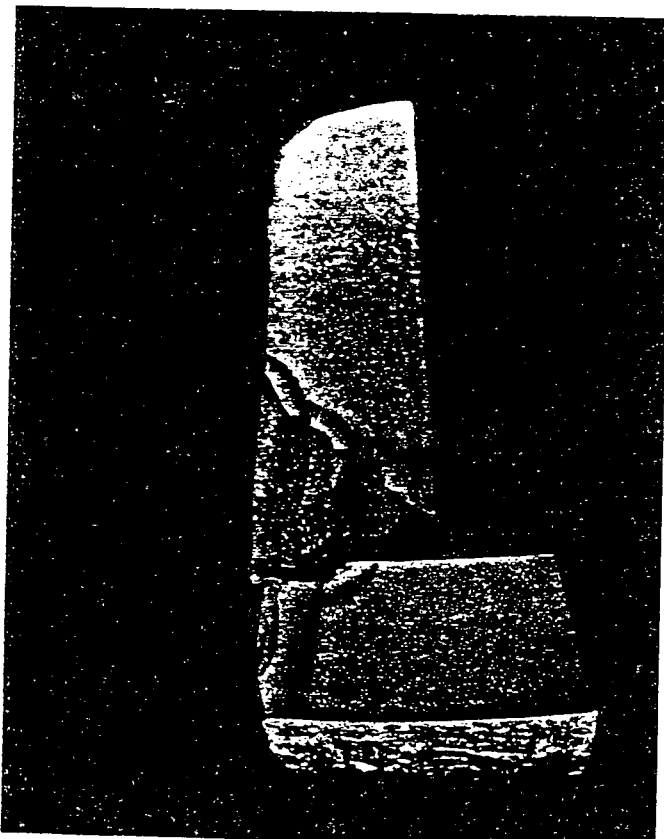
Figure 2

The weld shown in figure 2 is believed to be from steam generator ^{A DEW}. The total weld thickness in this part is approximately 0.350"; however, the depth of fusion is only about 0.200" on the side that broke. There are also lack of fusion and lack of penetration defects at the edge of the weld opposite the failure. The original machined weld preparation can be seen at the root of the weld. The base material has the same appearance as that of figure 1. The base metal hardness of the two parts is in the range HR_B 68-78.

Section of weld from
aux. feedwater header
Oconee Unit 3 A
generator

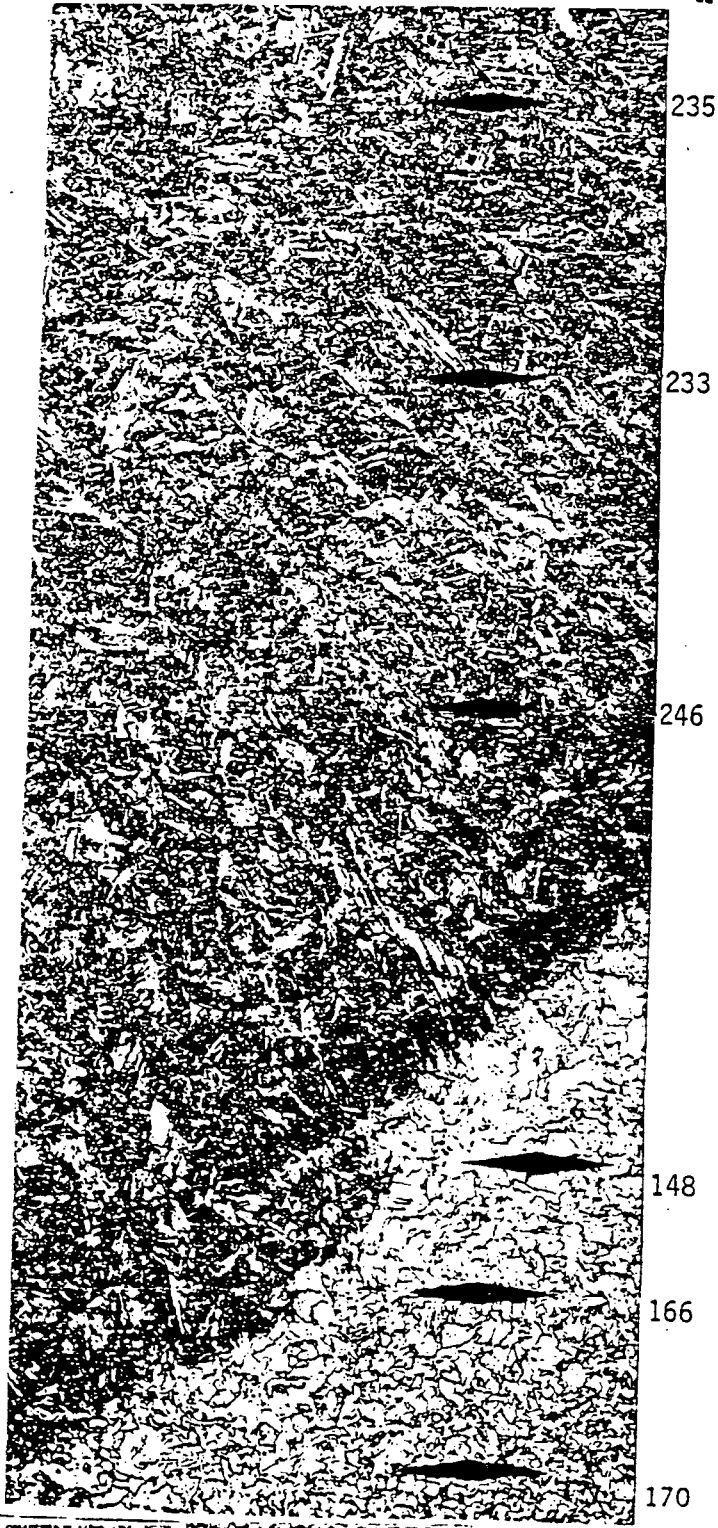
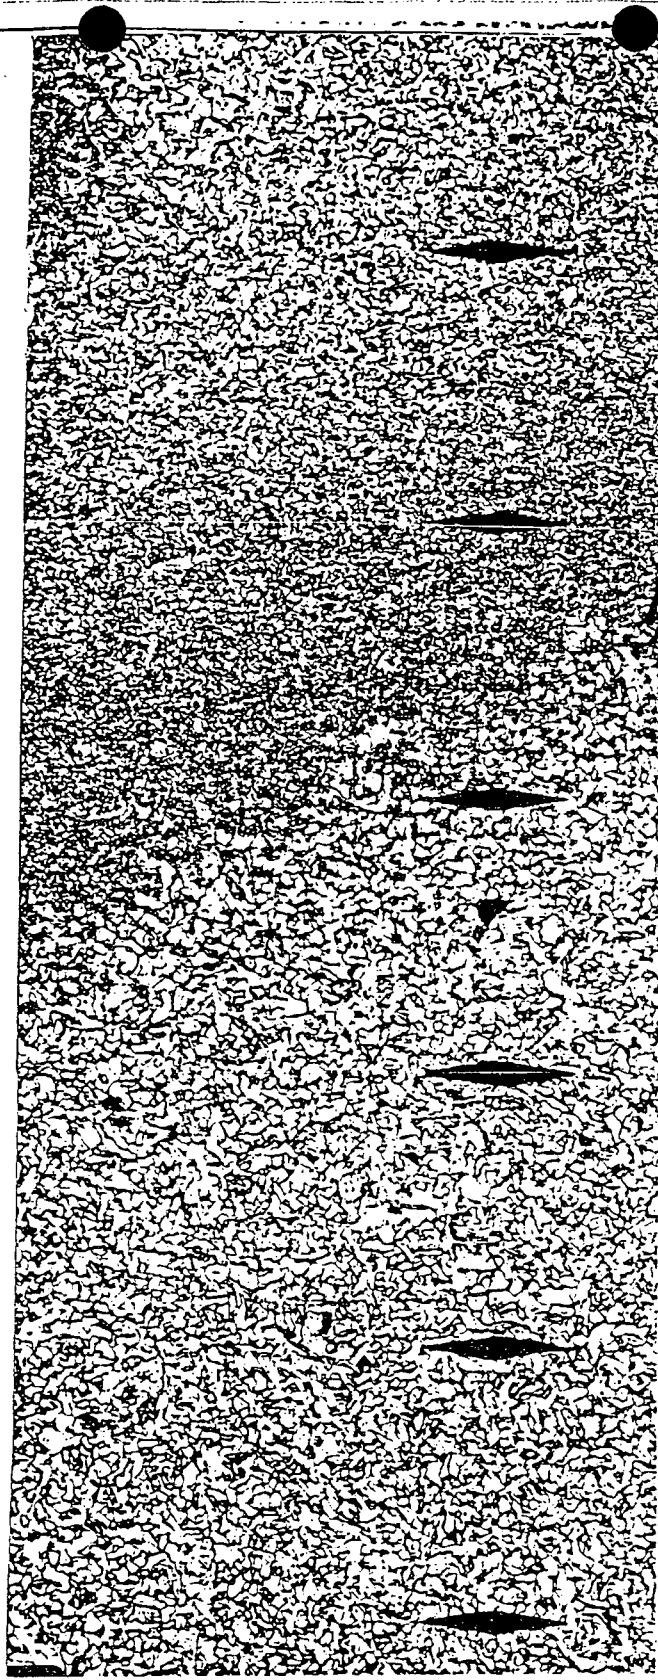
Figure 3 shows the typical weld, heat affected zone, and base metal microstructures. A knoop microhardness transverse is also shown. The microhardness is typical of what is expected in the area of a weld in low carbon steel and agrees with the macrohardness numbers reported above.

Weld, heat affected zone, and base metal from typical area of weld.
Black diamonds and corresponding numbers are KHN 500 g.
