SUBJECT: LER 89-006-01: on 891127, polar crane Tech Spec violated due to mgt deficiency, inadequate policy.

Subject: Oconee Nuclear Station
Docket Nos. 50-269, -270, -287
LER 287/89-06 Supplement, Revision 1

TITLE (4)
Polar Crane Technical Specification Violated Due to Management Deficiency, Inadequate Policy

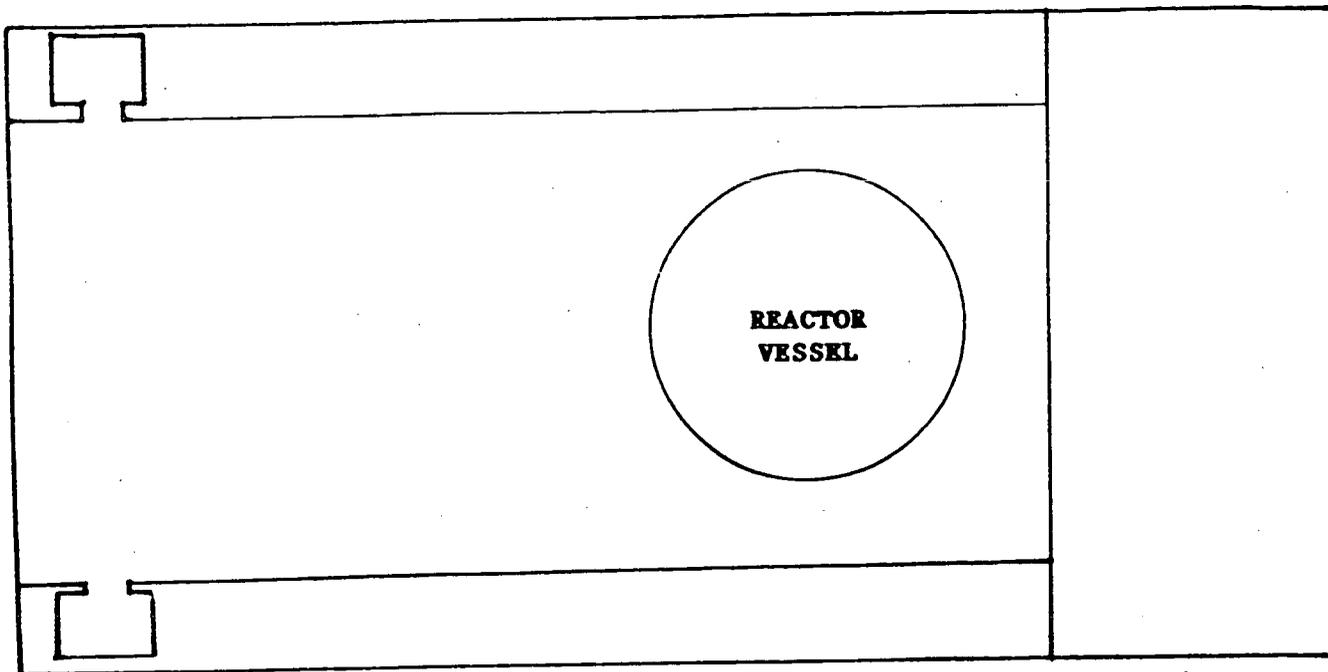
FUEL TRANSFER CANAL

The fuel transfer canal forms a passageway in the reactor building extending from the reactor vessel to the reactor building wall (see figure-page 7). It is formed by an upward extension of the primary shield walls. The enclosure is a reinforced concrete structure lined with stainless clad plate to form a canal above the vessel which is filled with borated water for refueling evolutions. Fuel movement is defined as any time a fuel assembly is attached to a fuel handling bridge, the auxiliary hoist, or is in the fuel transfer carriage mechanism which transports spent fuel assemblies to and from the reactor building and spent fuel pool.
